Devon Energy
Spud 16 State 8H
Delineation Report & Work Plan

Section 16, Township 23S, Range 29E
Eddy County, New Mexico

30-015-40038

April 17, 2019

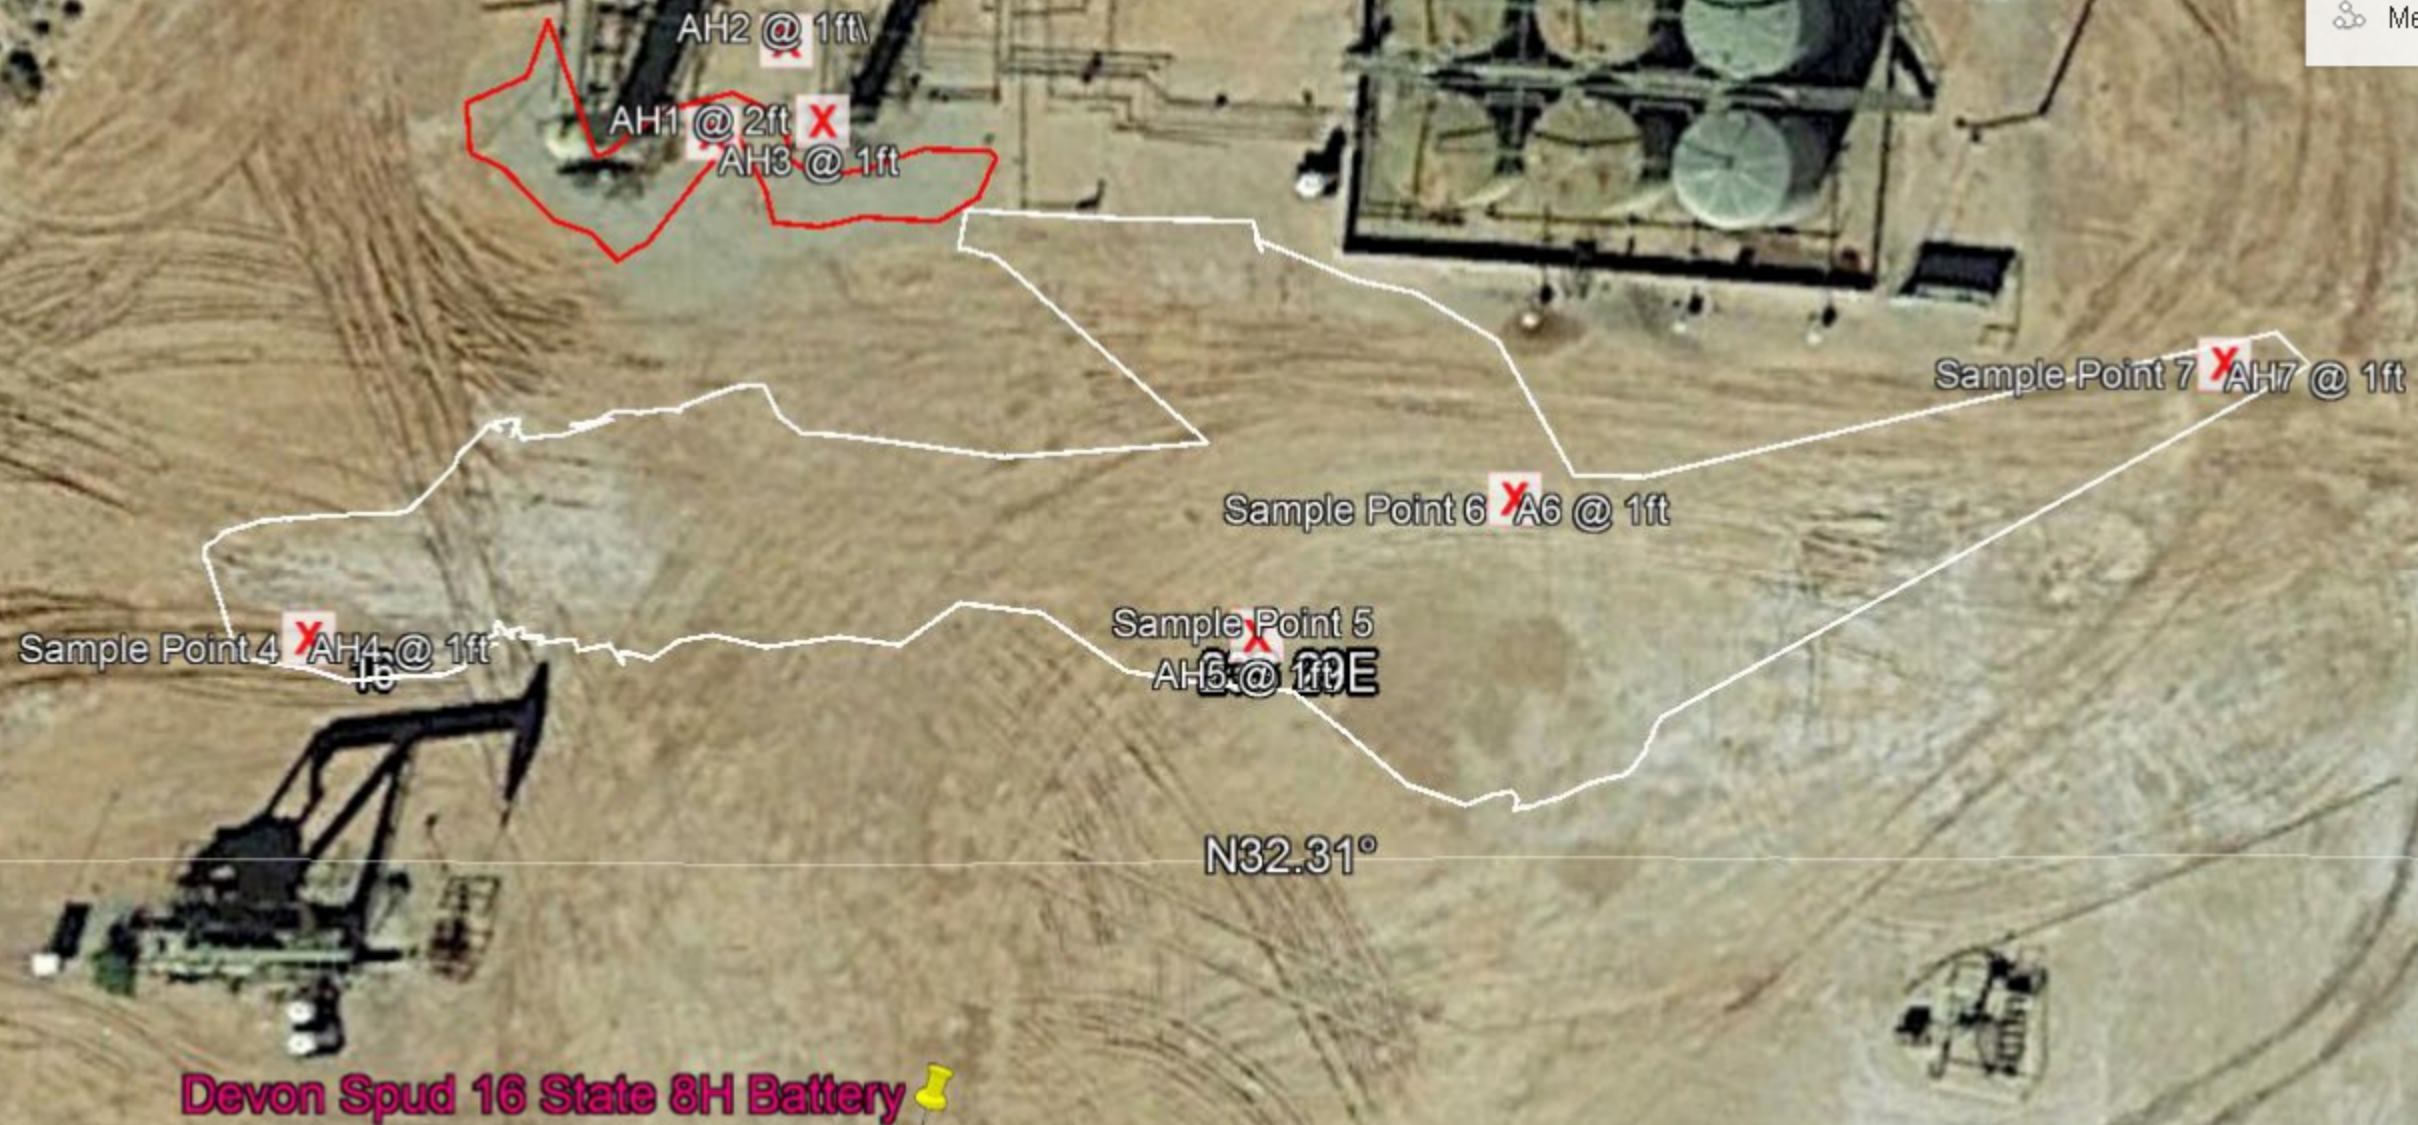
Figure 2 Site Plan

AH2 @ 1ft
AH1 @ 2ft
AH3 @ 1ft
AH7 @ 1ft
AH6 @ 1ft

- Devon Spud 16 State 8H Battery
- Feature 1
- Manual Excavation
- Mechanized Excavation

Based on the NMOCD soil screening levels, depth to groundwater for this area, and number of lines: It is proposed to “hand dig” the interior of the bermed area to a depth whereby TPH levels are below 100 mg/kg. The estimated area of impact is Two Hundred Forty Nine (249) cubic feet. The interior of the bermed area will be backfilled with like material and the berm restored. There is TPH contamination on surface area of pad, however this a heavily trafficked area with transport trucks, and will need to be remediated with caution, and backfilled immediately in order to prevent accidents. The approximate area of impact for the surface area of the pad is Two Thousand Nine Hundred Sixty One (2,961) cubic feet. It is proposed to grab sidewall and bottom samples for field testing as confirmation of the vertical and horizontal remediation respectively. All confirmations samples will be sent to an NMOCD approved laboratory for final analyses.

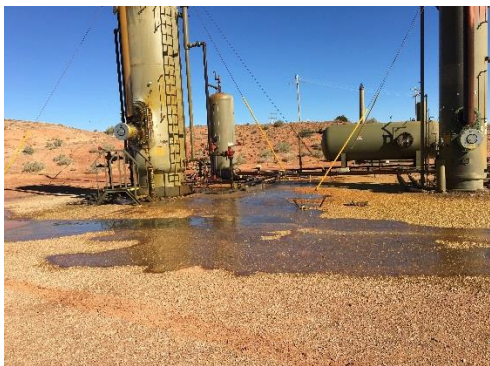
According to the C-141: According to the C-141 the cause of release, was a broken site glass on the heater treater. The affected area measured approximately 125' x 30'. All fluids remained on the location pad area. A Trimble Juno 3B handheld was used to map the spill area. (Figure 2). Approximately 11,307 cubic feet of surface area was impacted.

Spill Source

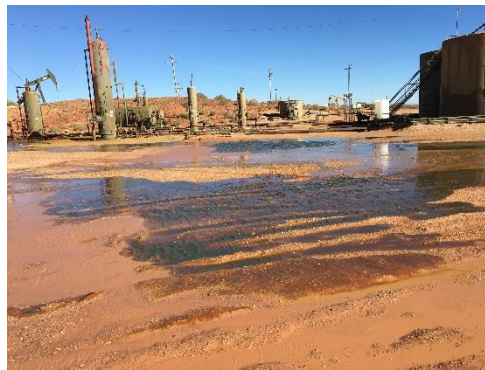
Impact to pad area

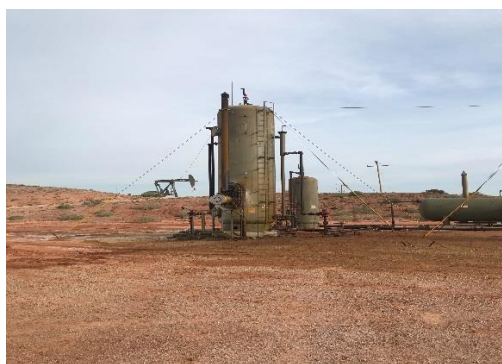
Spill area post Vac Truck activity

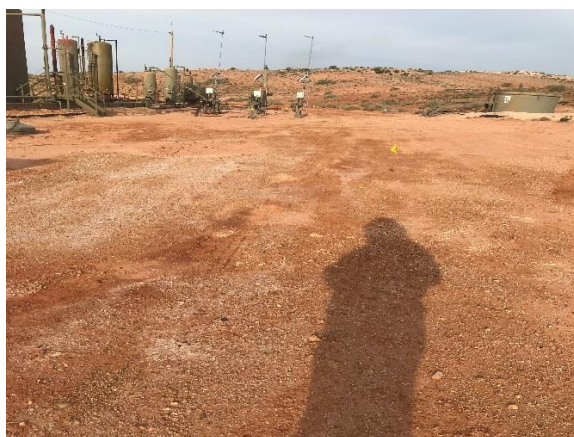
On March 27, 2019 SESI personnel were on site in order to meet with Devon Energy personnel regarding the safety issues, number of high pressure lines, as well as electrical lines on the location. The area was flagged for future New Mexico One Call clearance.

Marked electrical lines on pad area
