Re: Closure Report
Bobwhite 12 State Com 1H Tank Battery (9/19/18)
API #: 30-025-40701
GPS: 32.500012, -103.528968
RP#: 1RP-5210
Unit Letter C, Section 12, Township 21 South, Range 33 East
Lea County, New Mexico

COG Operating, LLC (COG) is pleased to submit the following closure report in response to a release that occurred at the Bobwhite 12 State Com 2H located in Unit Letter B, Section 12, Township 21 South, Range 33 East in Lea County, New Mexico.

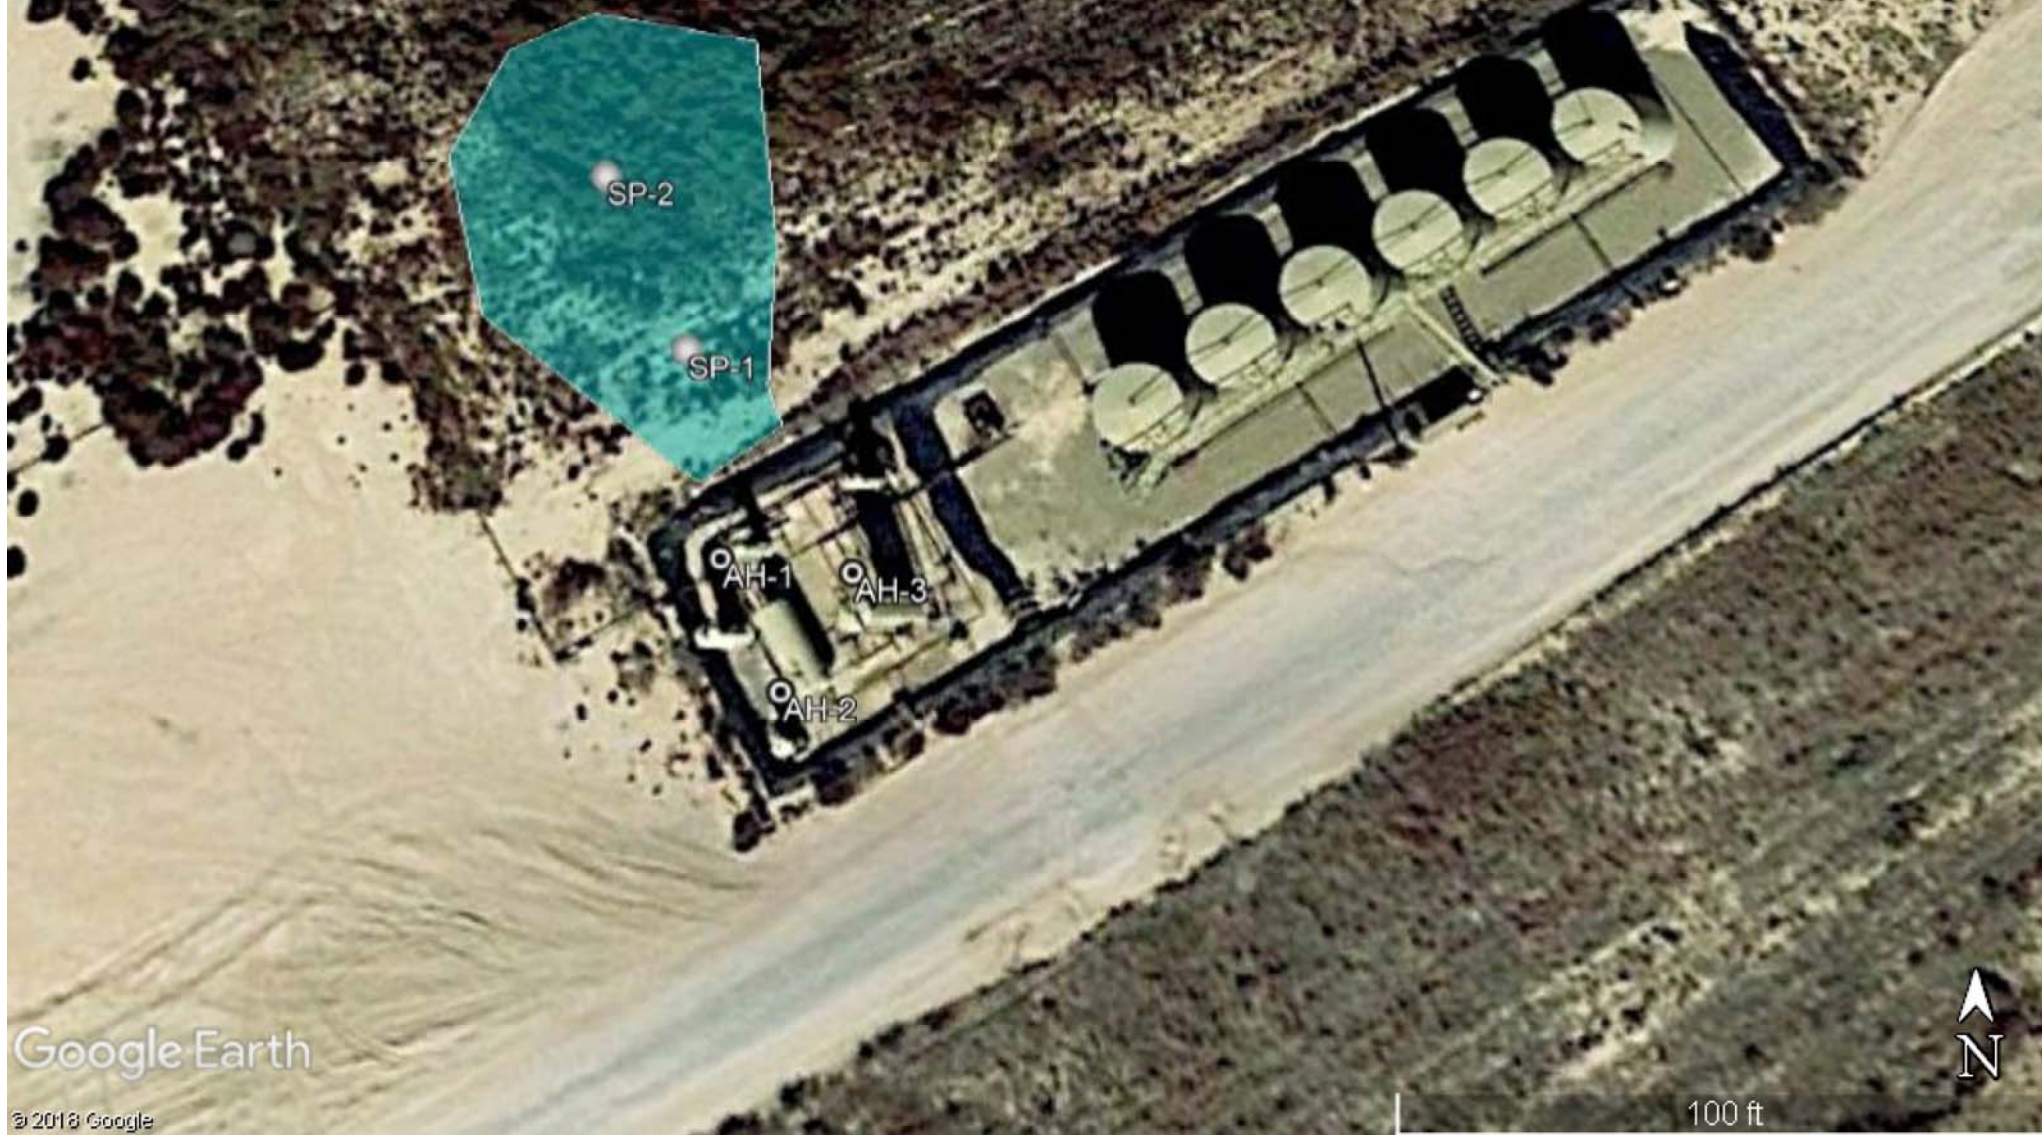
A total of three (3) hand augers (AH-1, AH-2 and AH-3) were installed inside the lined facility to assess the soil underneath the liner. In addition, SP-1 and SP-2 were installed in the overspray area. Referring to Table 1, the overspray area did not show any impact above the Table 1 closure criteria.

On October 23, 2018, COG installed one (1) auger hole (AH-1) near the northwest corner inside the facility. The sampling results showed a chloride spike of 2,810 mg/kg at 1-1.5' and declined with depth at 2-2.5' of 267 mg/kg. Based on the results, the NMOCD requested additional samples to further evaluate underneath the liner. On January 14, 2019, two (2) additional auger holes (AH-2 and AH-3) were installed and showed chloride concentrations ranging from 970 mg/kg (0-1') to 2,450 mg/kg (0-1'). Based on the results, all the samples collected were all below the Table 1 closure criteria.

Bobwhite 12 #1H Tank Battery
Section 12, T21S, R33E
Lea County, New Mexico
32.500012, -103.528968

- Auger holes (AH)
- Overspray Area
- Sample Points (SP)

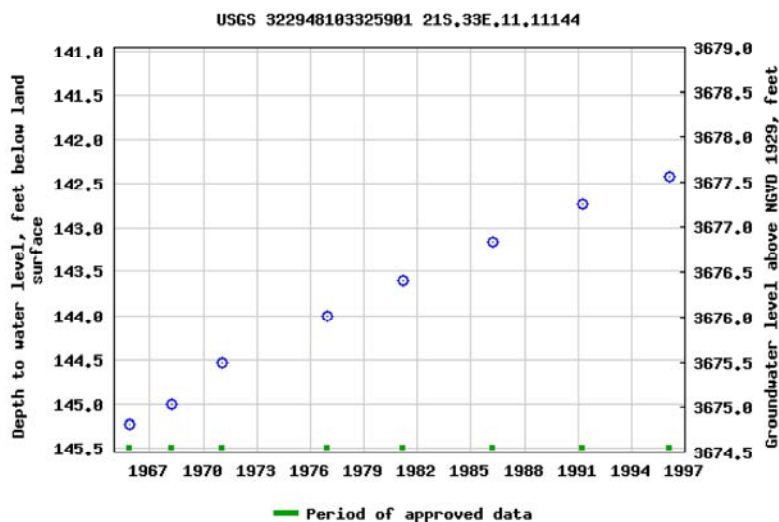
USGS 322948103325901 21S.33E.11.11144

The depth of the well is 195 feet below land surface.

This well is completed in the Alluvium, Bolson Deposits and Other Surface Deposits (110AVMB) local aquifer.

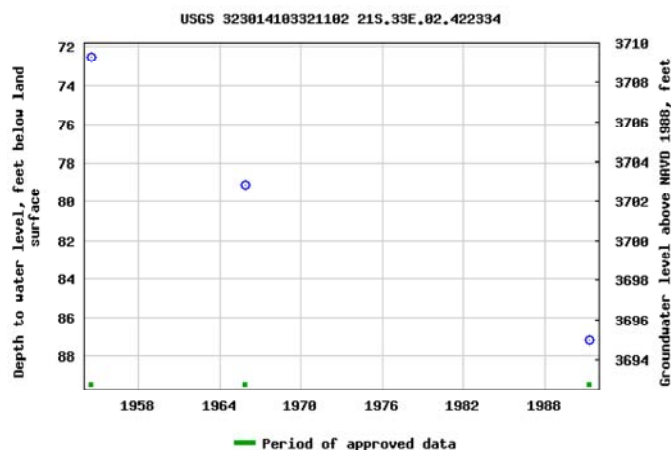
USGS 323014103321102 21S.33E.02.422334

The depth of the well is 100 feet below land surface.

This well is completed in the Alluvium, Bolson Deposits and Other Surface Deposits (110AVMB) local aquifer.

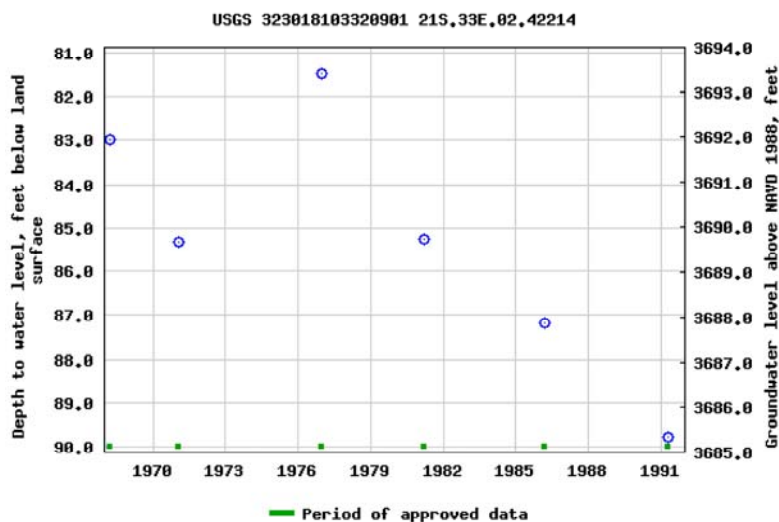
USGS 323018103320901 21S.33E.02.42214

The depth of the well is 150 feet below land surface.

This well is completed in the Alluvium, Bolson Deposits and Other Surface Deposits (110AVMB) local aquifer.
