Release Notification Responsible Party

Site Name Poker Lake Unit 23 DTD 108H	Site Type Production Well Facility
Date Release Discovered 2/13/2019	API# (if applicable) 30-015-42452

On February 13, 2019, 149 barrels (bbls) of produced water were released from a buried salt water disposal (SWD) line onto the right-of-way (ROW) along the western and southern border of the caliche well pad. The released fluid was contained on the ROW due to raised soil along the edge, which acted as a berm. Pumps were shut down until repairs could be made. No fluid was recovered. XTO reported the release to the New Mexico Oil Conservation Division (NMOCD) on a Release Notification and Corrective Action Form C-141 (Form C-141) on February 26, 2019, and was assigned RP Number 2RP-5287 (Attachment 1).

FIGURE 2
PRELIMINARY SOIL SAMPLE LOCATIONS
POKER LAKE UNIT 23 DTD 108H
UNIT A SEC 23 T24S R30E
EDDY COUNTY, NEW MEXICO
XTO ENERGY, INC.

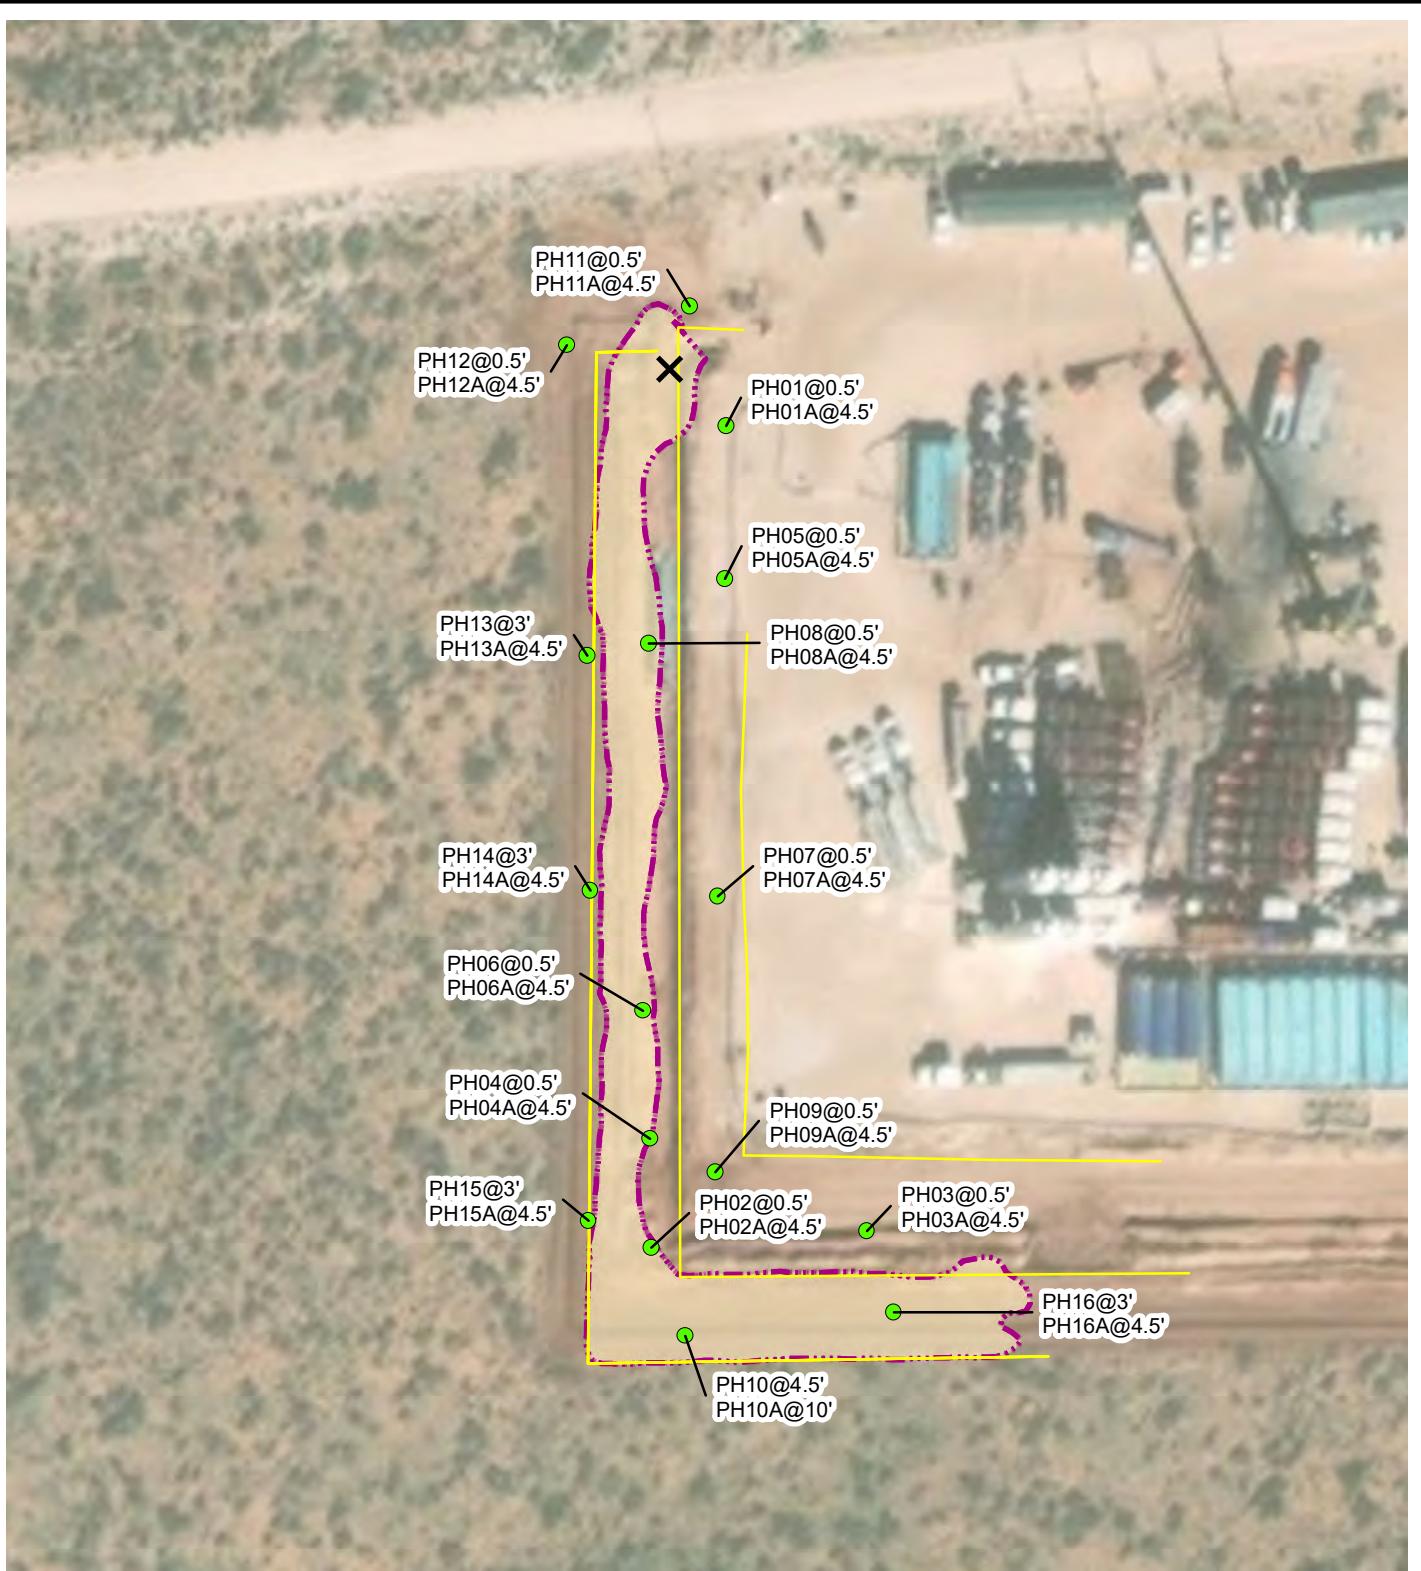
Laboratory analytical results for the delineation soil samples collected from potholes PH01 through PH16 indicated the benzene, BTEX, GRO and DRO, TPH, and chloride concentrations were compliant with the Closure Criteria. Chloride-containing soil was excavated as indicated by laboratory analytical results, field screening activities, and observed salt crusting within the release extent. Following excavation of chloride-containing soil, confirmation soil samples were collected from the sidewalls and floor of the excavation. Laboratory analytical results indicated benzene, BTEX, GRO and DRO, TPH, and chloride concentrations were compliant with the Closure Criteria in excavation soil samples SW01 through SW08 and FS01 through FS43. Laboratory analytical results are summarized in Table 1. The complete laboratory analytical reports are included as Attachment 4.

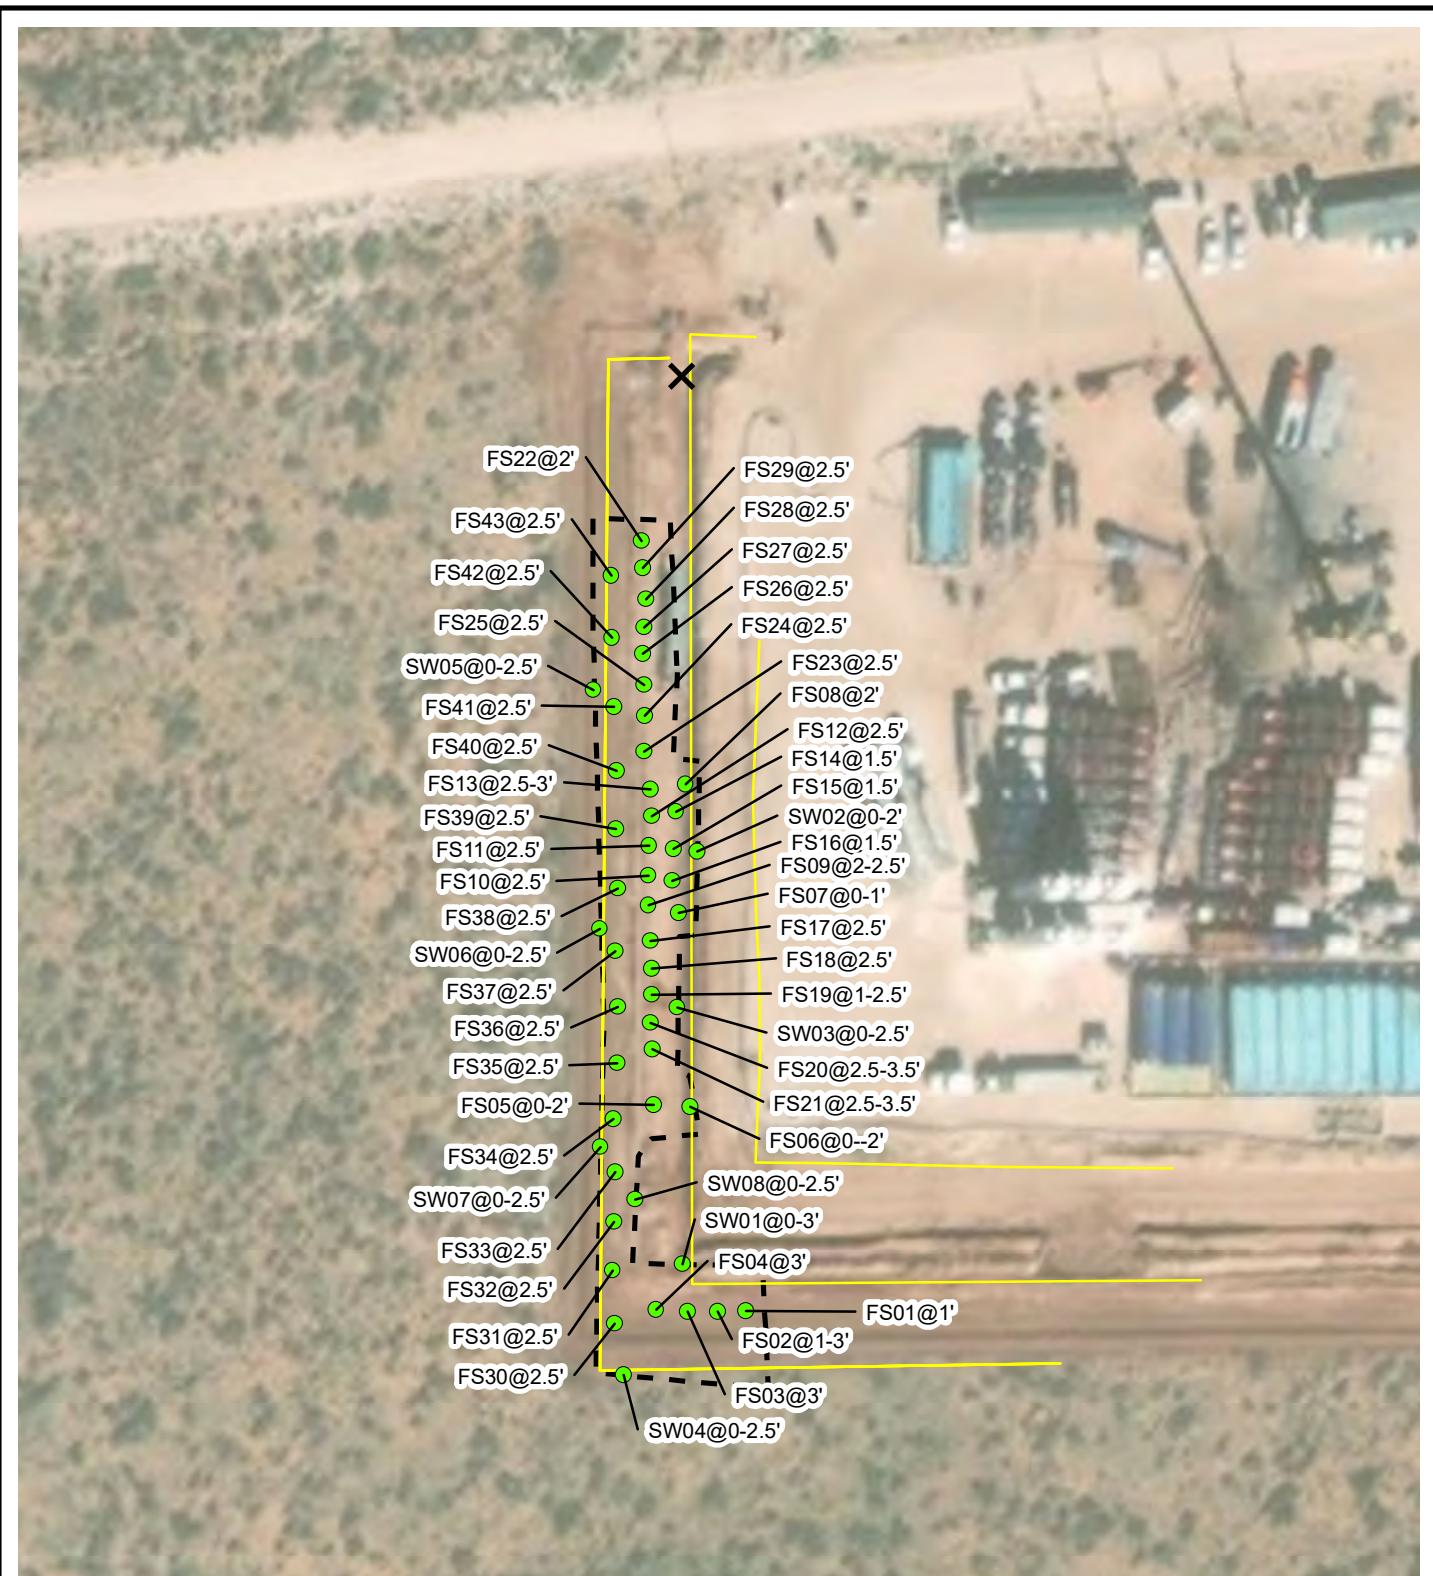
FIGURE 3
DELINEATION SOIL SAMPLE LOCATIONS
POKER LAKE UNIT 23 DTD 108H
UNIT A SEC 23 T24S R30E
EDDY COUNTY, NEW MEXICO
XTO ENERGY, INC.

Chloride-containing soil was excavated from the release area as indicated by laboratory analytical results for the preliminary soil samples, field screening activities, and observed salt crusting within the release area. A total of approximately 1,490 cubic yards of soil were excavated from the Site. Delineation soil sampling was completed in and around the release extent. Laboratory analytical results for the delineation and excavation soil samples indicated that benzene, BTEX, GRO and DRO, TPH, and chloride concentrations were compliant with the Closure Criteria and no further excavation was required.

Initial response efforts and excavation of impacted soil have mitigated impacts at this Site. XTO requests no further action for release number 2RP-5287. Upon approval of this closure request, XTO will backfill the excavation with material purchased locally and recontour the Site to match pre-existing site conditions. An updated Form C-141 is included as Attachment 1.

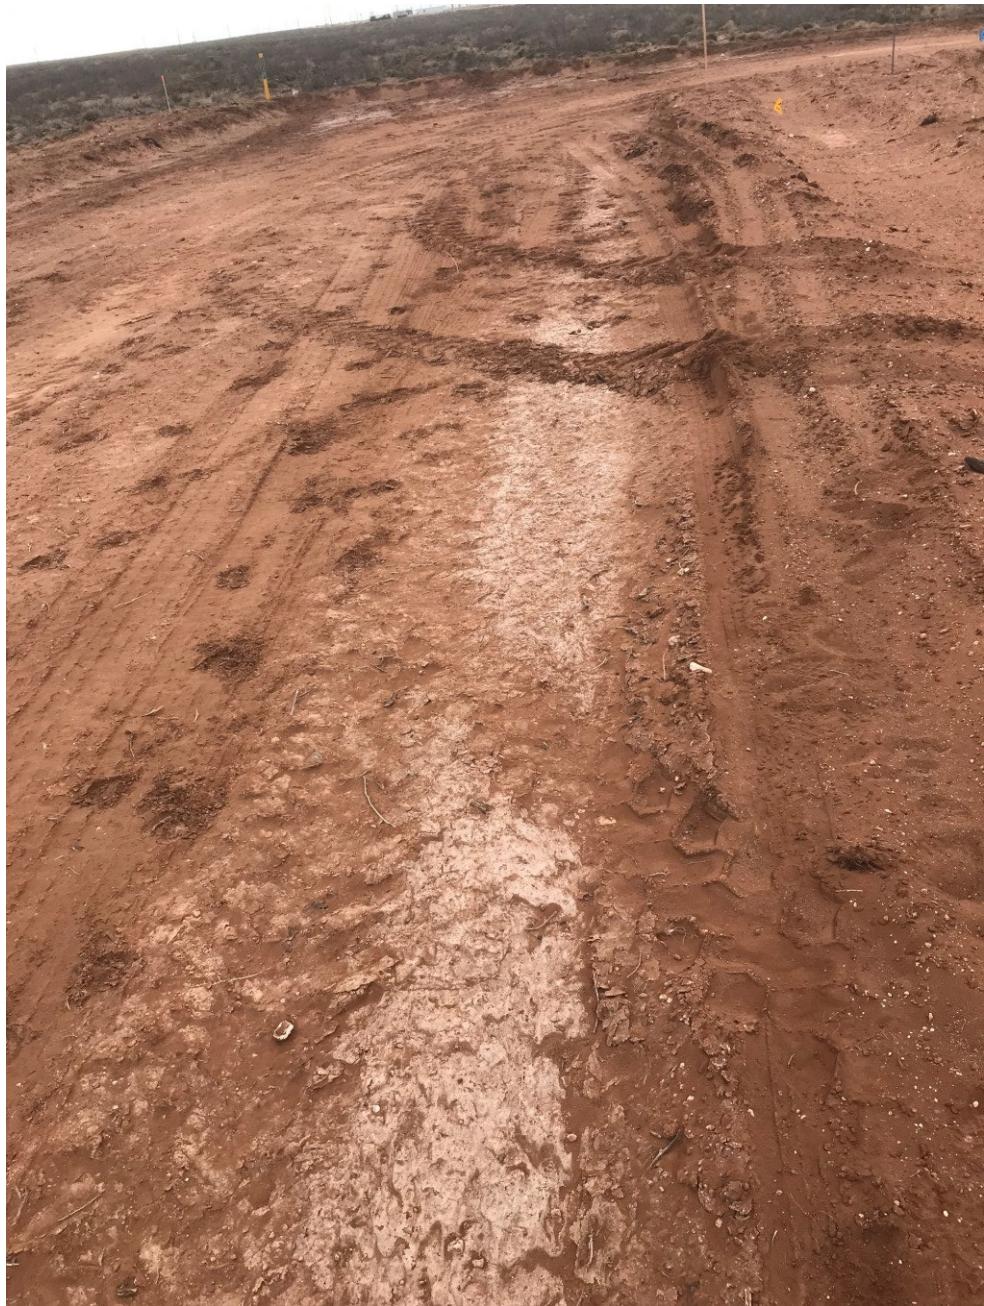
Salt crusting on soil surrounding the point of release during site assessment activities.

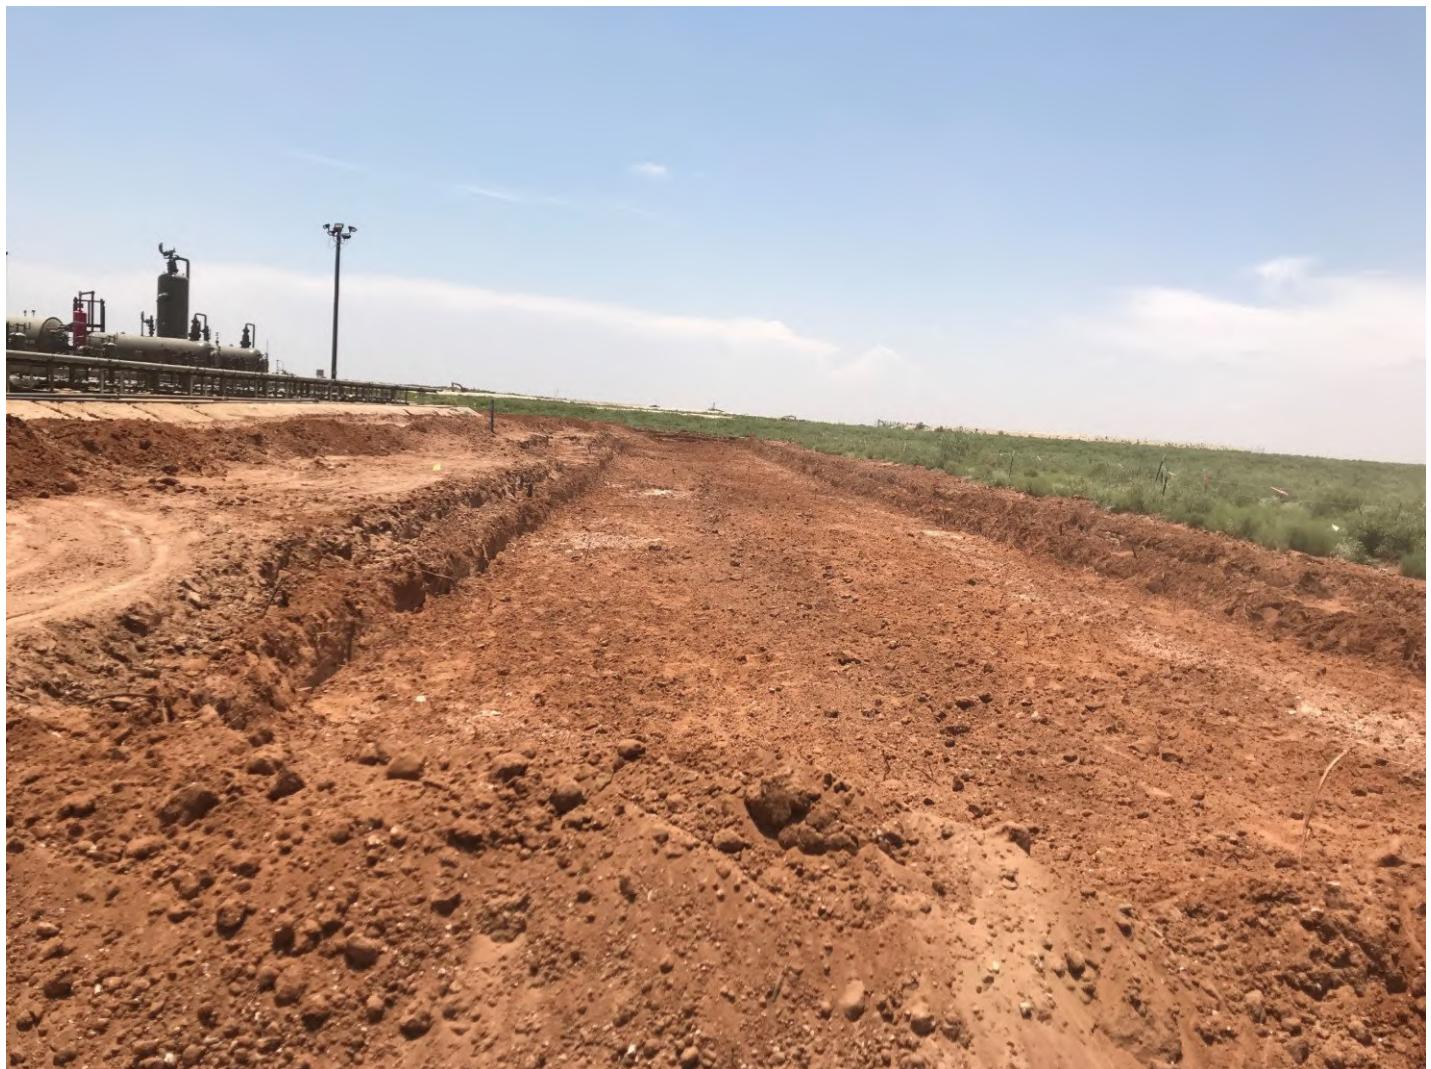
Southern view of final excavation extent during confirmation soil sampling activities.
