Re: 2RP-5324 Stella Blue Flowback Line Release

Please find attached an updated "Amended Release Investigation and Remedial Action Plan" with the attachments that were inadvertently left off previously upon document uploading.

Incident ID	NAB 1909136893
District RP	2RP-5324
Facility ID	fAB 1909136494
Application ID	pAB 1909136607

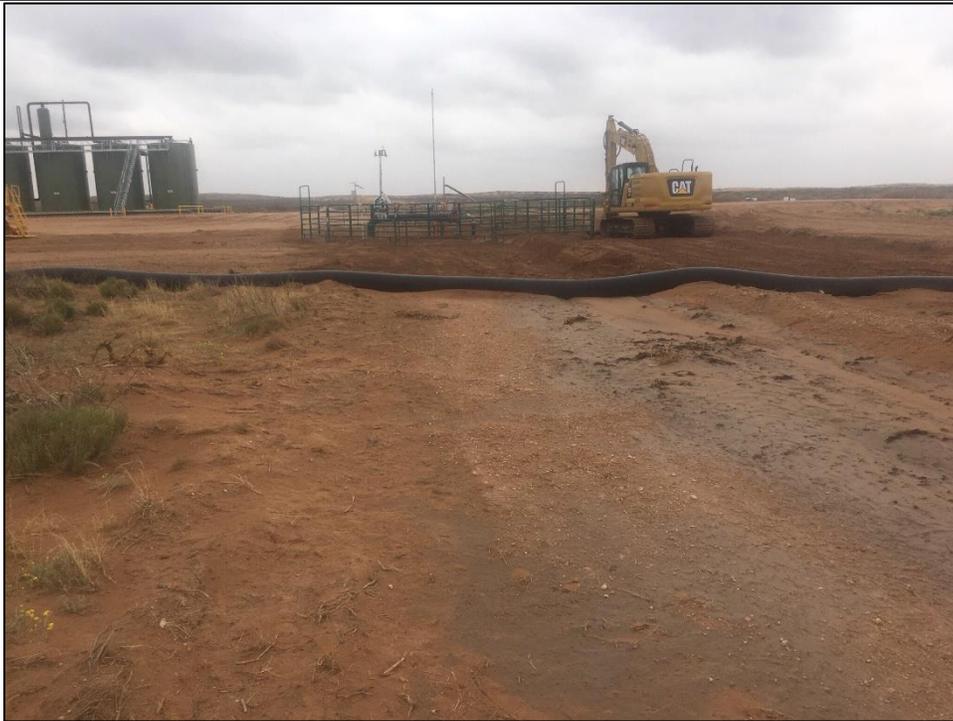
PHOTO 1: View of release origin, east. 3/21/2019 / **TIME:** 2:05PM / **GPS:** 32.0066, -103.8266

Initial source elimination was accomplished by the Solaris Water Midstream foreman shutting in the leaking line and repairing the malfunctioning poly line with a saddle fusion. Solaris Water Midstream deployed C2 Oilfield Services (C2), an on-site contractor, to secure the site and perform containment and site stabilization activities.

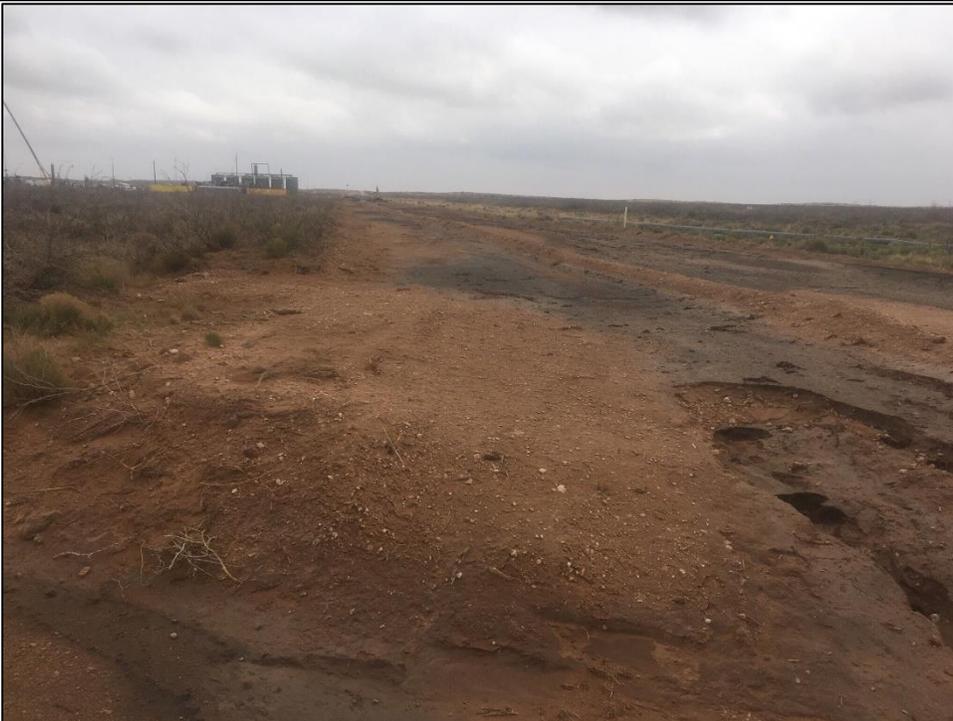
PHOTO 2: View of impact on pipeline, facing east. 3/21/2019 / **TIME:** 2:01PM / **GPS:** 32.0067, -103.8292

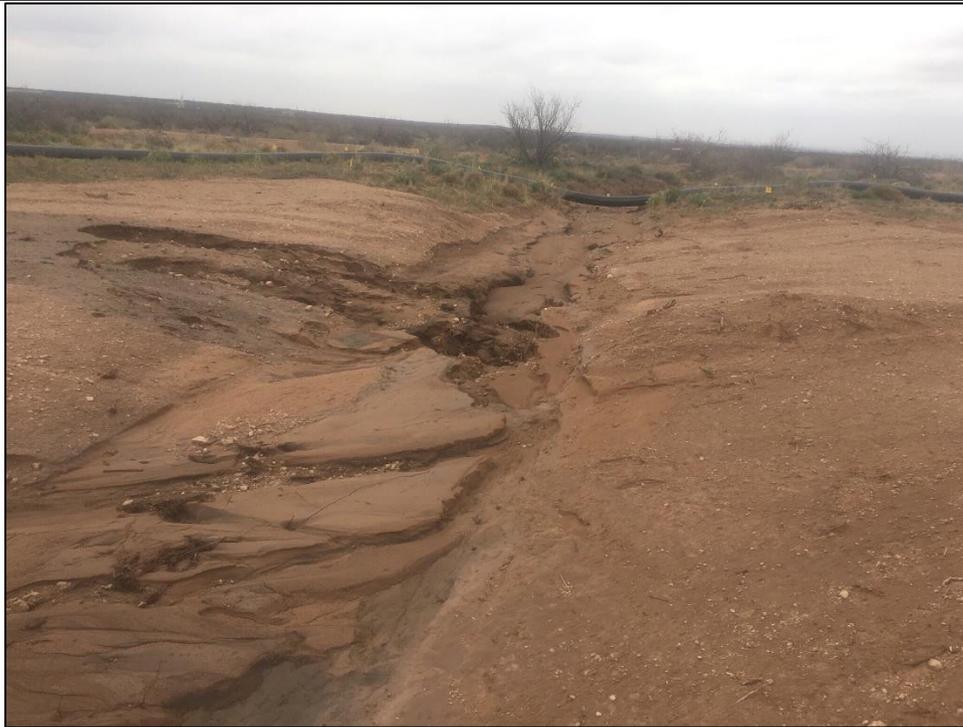
PHOTO 3: View of release going to bar ditch, facing south. 3/21/2019 / **TIME:** 2:01PM / **GPS:** 32.0067, -103.8292

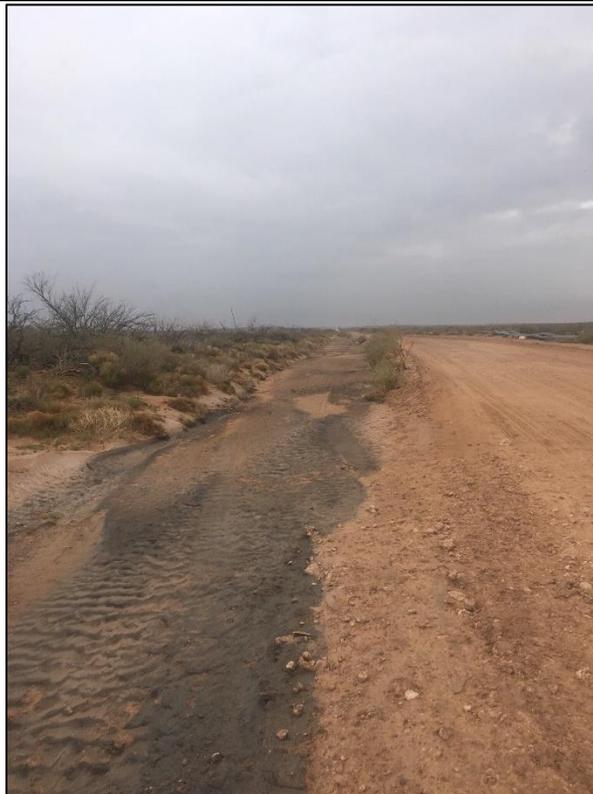
PHOTO 4: View of release in ditch, facing east. 3/21/2019 / **TIME:** 1:13PM / **GPS:** 32.0063, -103.8376

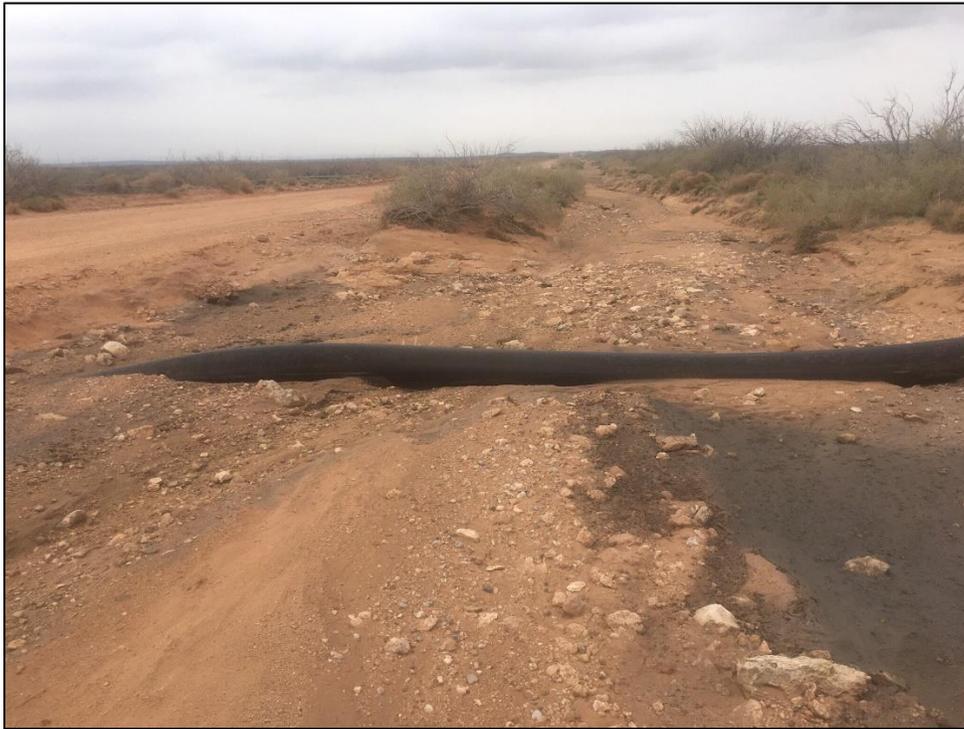
PHOTO 5: View of release in ditch, facing west. 3/21/2019 / **TIME:** 1:57PM / **GPS:** 32.0062, -103.8323

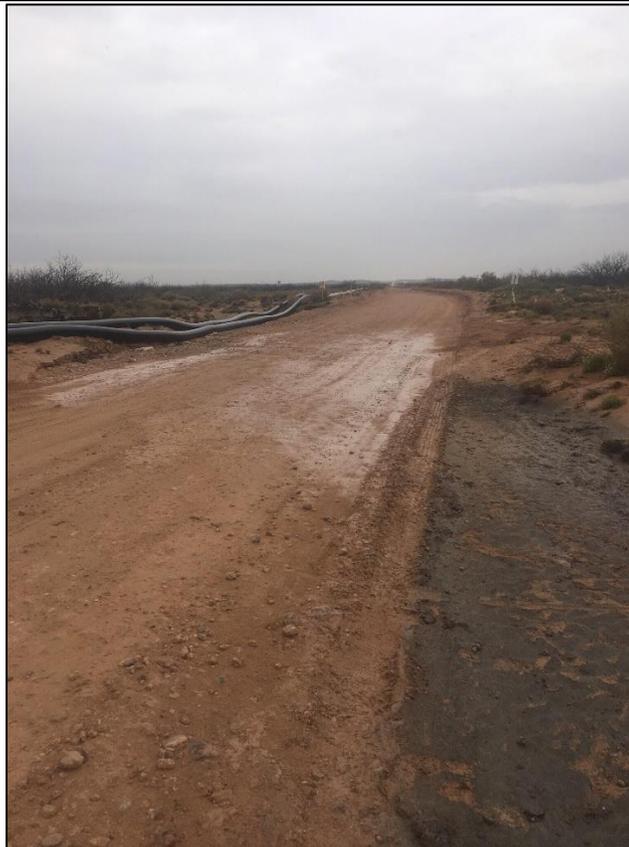
PHOTO 6: View of release crossing lease road, facing west. 3/21/2019 / **TIME:** 1:13PM / **GPS:** 32.0063, -103.8376

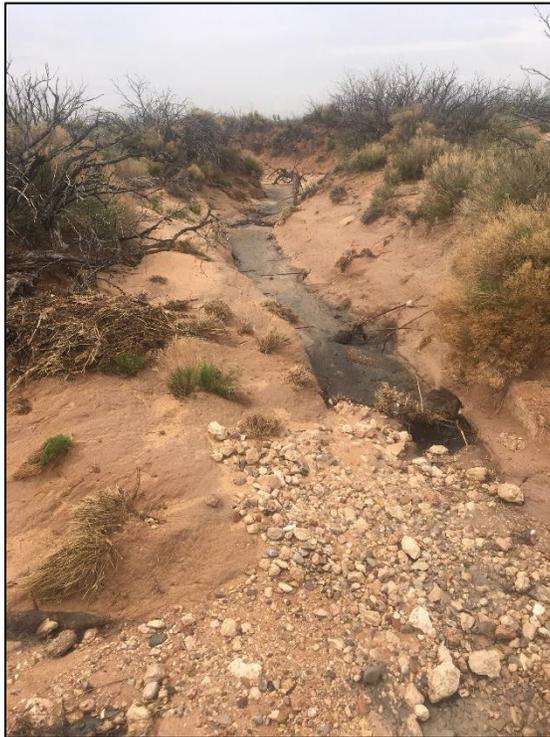
PHOTO 7: View of release in eroded area, facing southeast. 3/21/2019 / **TIME:** 1:18PM / **GPS:** 32.0047, -103.8393

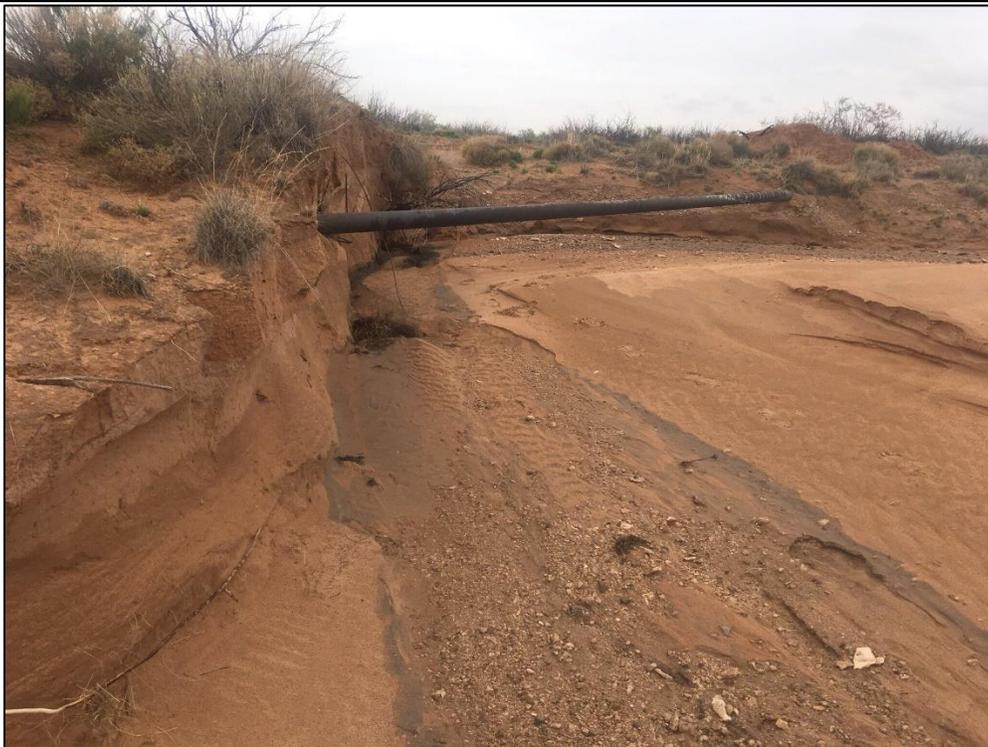
PHOTO 8: View of release in eroded lease road, facing north. 3/21/2019 / **TIME:** 1:44PM / **GPS:** 32.0039, -103.8405

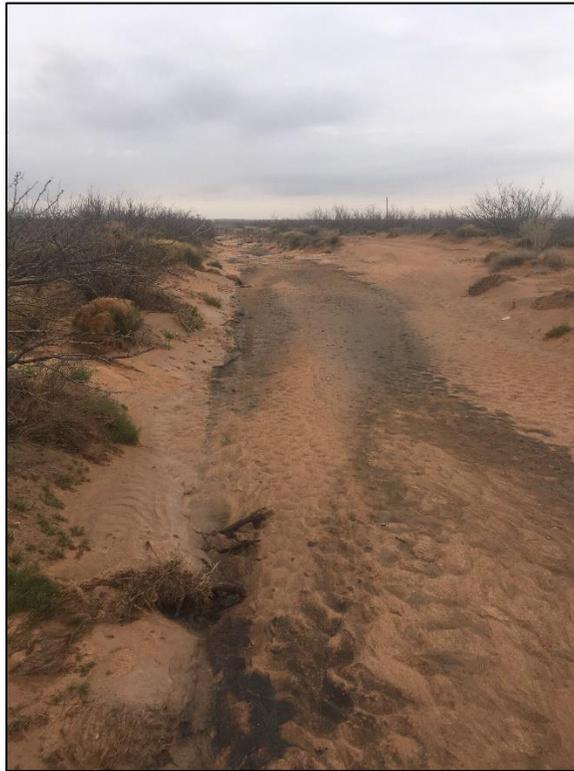
PHOTO 9: View of release following eroded lease road, facing south. 3/21/2019 / **TIME:** 1:25PM / **GPS:** 32.0005, -103.8405

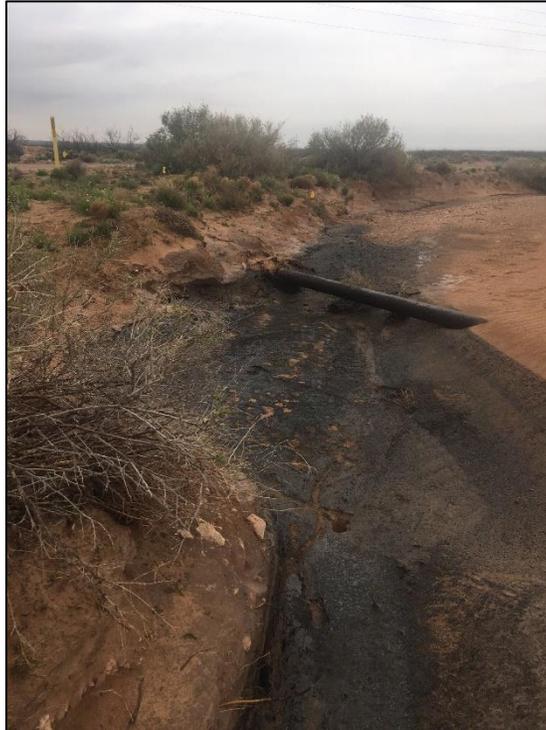
PHOTO 10: View of release end of eroded lease road, facing southwest. 3/21/2019 / **TIME:** 1:28PM / **GPS:** 31.9986, -103.8405

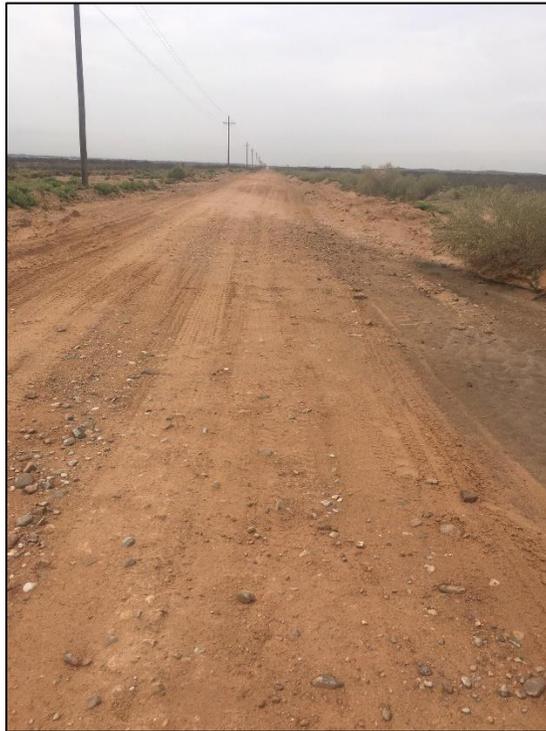
PHOTO 11: View of release end crossing last lease road, facing west. 3/21/2019 / **TIME:** 1:30PM / **GPS:** 31.9984, -103.8419

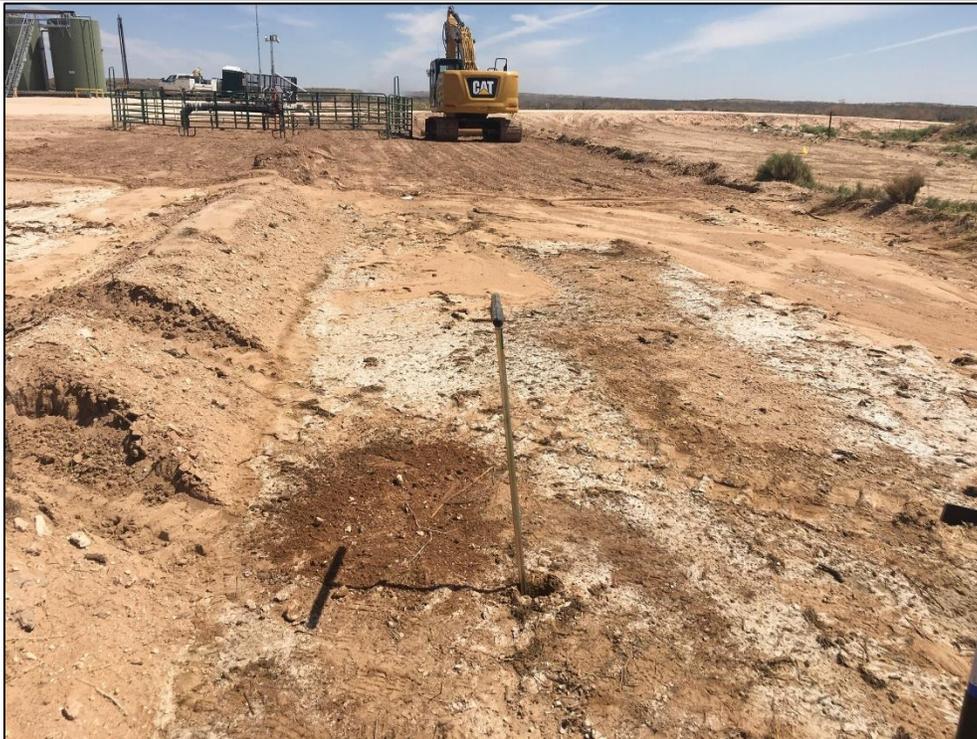
PHOTO 12: View of HA-1, facing east. 3/25/2019 / **TIME:** 2:15PM / **GPS:** 32.0065, -103.8267

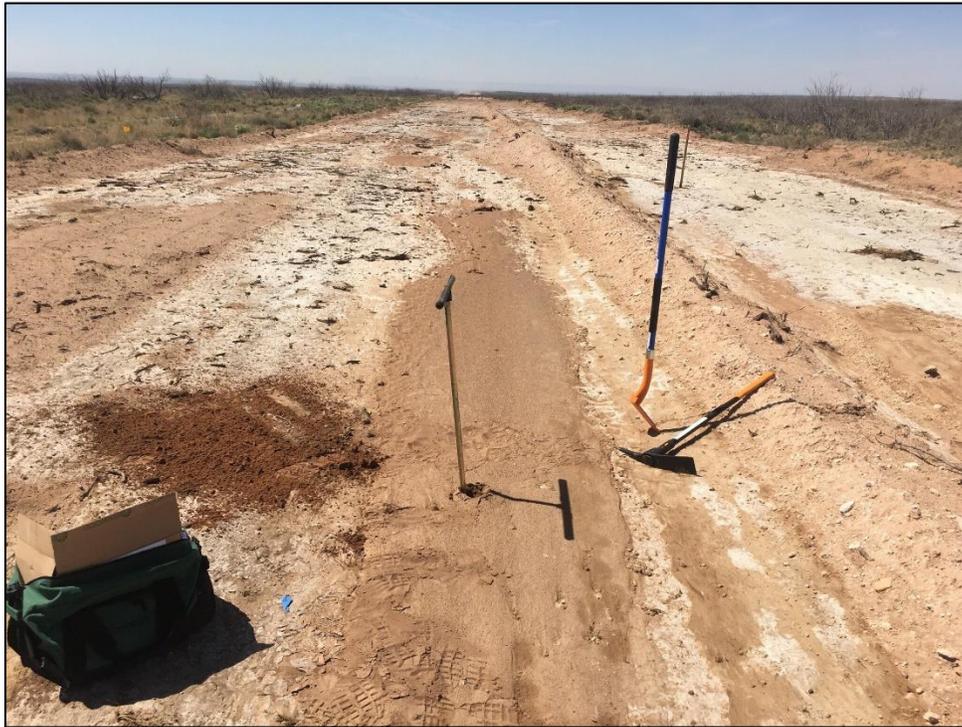
PHOTO 13: View of HA-2, facing west. 3/25/2019 / **TIME:** 2:26PM / **GPS:** 32.0066, -103.8281

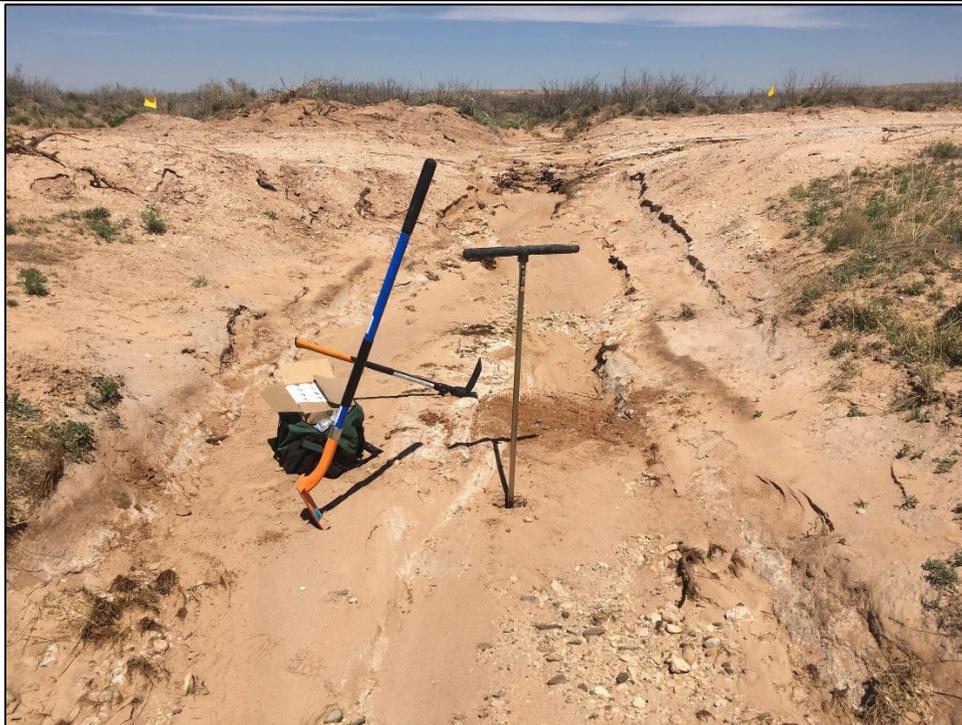
PHOTO 14: View of HA-3, facing north. 3/25/2019 / **TIME:** 2:34PM / **GPS:** 32.0064, -103.8239

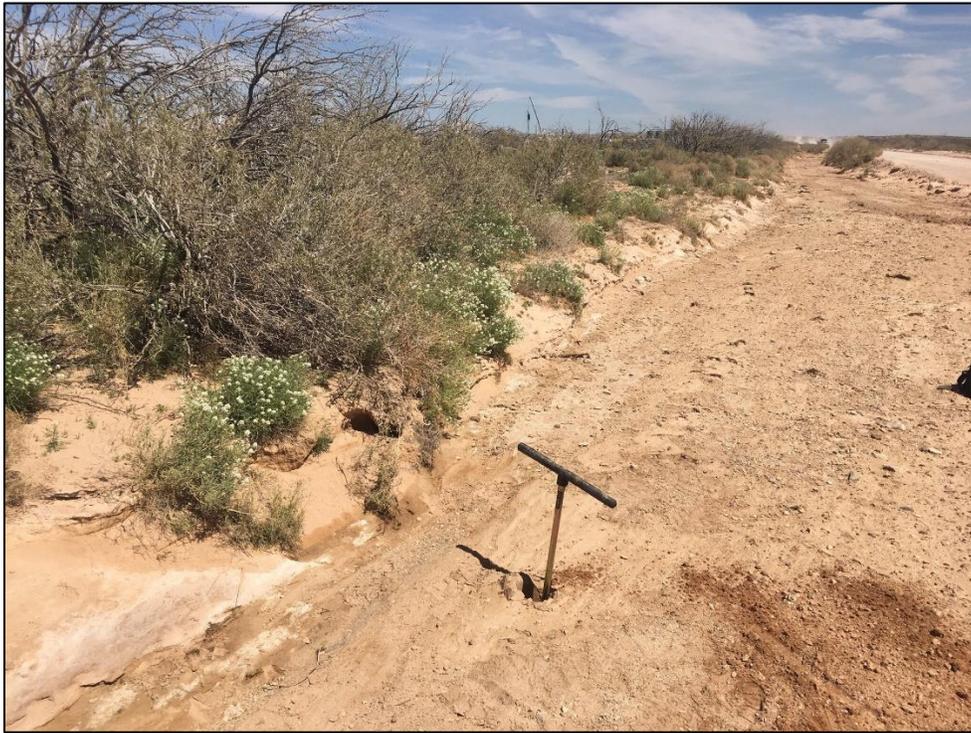
PHOTO 15: View of HA-4, facing east. 3/25/2019 / **TIME:** 2:48PM / **GPS:** 32.0063, -103.8315

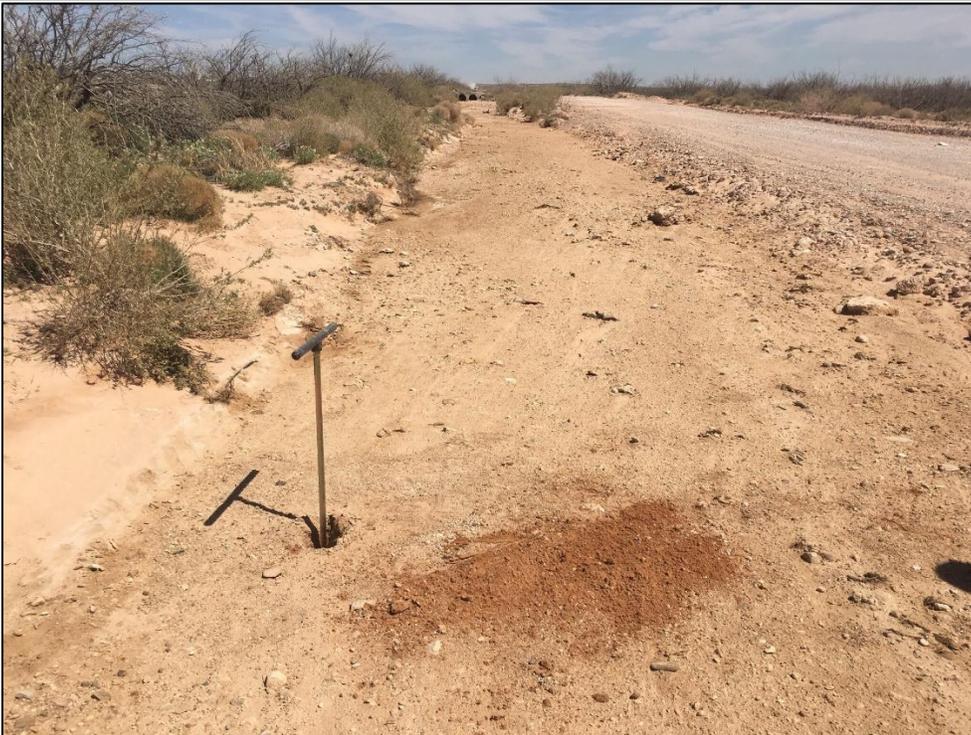
PHOTO 16: View of HA-6, facing east. 3/25/2019 / **TIME:** 3:01PM / **GPS:** 32.0063, -103.8339

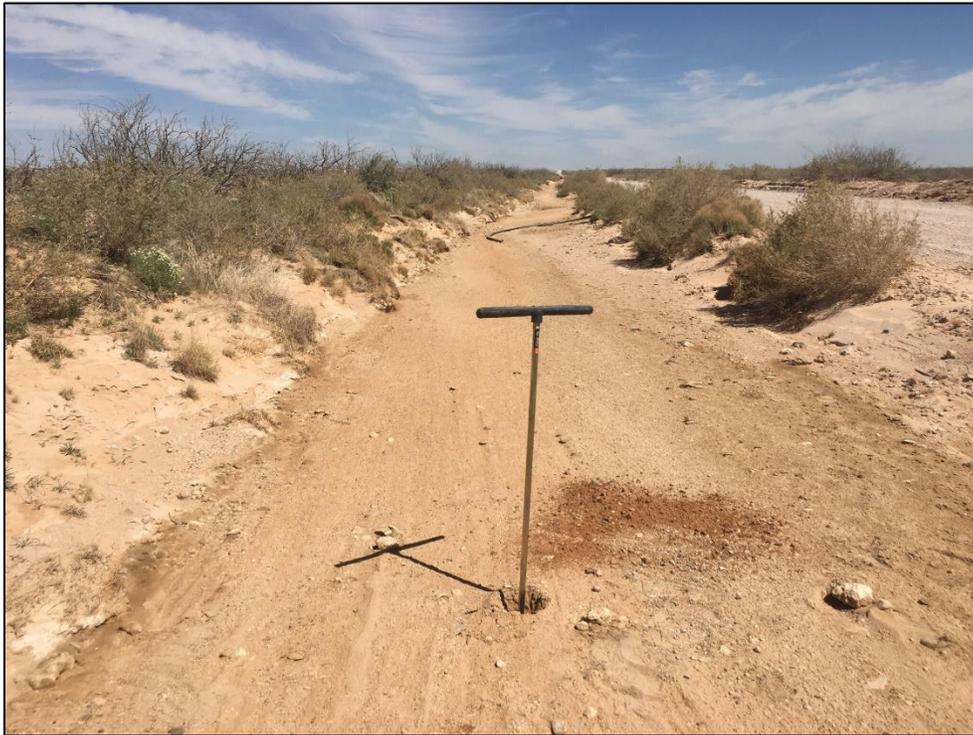
PHOTO 17: View of HA-7, facing east. 3/25/2019 / **TIME:** 3:10PM / **GPS:** 32.0063, -103.8354

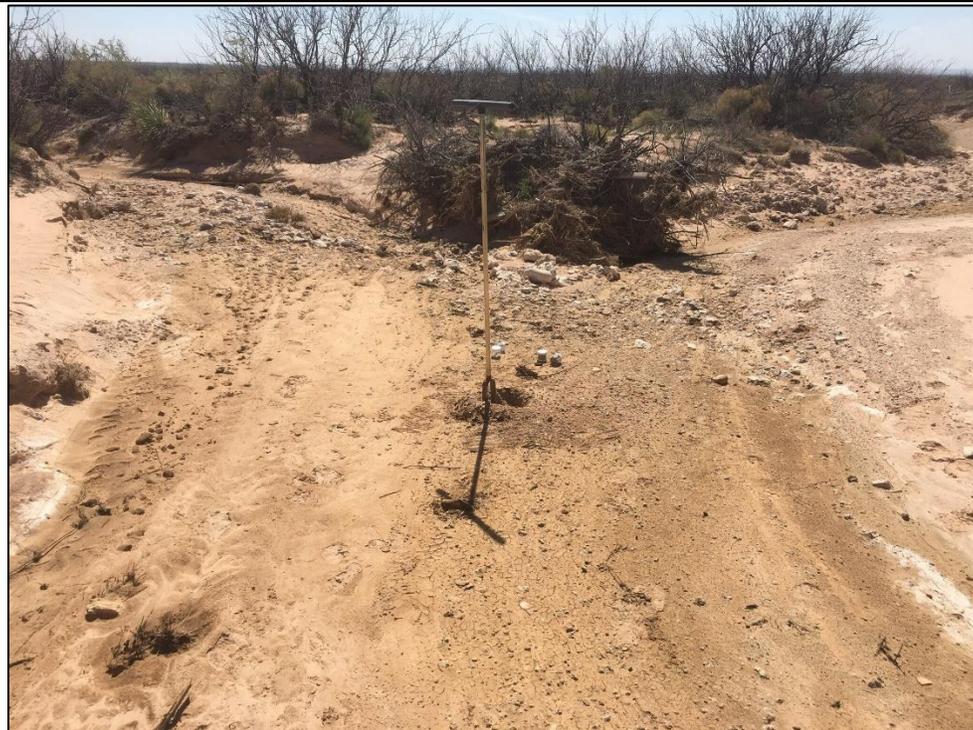
PHOTO 18: View of HA-8, facing southwest. 3/25/2019 / **TIME:** 3:24PM / **GPS:** 32.0055, -103.8387

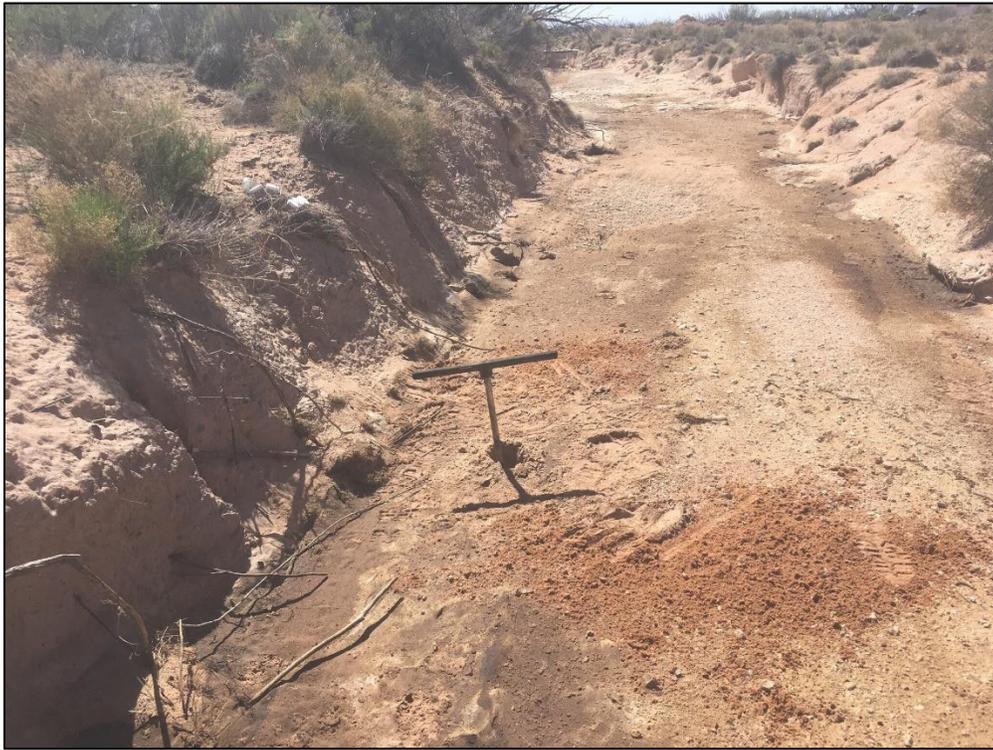
PHOTO 19: View of HA-9, facing west. 3/25/2019 / **TIME:** 3:33PM / **GPS:** 32.0042, -103.8401

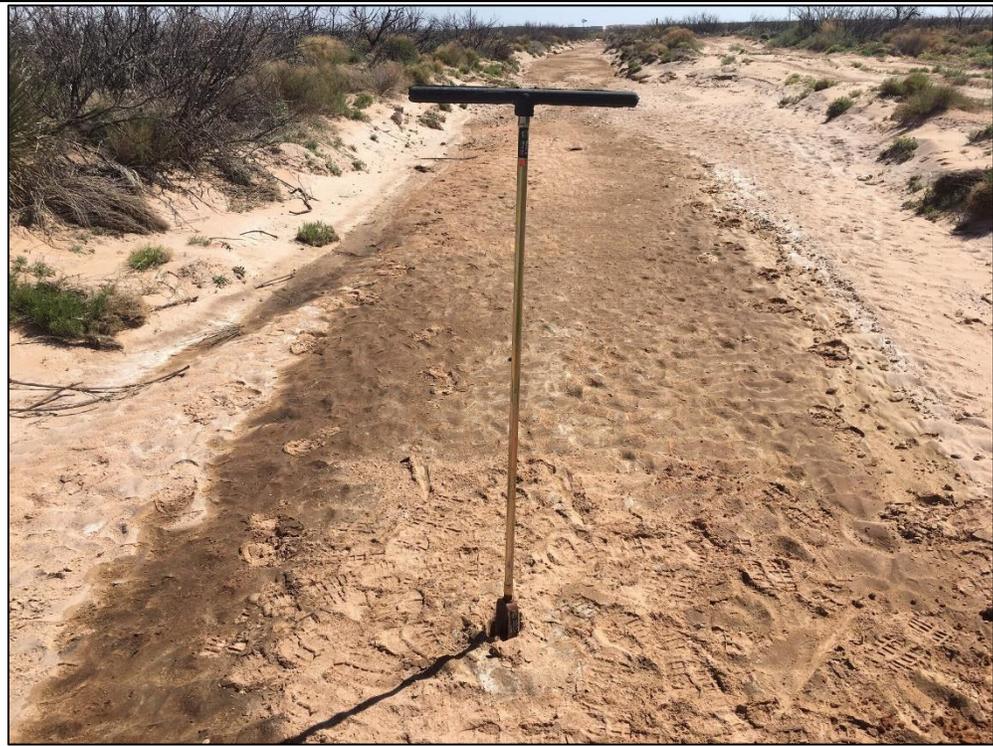
PHOTO 20: View of HA-10, facing south. 3/25/2019 / **TIME:** 3:53PM / **GPS:** 32.0030, -103.8405

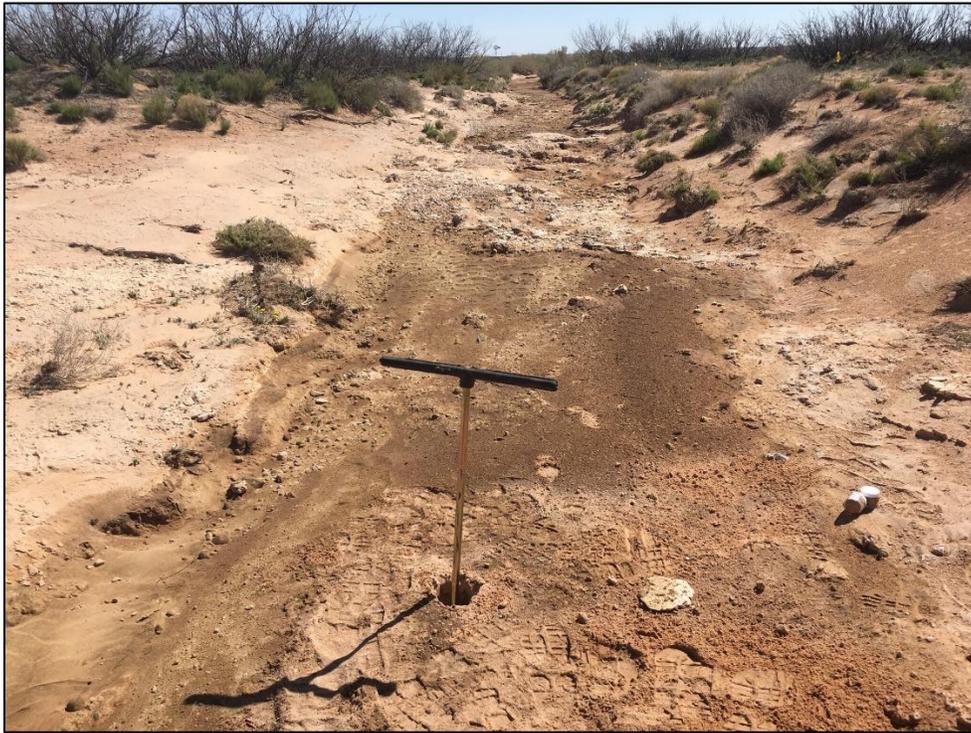
PHOTO 21: View of HA-11, facing south. 3/25/2019 / **TIME:** 4:00PM / **GPS:** 32.0013, -103.8406
