SUBJECT: Remediation Closure Report for the Mohawk State #1 Release (2RP-5248), Chavez County, New Mexico

On behalf of Marathon Oil Permian LLC, Souder, Miller & Associates (SMA) has prepared this Remediation Closure Report that describes the delineation and remediation for a release of liquids related to oil and gas production activities at the Mohawk State #1 site. The site is in Unit P, Section 20, Township 08S, Range 33E, Chavez County, New Mexico, on State land. Figure 1 illustrates the vicinity and site location on an USGS 7.5 minute quadrangle map.

**Mohawk State #1 (2RP-5248) Photo Log**

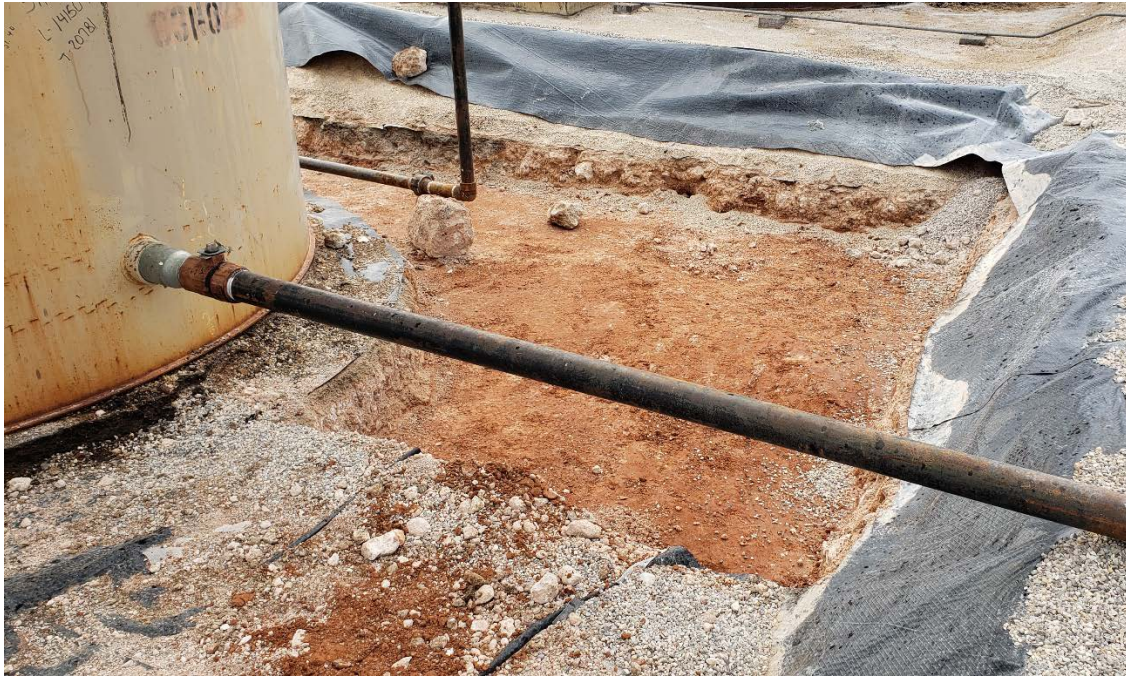
July 17, 2019  
L2 facing North

On July 12, 2019, collected a confirmation sample from the eastern base of the one-foot deep excavation, in the area of sample L2. On July 17 2019, SMA returned to the location to collect confirmation samples from the western portion of the excavation (L3), from the northern sidewall (CSW2), and the southern sidewall (CSW1), which abutted the production tank. The final excavation measured 25 feet by 11 feet and was approximately one foot deep (275 cubic feet total).

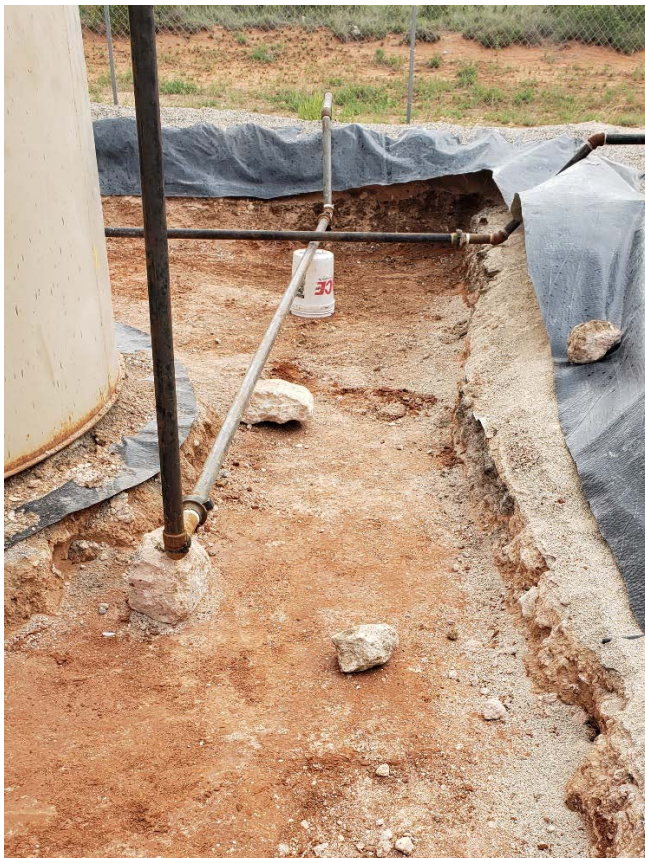
July 17, 2019  
L3 facing West
