**SITE INFORMATION****Report Type: Closure Report      1RP-5255****General Site Information:**

**ID72I-190808-C-1410**

**Re: Closure for the COG Operating, LLC, Stratocaster 20 Federal #3H, Unit O, Section 20, Township 23 South, Range 34 East, Lea County, New Mexico. 1RP-5255**

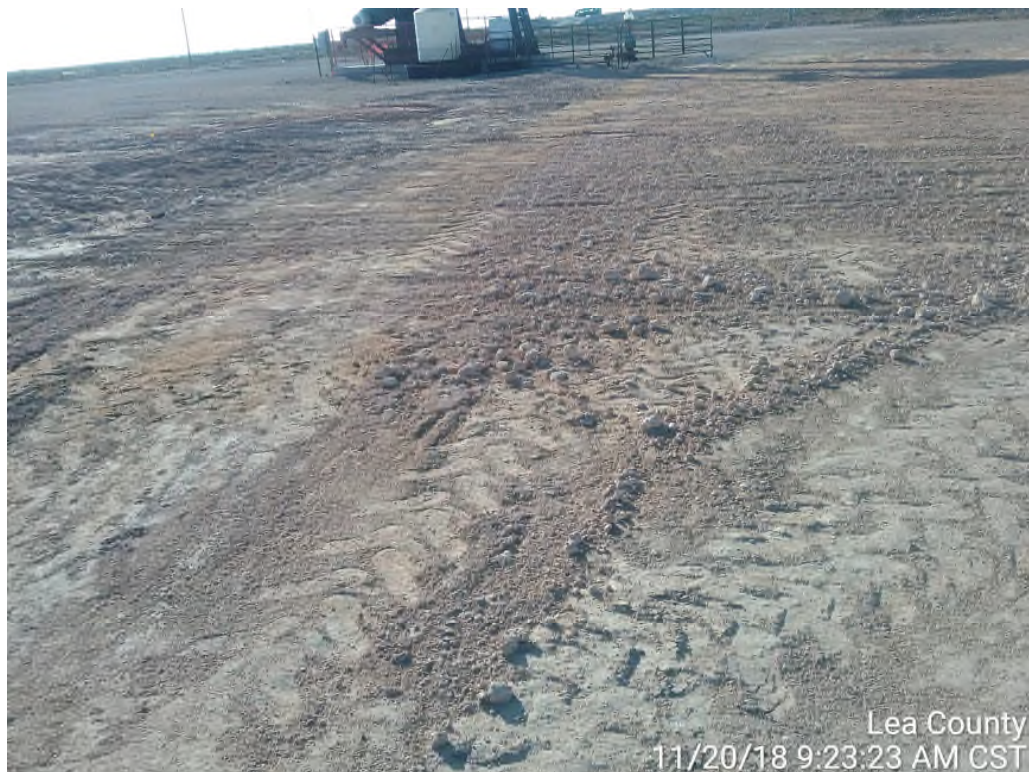
View South – Area of AH-4

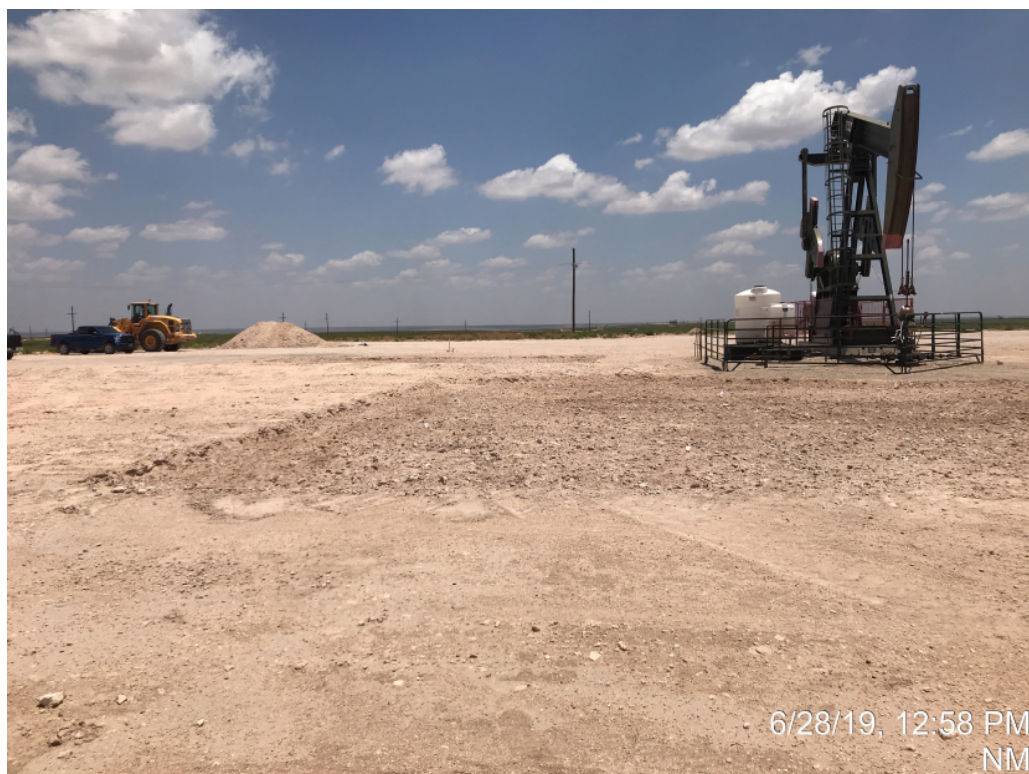
View North – Excavated Area

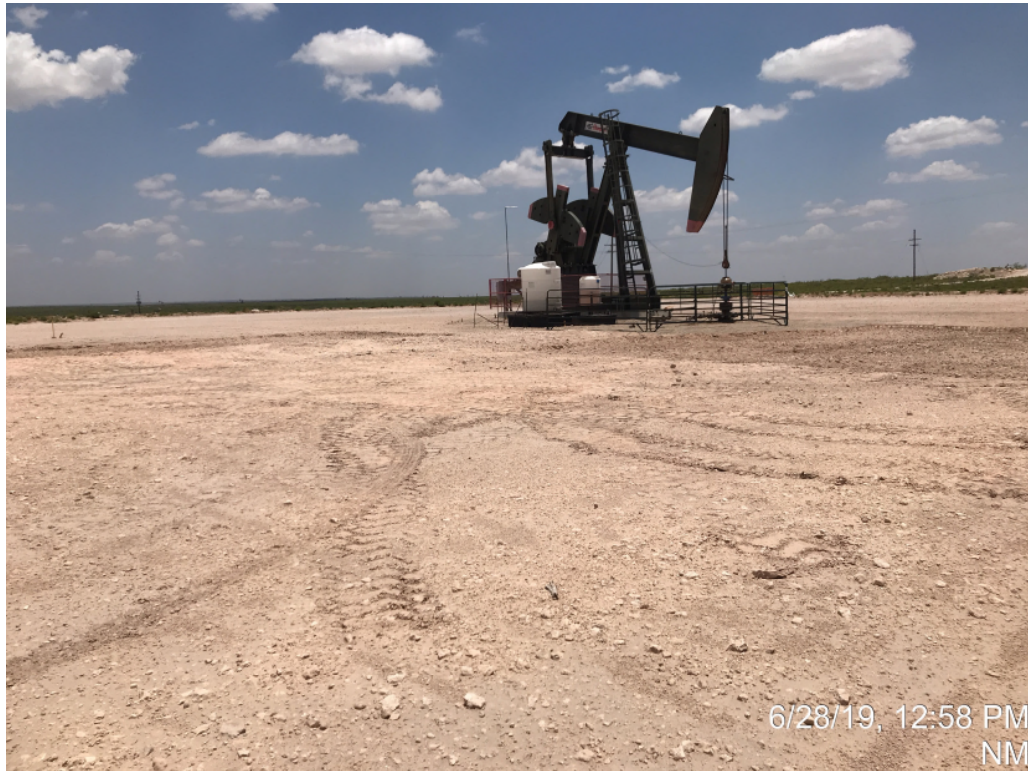
View Northeast – Excavated Area

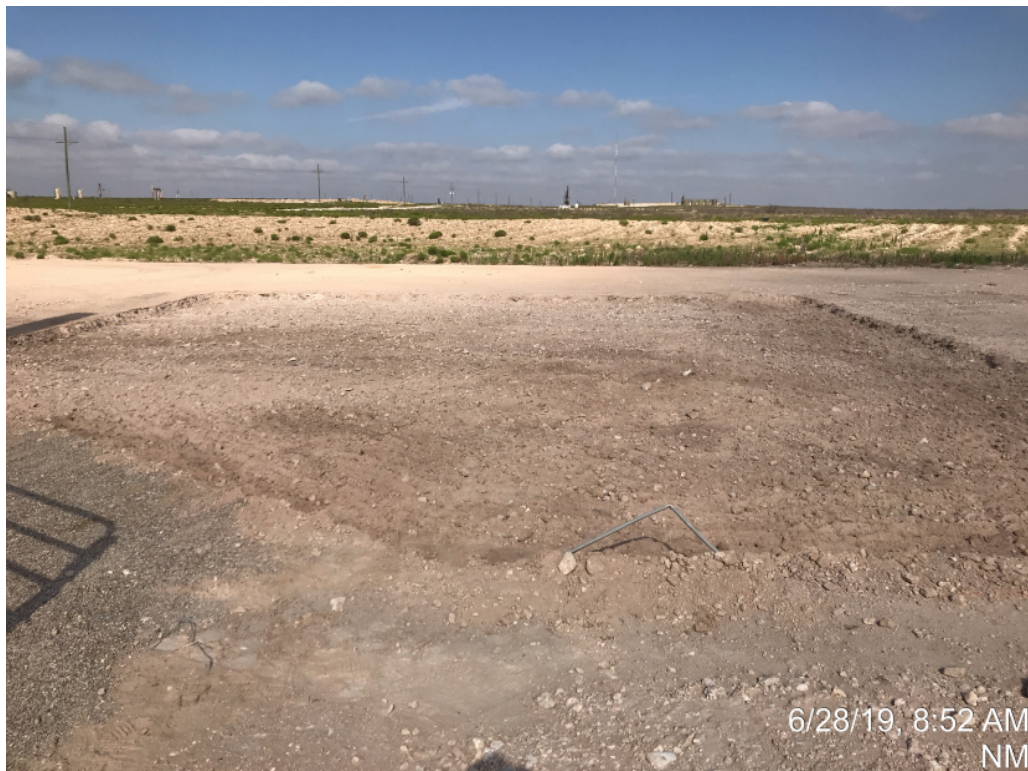
View North – Excavated Area
