**RE: Closure Request  
Mis Amigos Battery  
Remediation Permit Number 1RP-5607  
Lea County, New Mexico**

LT Environmental, Inc. (LTE), on behalf of XTO Energy, Inc. (XTO), presents the following Closure Request detailing site assessment and soil sampling activities at the Mis Amigos Battery (Site) in Unit O, Section 31, Township 23 South, Range 33 East, in Lea County, New Mexico (Figure 1). The purpose of the site assessment and soil sampling activities was to address impacts to soil following a release of crude oil at the Site. Based on the results of the soil sampling events, XTO is submitting this Closure Request requesting no further action for the release event.

**FIGURE 1**  
**SITE LOCATION MAP**  
**MIS AMIGOS BATTERY**  
**UNIT O SEC 31 T23S R33E**  
**LEA COUNTY, NEW MEXICO**  
**XTO ENERGY, INC.**

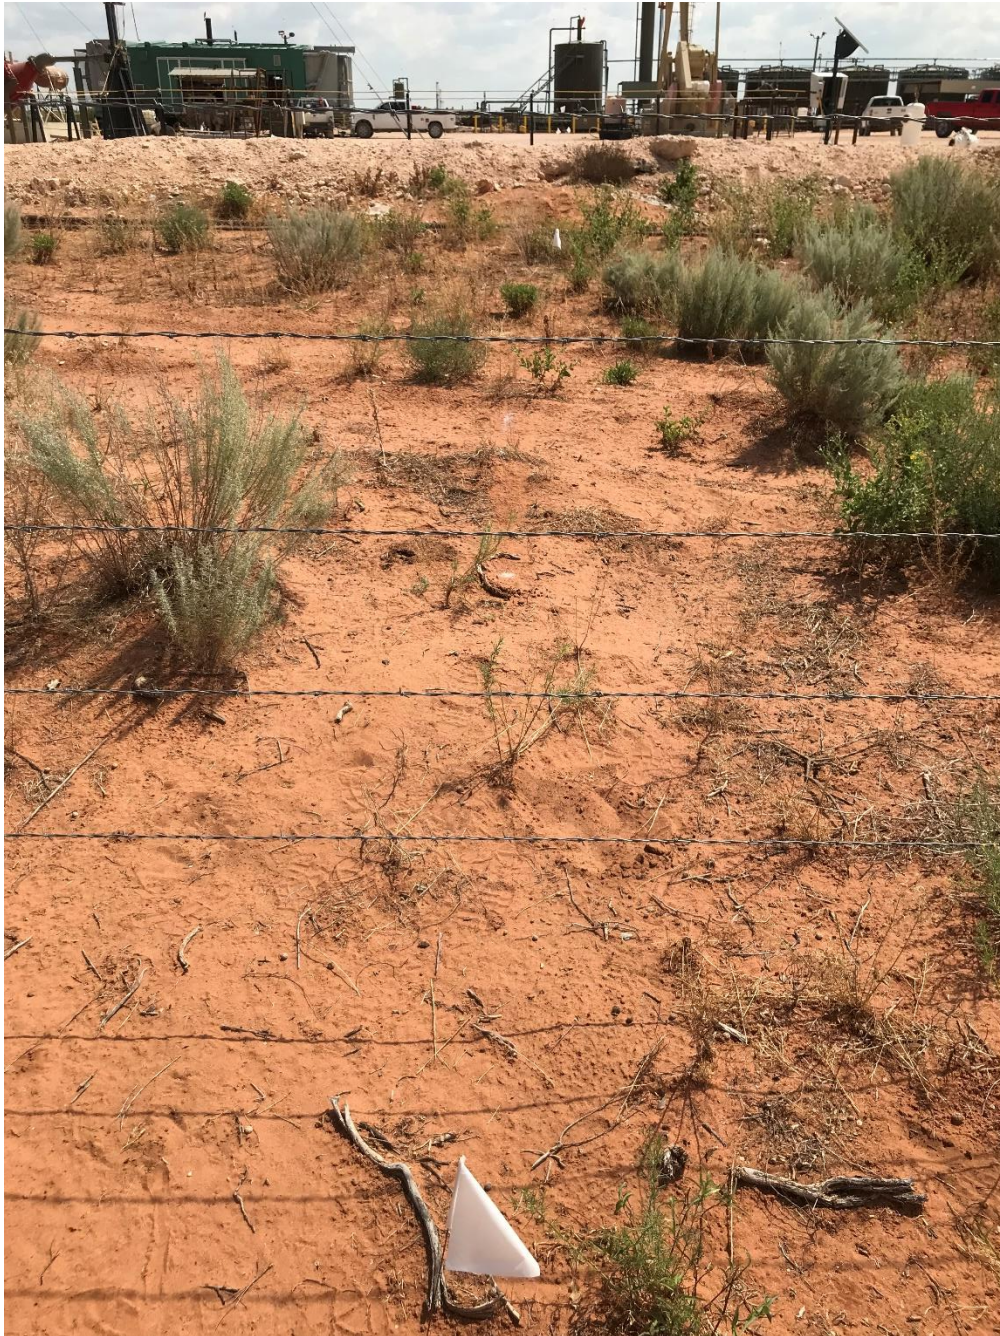
Project: 012919176	XTO Energy, Inc. Mis Amigos Battery

**Eastern view of release area during site assessment activities.**

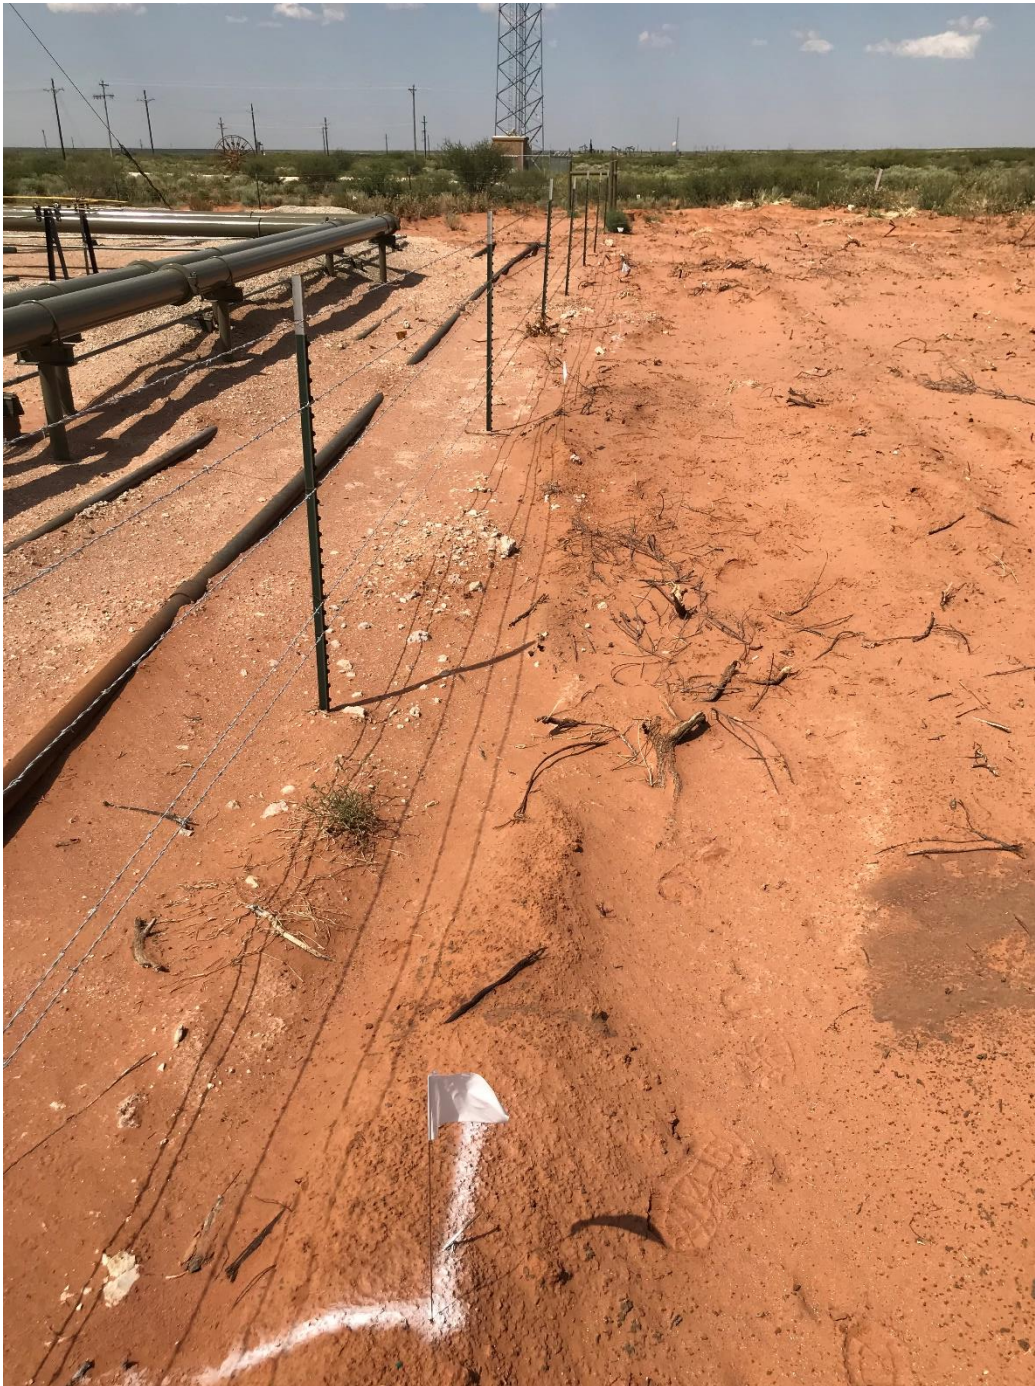
Project: 012919176

**Western view of release area during delineation soil sampling activities.**
