Closure

Re: Remediation Summary and Closure Report
Former EK Queen Station Historical
API No. N/A
GPS: Latitude 32.726736 Longitude -103.631709
UL "O", Sec. 23, T18S, R33E
Lea County, NM
NMOCD Ref. No. 1RP-5593

<div>Tasman Geosciences, Inc. 2620 W. Marland Blvd. Hobbs, NM 88240</div>	Plains Pipeline, LP Former EK Queen Station Historical GPS: 32.726736, -103.631709 UL "O", Section 23, Township 18 South, Range 33 East Lea County, New Mexico	Site Characteristics Map	Figure 1
DESIGNED BY: BC				
DRAWN BY: BC

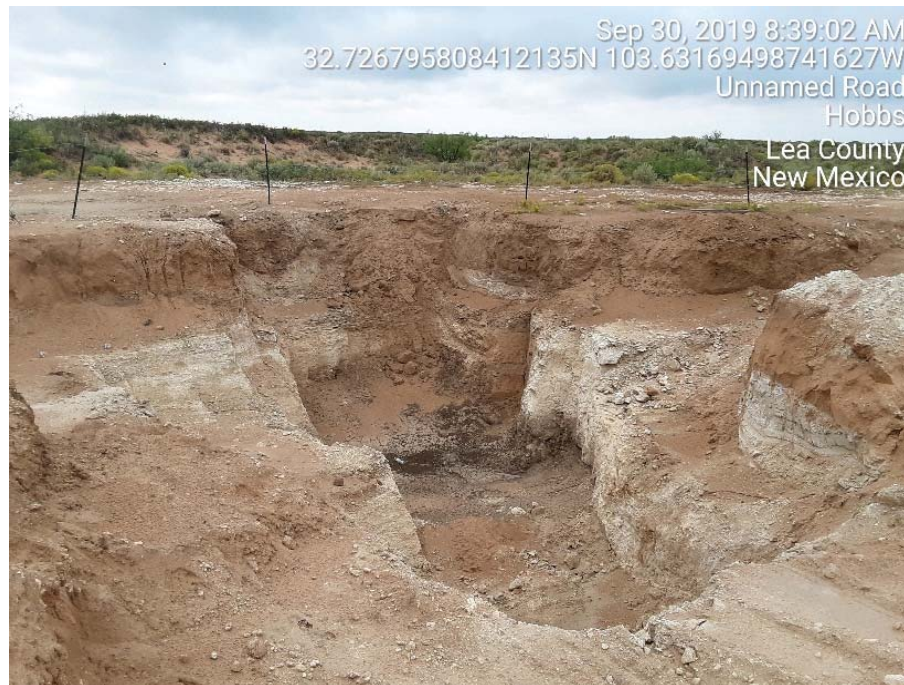
Seq Number: 3091325

Impacted soil in the areas characterized by sample point HA-3 were excavated to a depth of one (1) foot BGS. Impacted soil in the area characterized by sample point HA-4 was excavated to a depth of four (4) ft. BGS. Impacted soil in the area characterized by sample points HA-1 and HA-2 was excavated to a depth of twelve (12) ft. BGS., which was the depth that all visibility stained areas had been removed and olfactory evidence suggested that soil impacts were below the NMOCD closure criteria. Excavated impacted soil was temporarily stockpiled on-site, atop an impermeable liner, pending final disposition. Upon completion of excavation activities, sixteen (16) confirmation composite method soil samples were collected from the floors and sidewalls of the excavated areas representing no more than two hundred (200) square feet. The collected soil samples were submitted to a commercial laboratory for analysis of TPH, BTEX, and chloride concentrations. Laboratory analytical results indicated that TPH, BTEX, and chloride concentrations were below the NMOCD closure criteria in all of the submitted soil samples. Upon receiving laboratory analytical results from confirmatory sampling, impacted soil was transported under manifest to a NMOCD-approved disposal facility and the excavated area was backfilled with locally sourced, non-impacted "like" material. A table summarizing laboratory analytical results from confirmation soil samples is provided below:

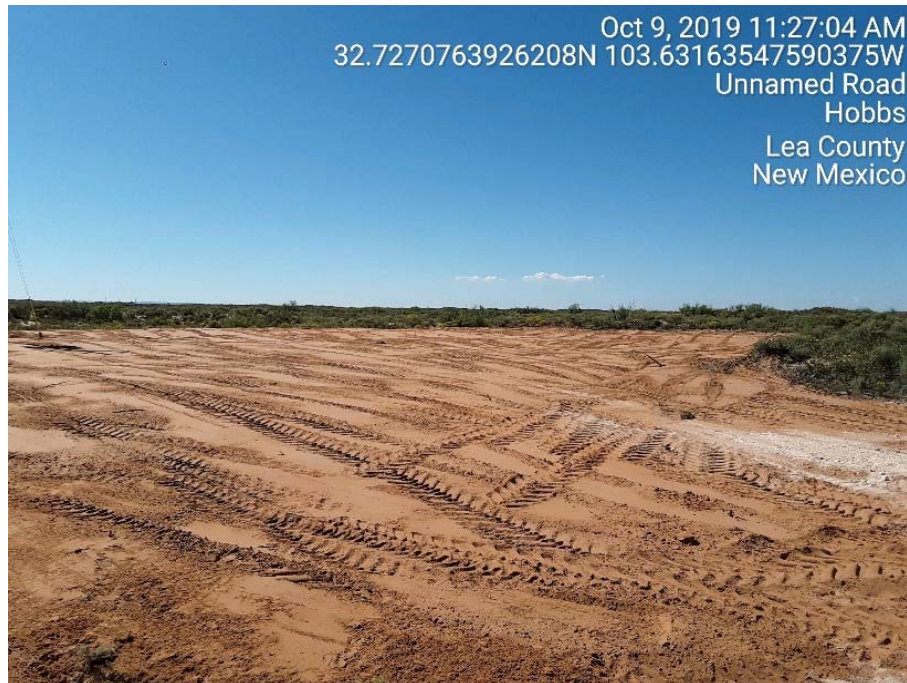
Prep Method: 1005

Areas affected by the Release and associated remediation activities were substantially restored to the condition which existed prior to the Release to the maximum extent practicable. Excavated areas were backfilled with locally sourced, non-impacted "like" material. The affected area was contoured and/or compacted to achieve erosion control, stability and preservation of surface water flow to the extent practicable.
