RE: Marathon Permian * Iron Duke 2H * 2RP-4956

SUBJECT: Remediation Closure Report for the Iron Duke #002H Release (2RP-4956), Artesia, Eddy County, New Mexico

Table 1: Release Information and Closure Criteria			
Name	Iron Duke #002H	Company	Marathon Oil Permian, LLC
API Number	30-015-39761	Location	32.761522° -104.378899°
Incident Number	2RP-4956		
Estimated Date of Release	August 18, 2018	Date Reported to NMOCD	August 31, 2018
Land Owner	Private	Reported To	NMOCD District 2
Source of Release	Ball valve on the load line failed		
Released Volume	10 bbls	Released Material	Produced water
Recovered Volume	Unknown	Net Release	Unknown
NMOCD Closure Criteria	51-100 feet to groundwater		
SMA Response Dates	August 22, 2018

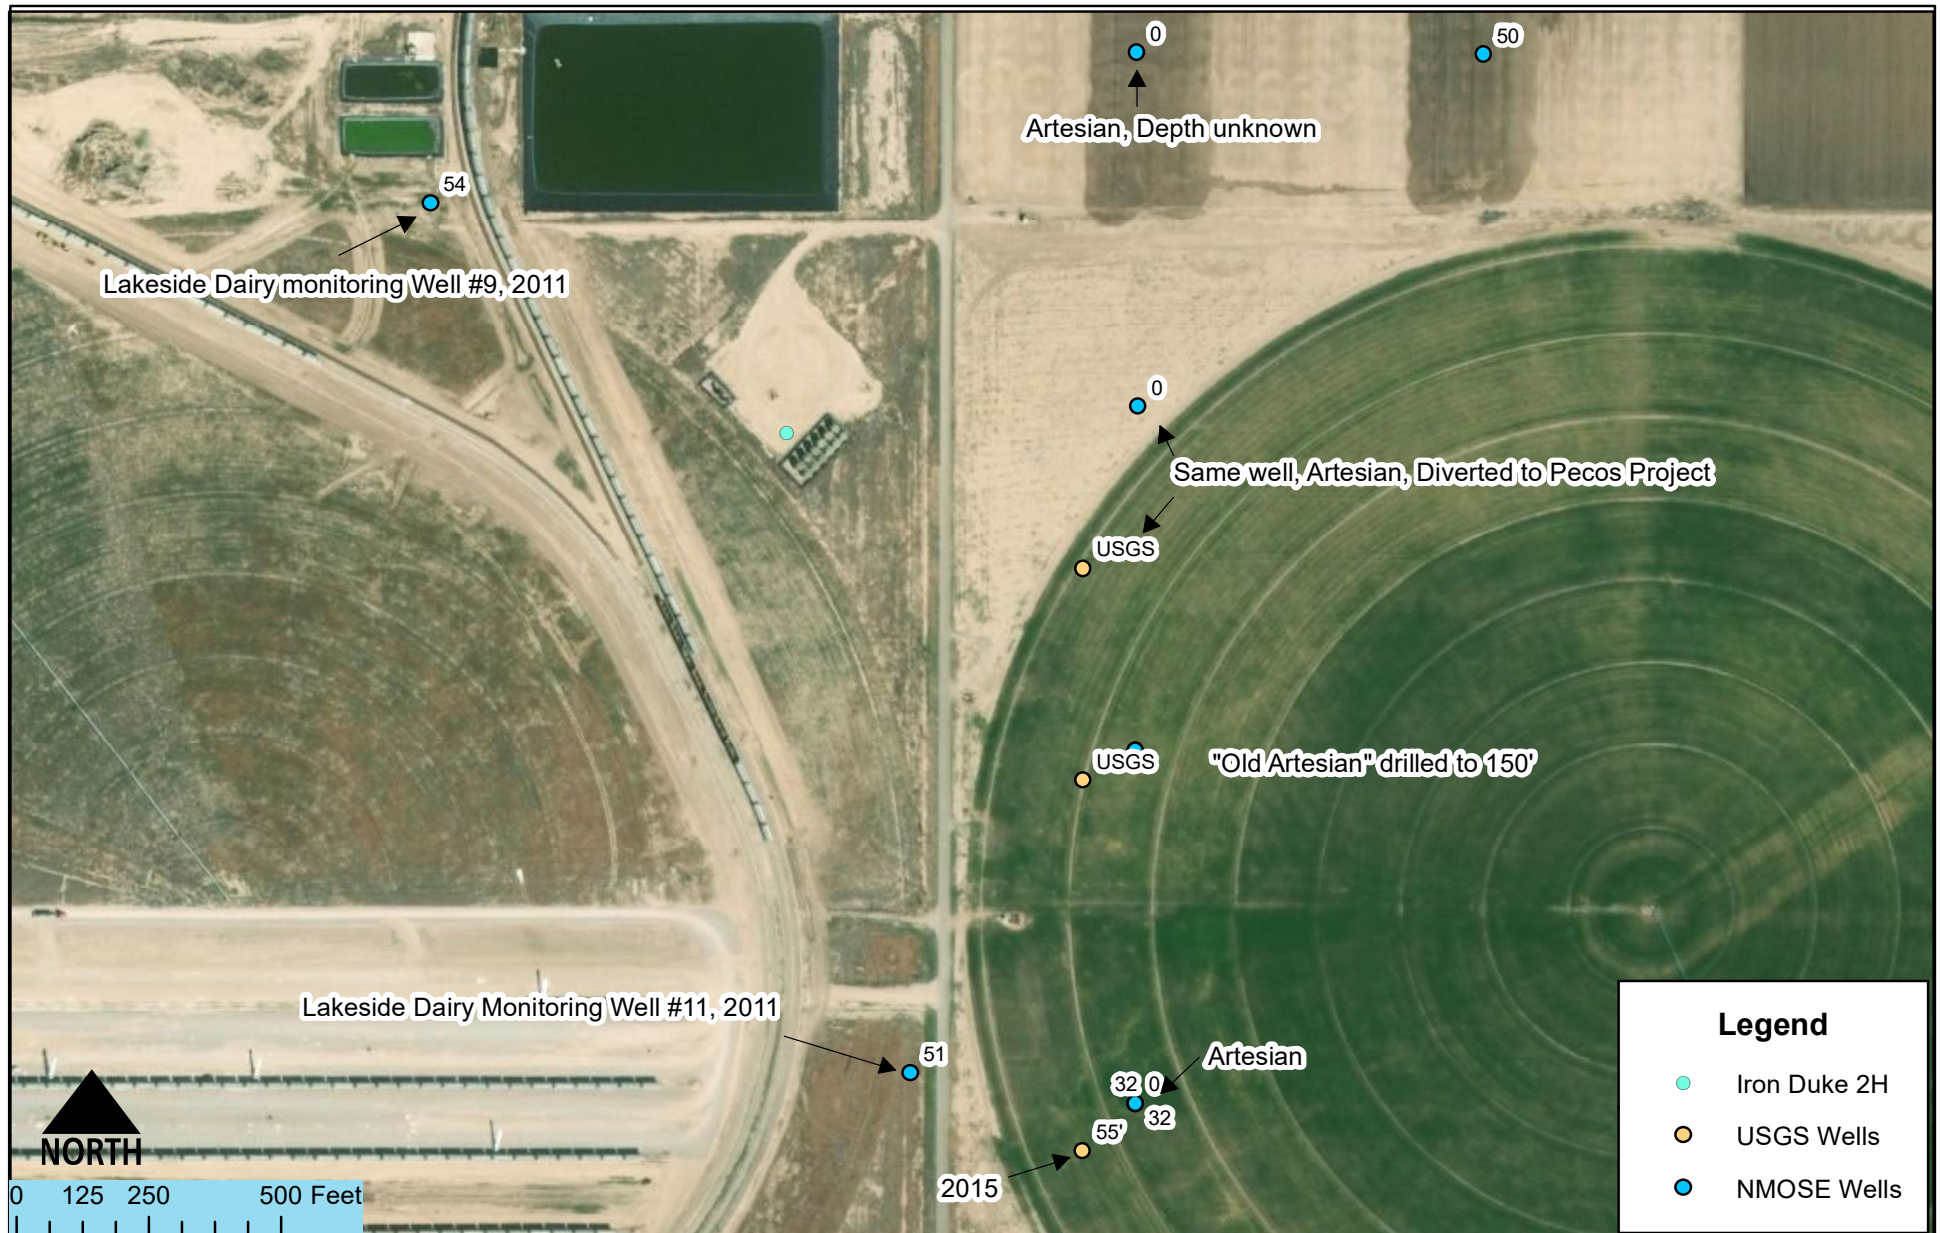
Figure 1

Thank you for your prompt response. The depth to groundwater was determined to be greater than 50' based on two 2011 monitoring wells, one located approximately 700' from the release point to the northwest, the other to the south. Both encountered water at greater than 50'. While there are other wells nearby that show depth to water at less than 50', further investigation shows they are predominately artesian wells, many of which have been diverted to the Pecos River Project. USGS data appears to also predominately come from artesian wells also, with only one having a recent reading. That well has data from 2015 showing a depth of 55'.

Attached is an additional figure with well information and the well logs of the two monitoring wells recently drilled nearby.

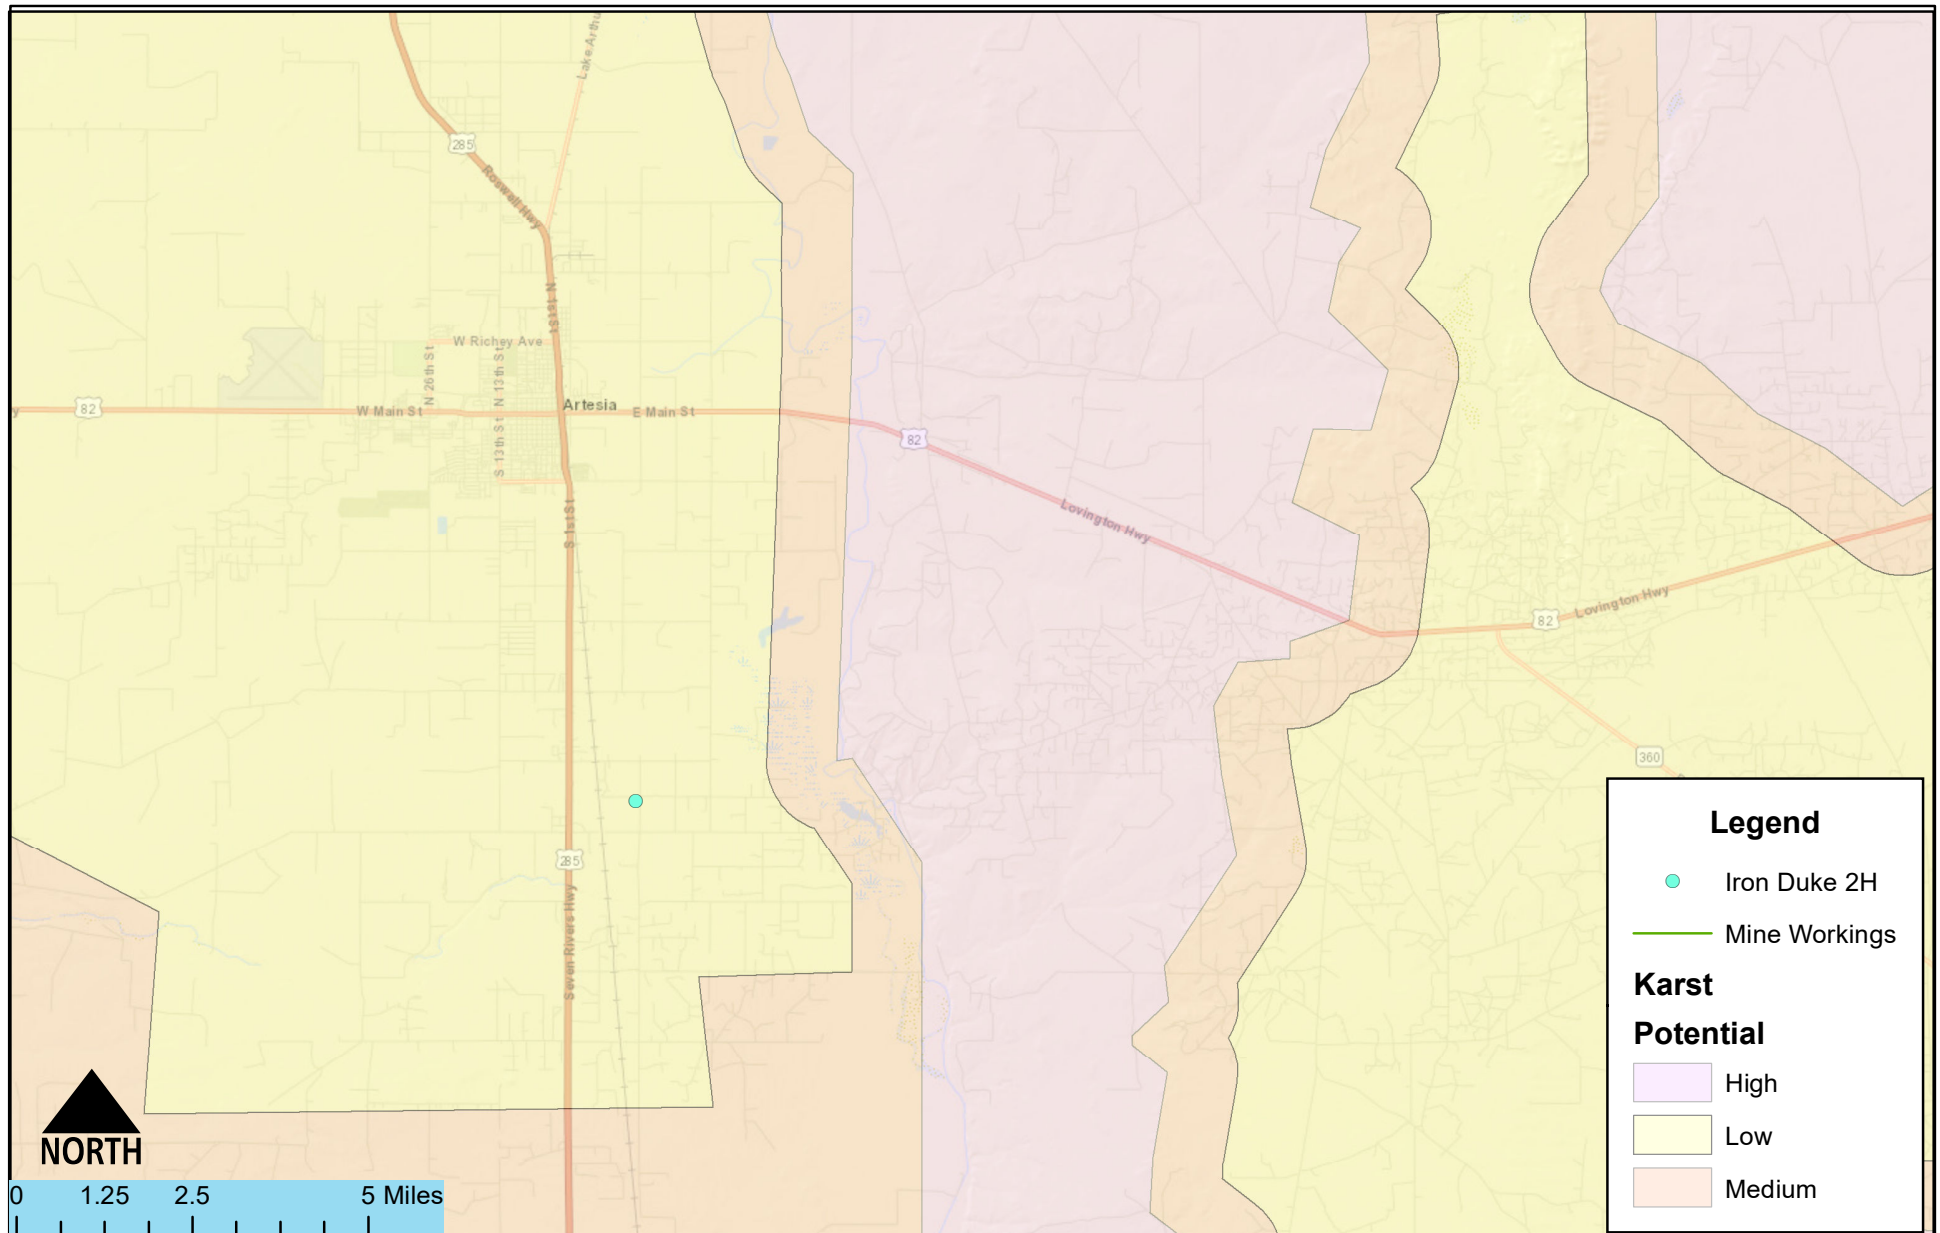
Figure 1a

Vicinity and Subsurface Protection Map
 Iron Duke #2H - Marathon
 S 9-T18S-R26E, New Mexico

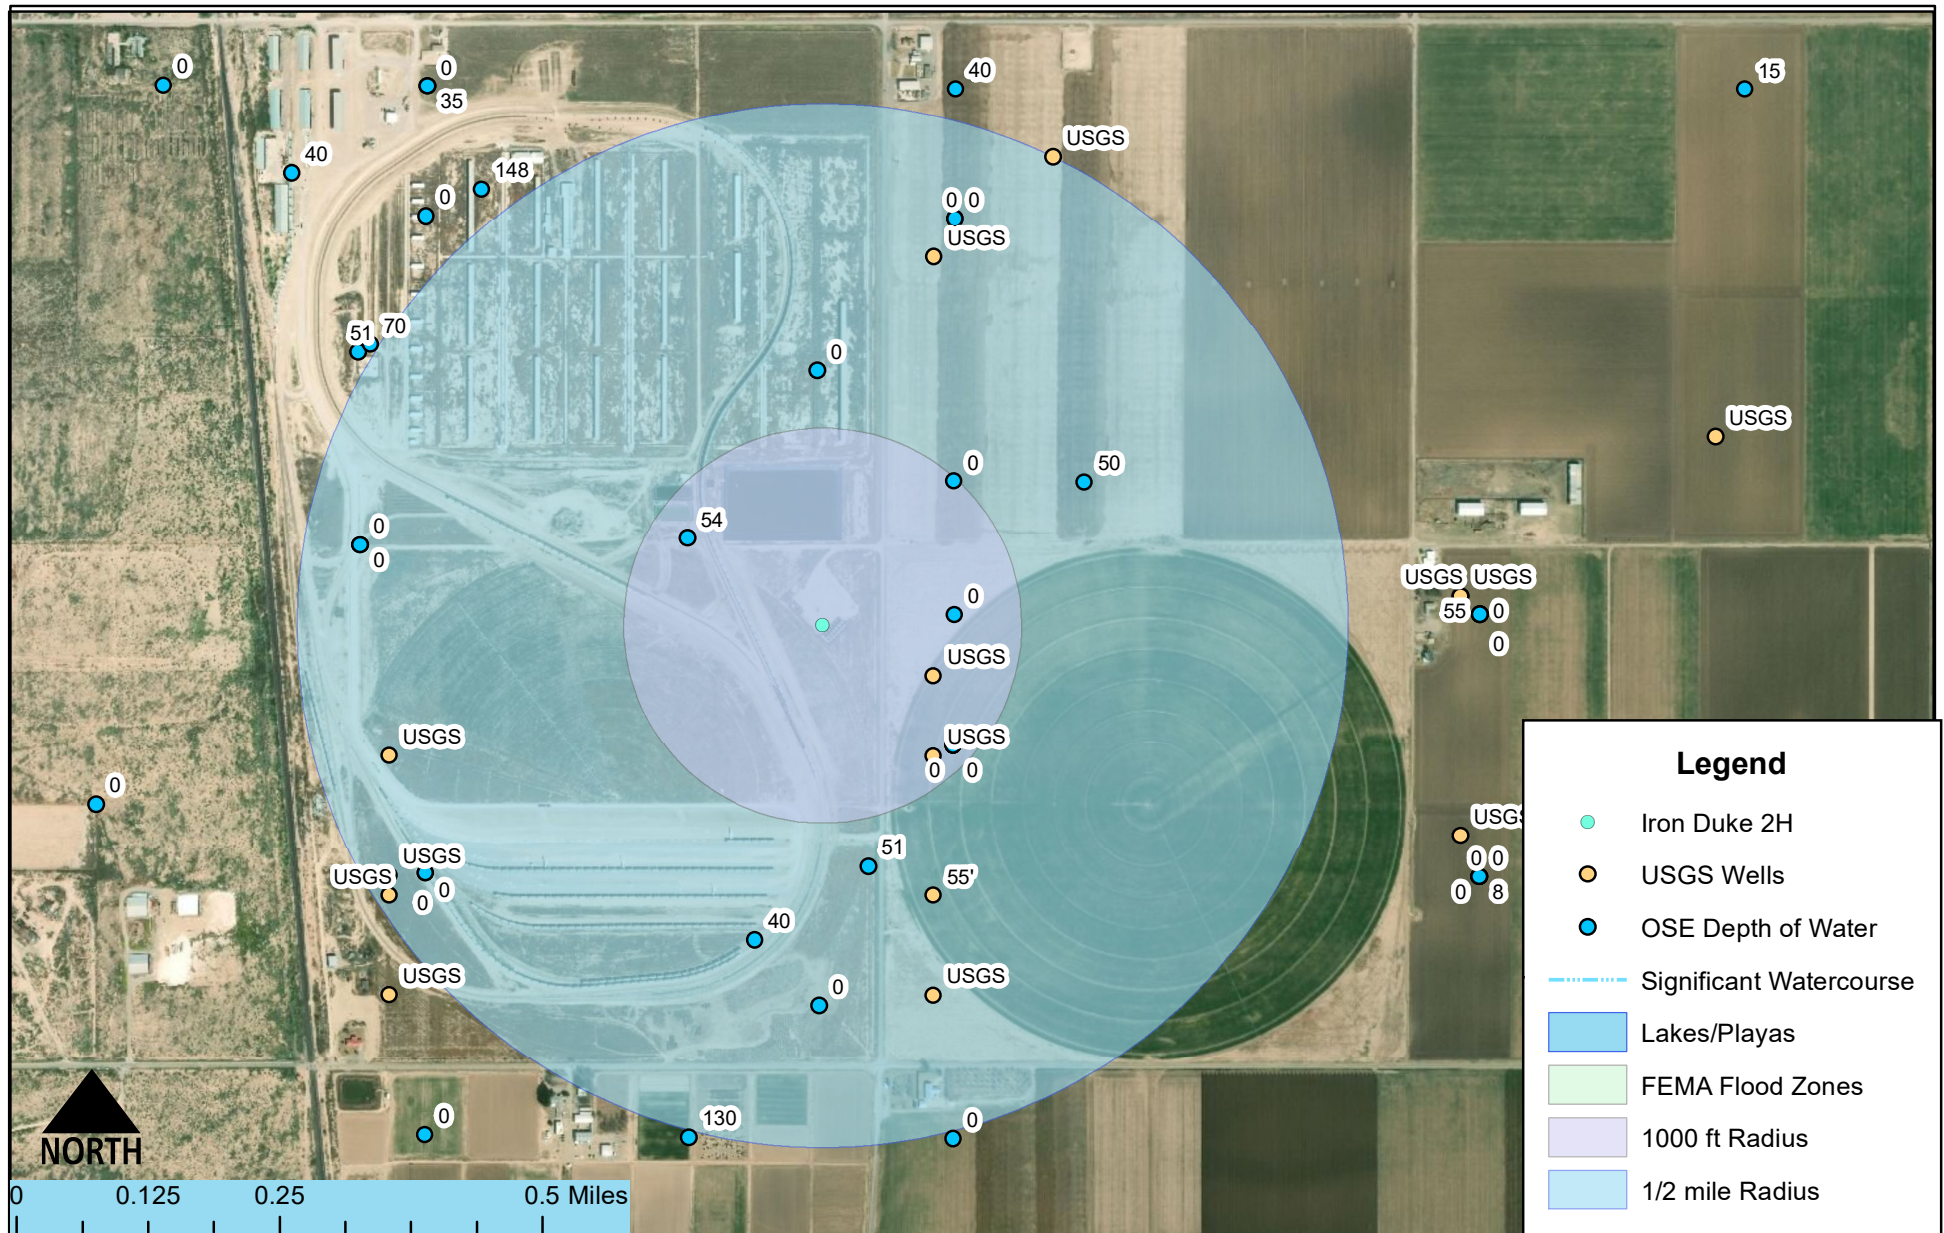
Figure 1b

As summarized in Table 2 and illustrated in Figure 1b, depth to groundwater in the area is estimated to be fifty-five (55) feet below grade surface (bgs). There are several known water sources within ½-mile of the location, according to the New Mexico Office of the State Engineer (NMOSE) online water well database (https://gis.ose.state.nm.us/gisapps/ose_pod_locations/; accessed 8/20/2018). One NMOSE well shows water at a depth of 32 feet bgs, but upon further investigation this was found to be invalid. The well was drilled as an Artesian well in 1927, at which point the water level within the well bore was 32 feet. The water level then subsided, and the well was re-drilled to a depth of 863 feet bgs. The strongest depth to groundwater data was found from the many monitoring wells drilled for the dairy on which this well is located. Several monitoring wells were drilled for the New Mexico Environment Department Ground Water Quality Bureau discharge permit for the dairy (DP 796). These wells were permitted under NMOCD RA 11682 and have been included in Appendix B. The nearest of these monitoring wells (MW-9) is located 750 feet to the west and encountered water at 57 feet bgs. The nearest significant watercourse is an unnamed pond, located approximately 4,085 feet to the south.

Well Head and Surface Water Protection Map
 Iron Duke #2H - Marathon
 S 9-T18S-R26E, New Mexico

Based on the information presented herein, the applicable NMOCD Closure Criteria for this site is for groundwater depth of between 51-100 feet bgs. Table 2 demonstrates the Closure Criteria applicable to this location. Pertinent well data is attached in Appendix B.

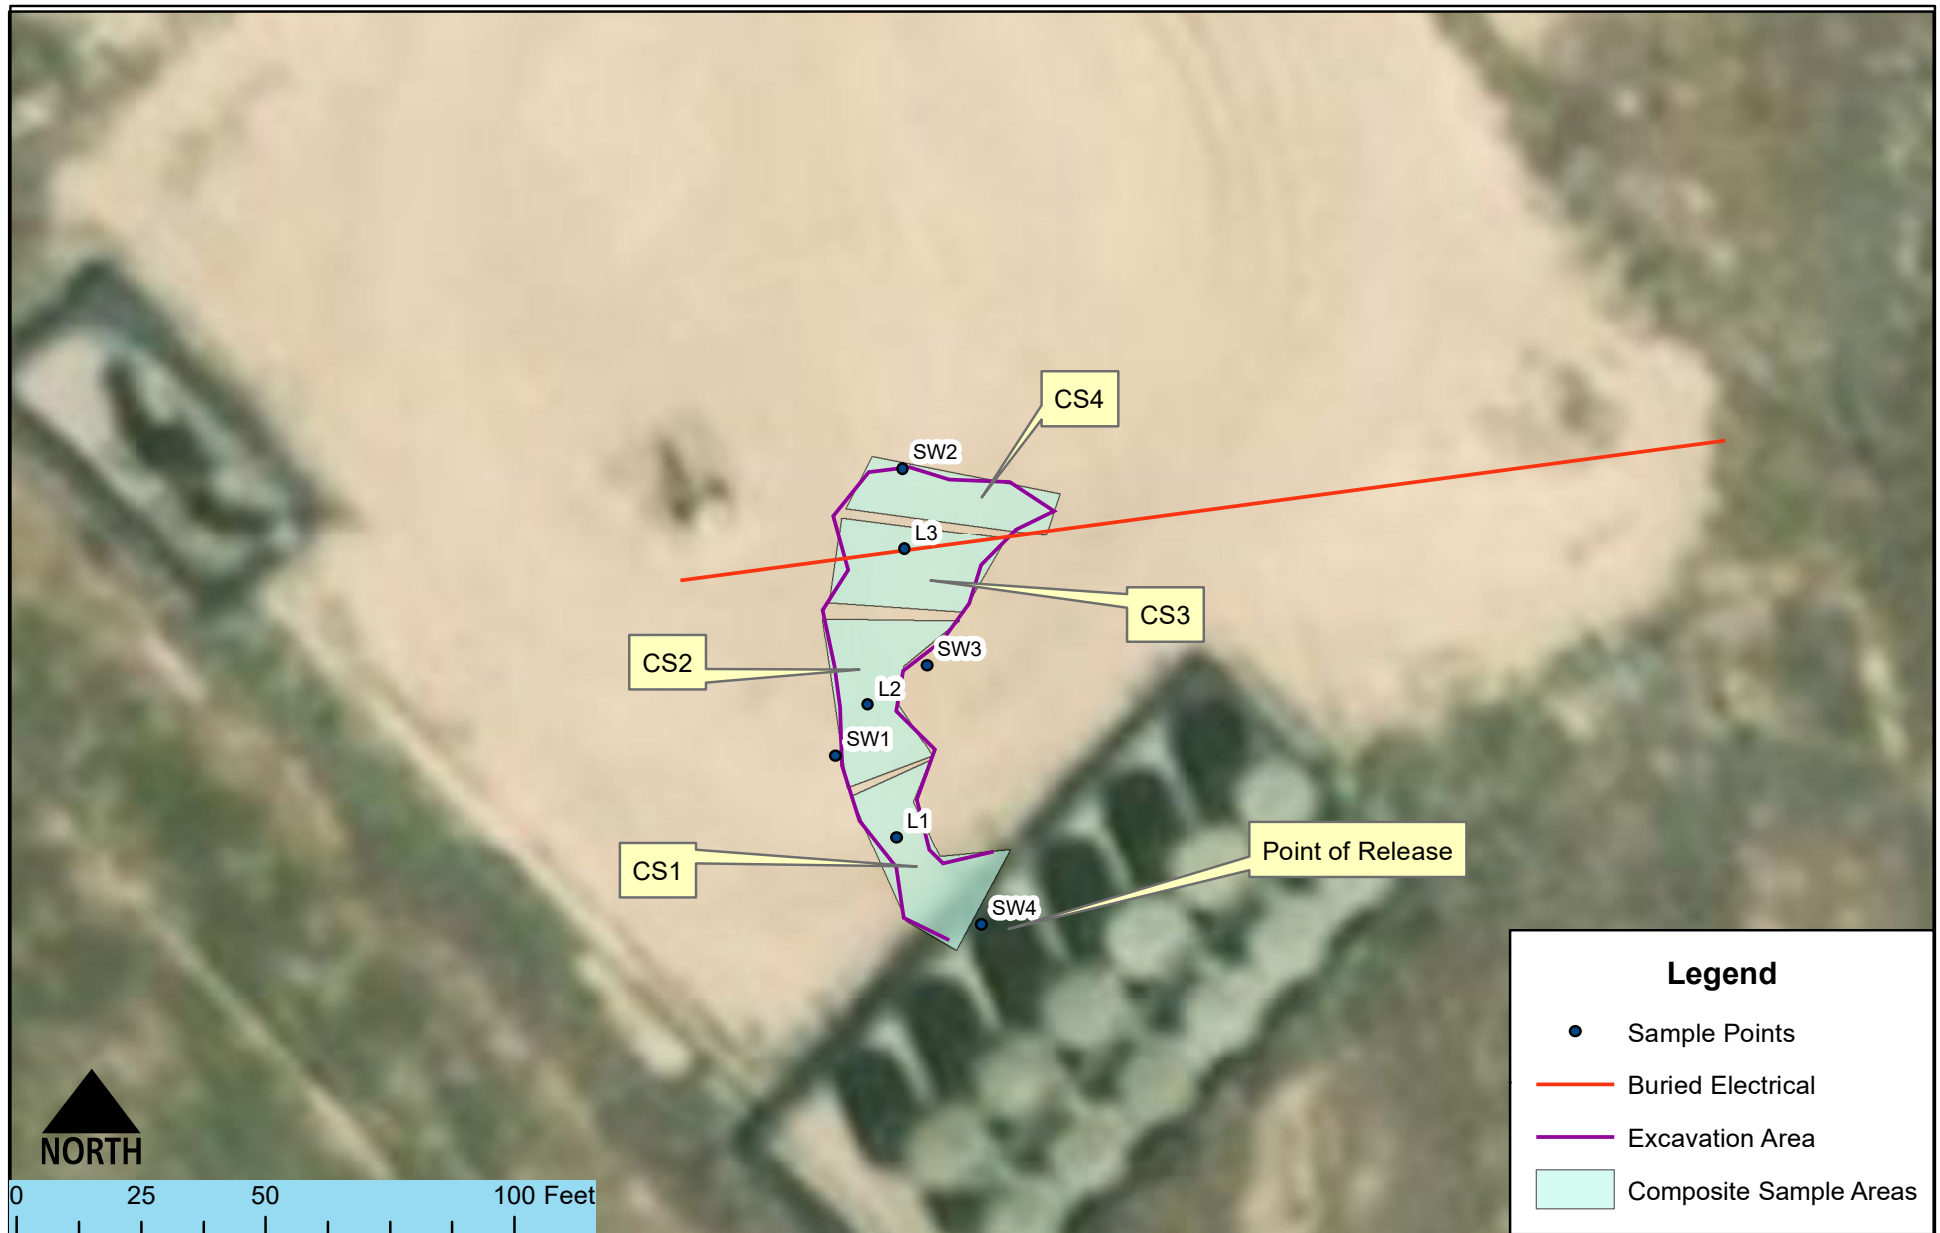
On August 18, 2018, a release was discovered at the Iron Duke #002H site due to the ball valve on the load line failing. Initial response activities were conducted by Marathon Oil Permian, LLC, and included isolating the source of the release and hydrovacating free standing fluid. Figure 1 illustrates the vicinity and site location, Figure 2 illustrates the release location. The C-141 form is included in Appendix A.

A total of three (3) sample locations (L1-L3) were investigated using a hand-auger, to depths up to one (1) foot bgs. A total of four (4) samples were collected for laboratory analysis for total chloride using EPA Method 300.0; benzene, toluene, ethylbenzene and total xylenes (BTEX) using EPA Method 8021B; and motor, diesel and gasoline range organics (MRO, DRO, and GRO) by EPA Method 8015D. Table 3 itemizes the samples and field-screening results as well as identifying any variances from the typical specification of two samples per boring. Locations for all samples are depicted on Figure 2.

The release area was excavated to the NMOCD Closure Criteria as demonstrated in the attached Table 3. Confirmation samples were collected from the excavation and were composed of four sidewall (SW1-SW4) and four base (CS1-CS4) 5-point composite samples, each representing less than 200 ft² of exposed excavation area. The confirmation samples were collected from within the excavation in accordance with the sampling protocol included in Appendix C. Approximately 100 cubic yards of contaminated soil were removed and replaced with clean backfill material in order to return the surface to previous contours. The contaminated soil was transported for disposal at R360 Landfill near Hobbs, NM, an NMOCD permitted disposal facility.

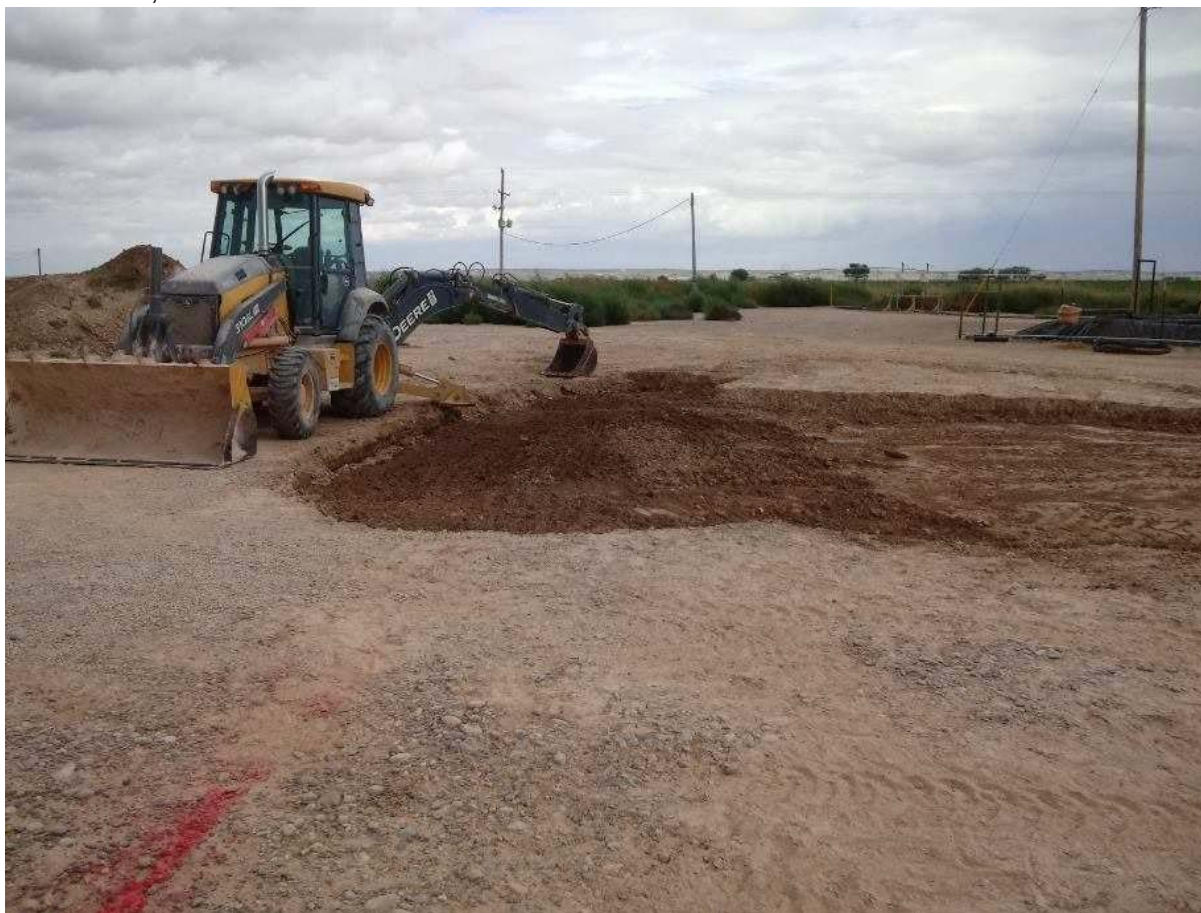
Facing southeast

32.761615°, -104.379232°

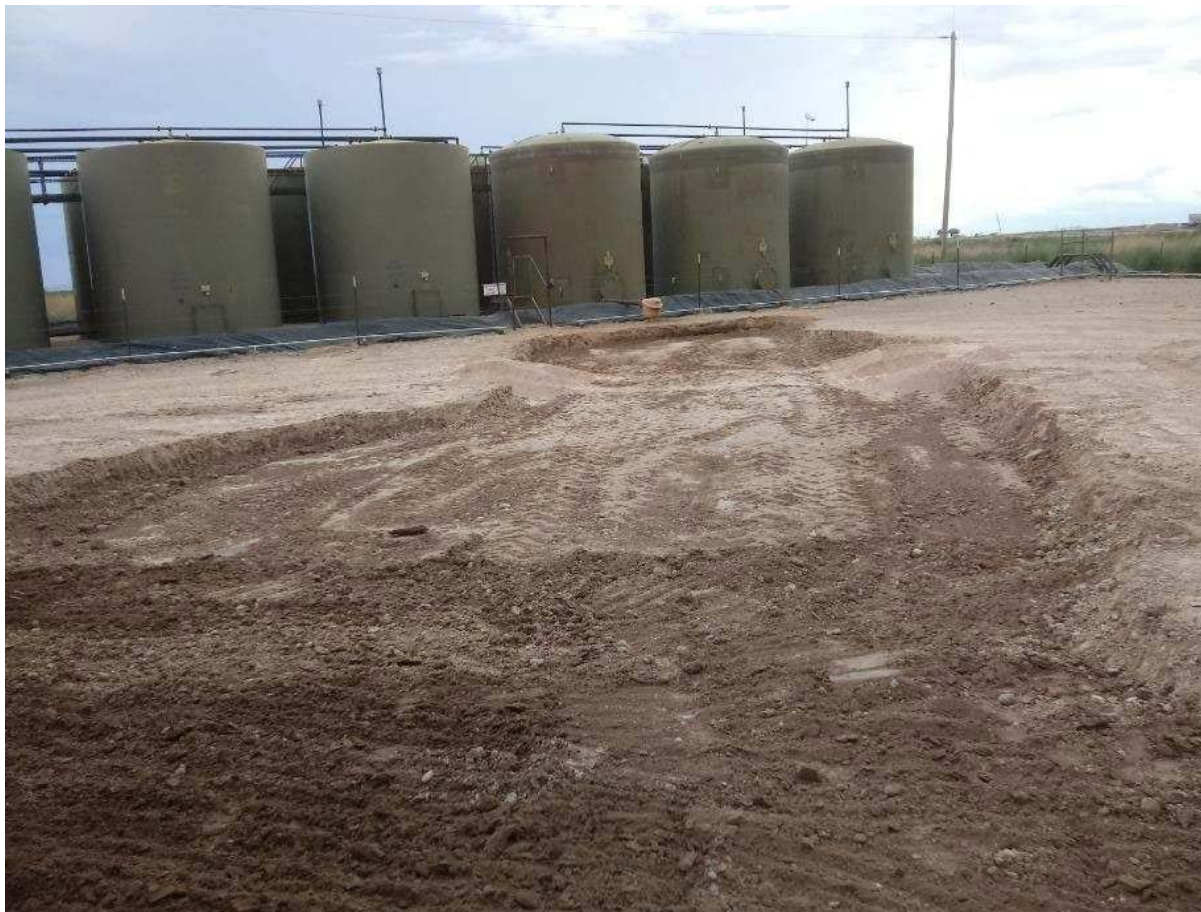
Photo Taken September 21, 2018

Facing south

32.761615°, -104.379232°
