OWWKV-190801-C-1410

July 25, 2019

Re: **Remediation Summary and Closure Report**
North Lea 3 Federal #1H Battery
GPS: Latitude **32.608471** Longitude **-103.540197**
UL "A", Sec. 3 T20S, R34E
Lea County, NM
NMOCD Ref. No. **1RP-5440**
Plains SRS No. **2019-041**

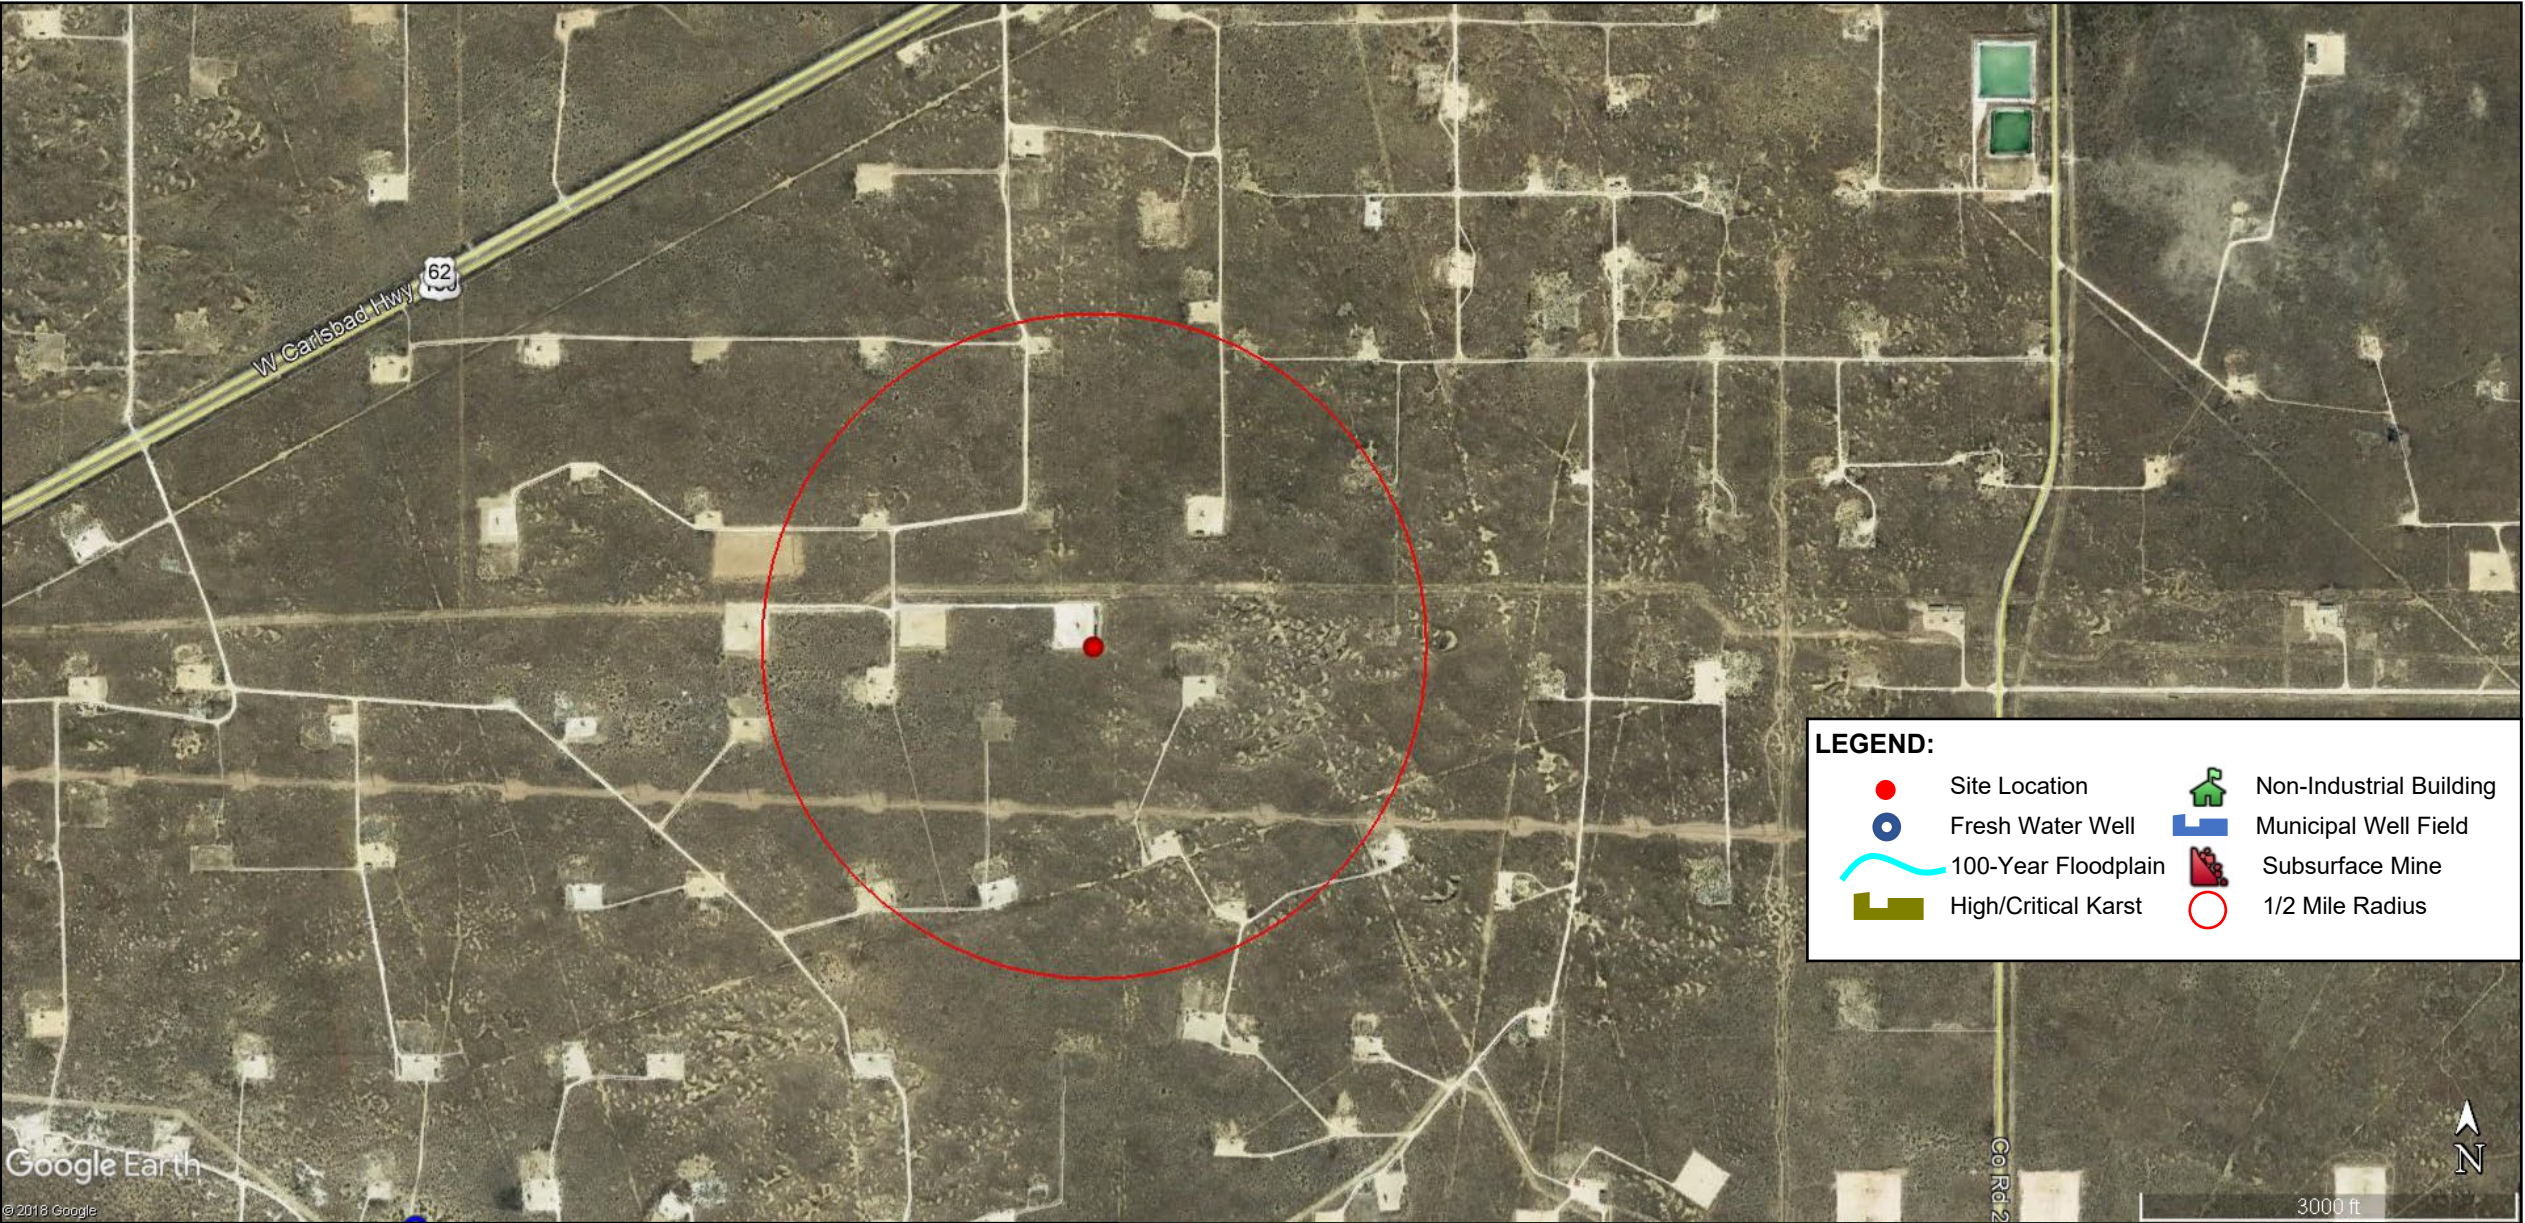
DATE: March 2019	<div><div><div></div></div><div>TASMAN GEOSCIENCES</div><div>Tasman Geosciences, Inc. 2620 W. Marland Blvd. Hobbs, NM 88240</div></div>	<div><div>Read & Stevens, Inc.</div><div>North Lea 3 Fed Com 1H</div><div>GPS: 32.608471, -103.540197</div><div>UL "A", Section 3, Township 20 South, Range 34 East</div><div>Lea County, New Mexico</div></div>	<div>Site Characteristics Map</div>	<div>Figure 1</div>
DESIGNED BY: ZC				
DRAWN BY: BD

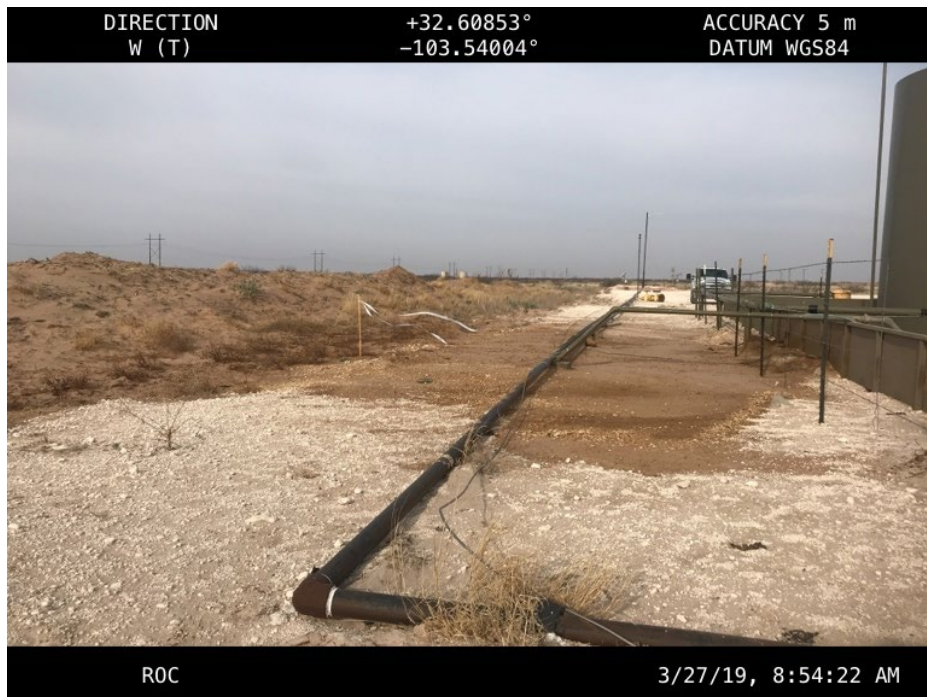
Initial Release

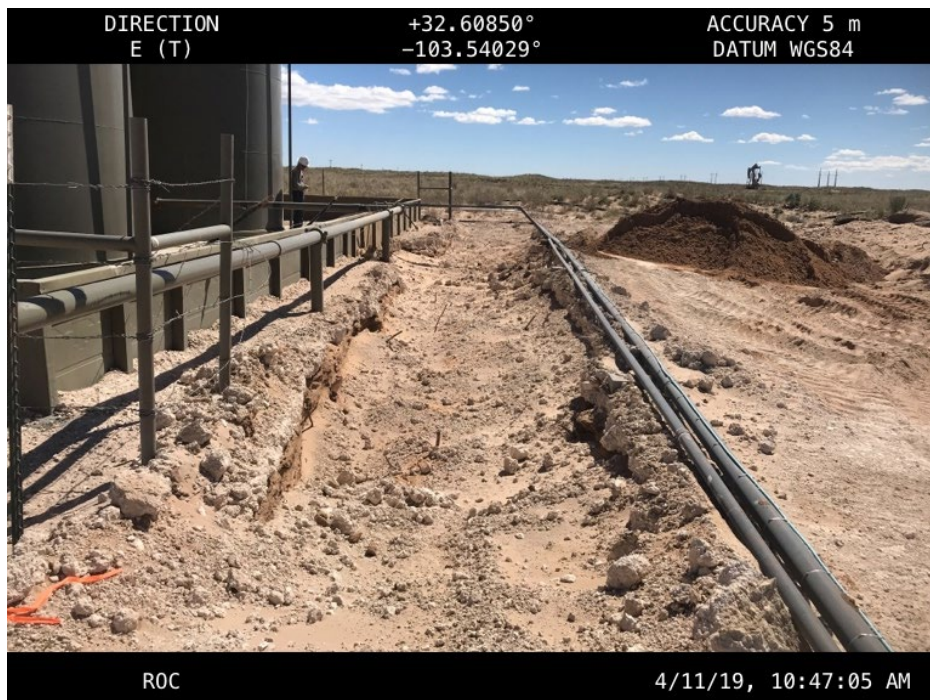
1 ft. Excavation

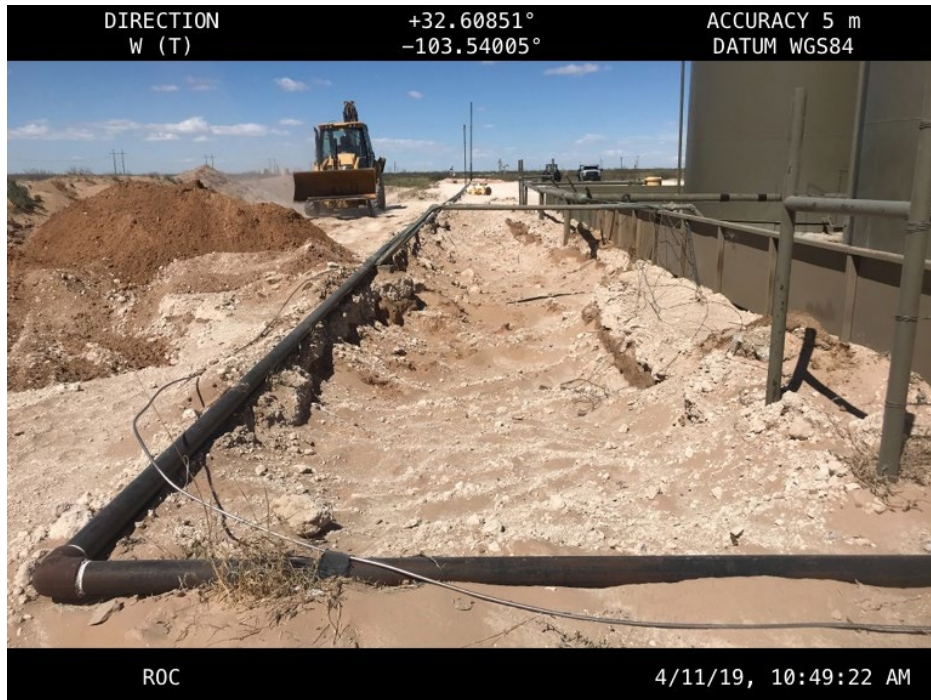
1 ft. Excavation

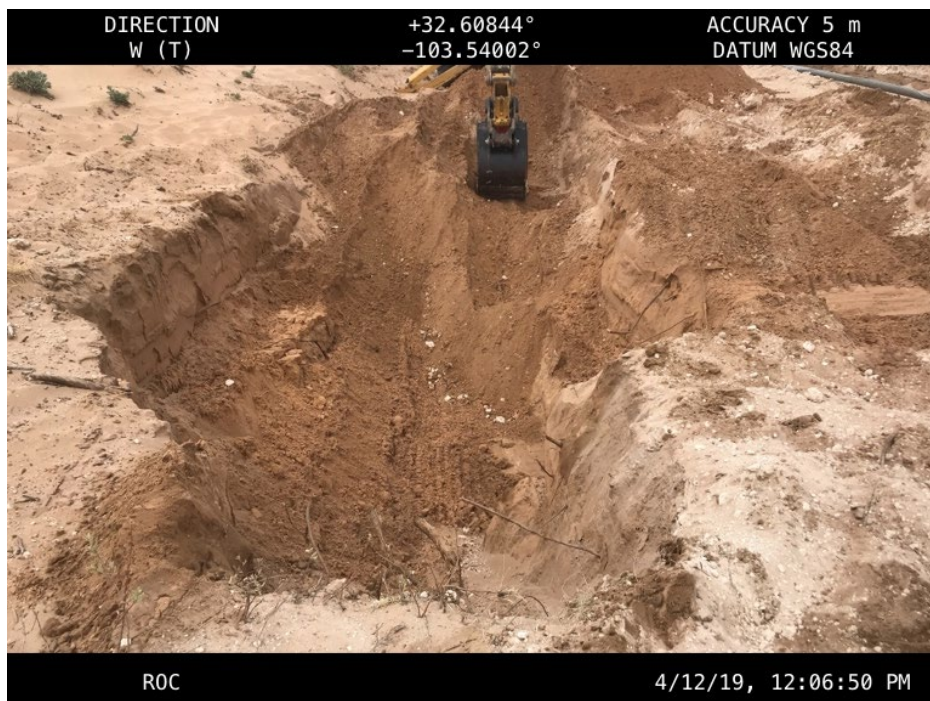
6 ft. Excavation

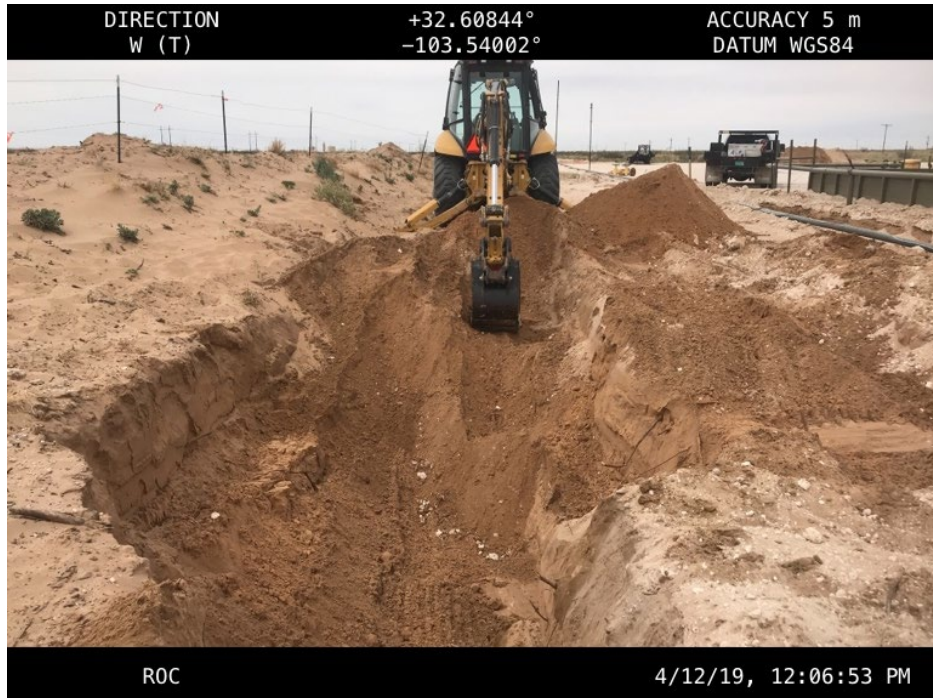
6 ft. Excavation

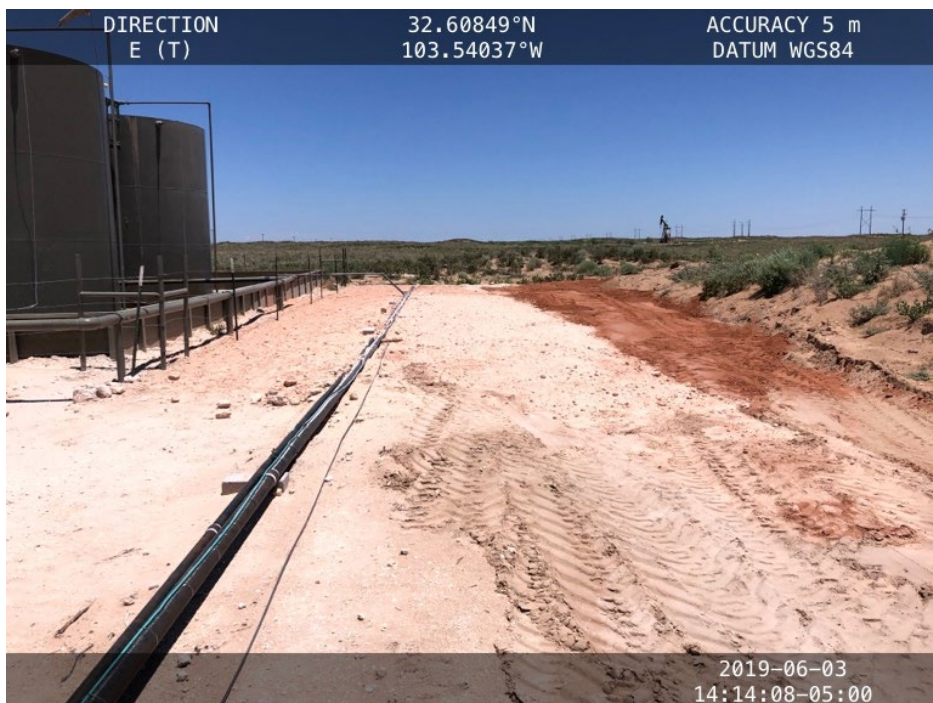
Back Filled Excavation

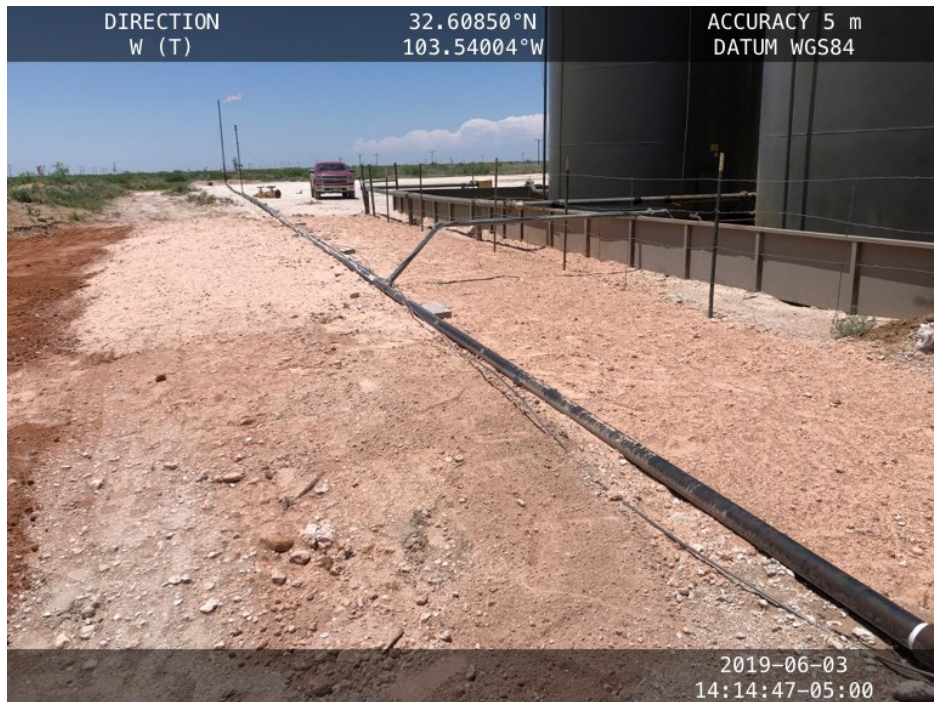
Back Filled Excavation
