1RP-5655 Characterization, Remediation & Closure Report ROC Mesa Water System

**Prepared for
Advance Energy Partners Hat Mesa LLC
Houston, Texas**

**Prepared by
R.T. Hicks Consultants, Ltd.
Albuquerque, New Mexico**

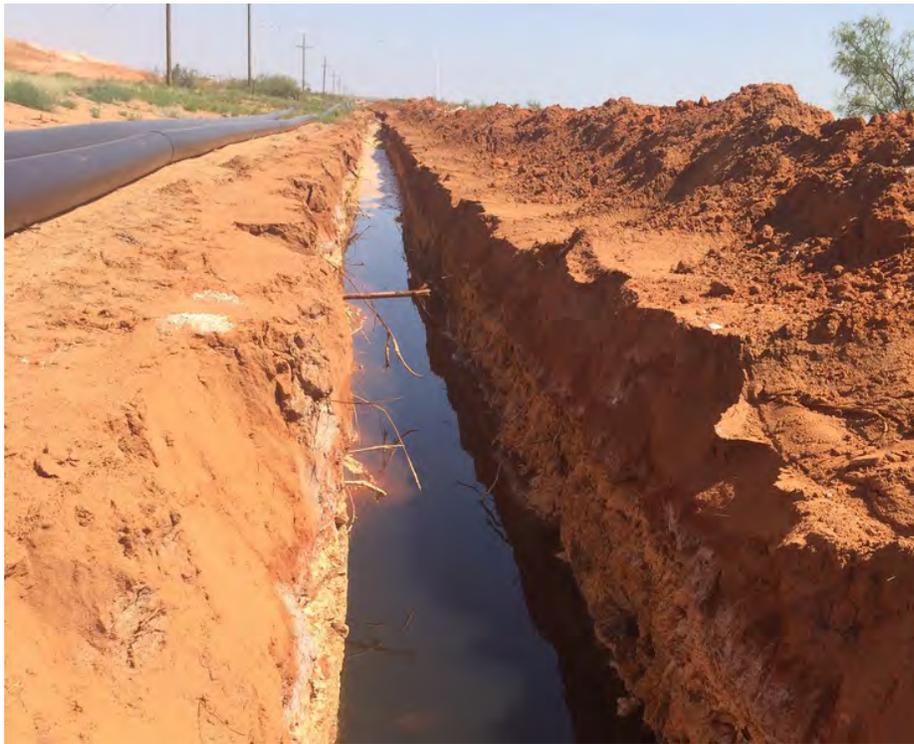
The produced water release occurred on July 31st, 2019 and occurred during fresh water flushing while bringing a new water transfer pipeline online. The release occurred and was confined within the open pipeline trench (Figure 1).

Figure 1: Produced water pooling in pipeline trench, viewing north. GPS: 32.4449083N, -103.6041028 W. Date/Time: 2019-08-01 10:18:38.

The flushing of the transfer line was shut down at 19:00hrs at the discovery of the release. Pooling of produced water was removed via vacuum truck.

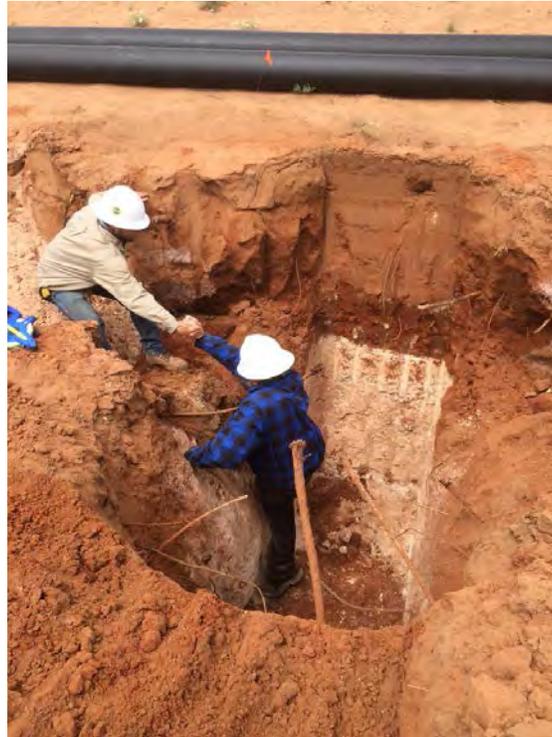
Lithology from the surface to 4.5-feet below ground surface is a silty sand. At 4.5-feet below ground surface a medium dense caliche was encountered. From 5 to 5.5-feet below ground surface a dense caliche was encountered.

Figure 2: Sampling trench Pooling-02 with a total depth of 9-feet below ground surface. A silty sand composes the upper 4.5-feet. Below 4.5-feet white caliche is visible at the lower depths of the sampling trench. GPS: 32.4451056 N, -103.6040639W. Date/time: 2019-08-03 11:29:24

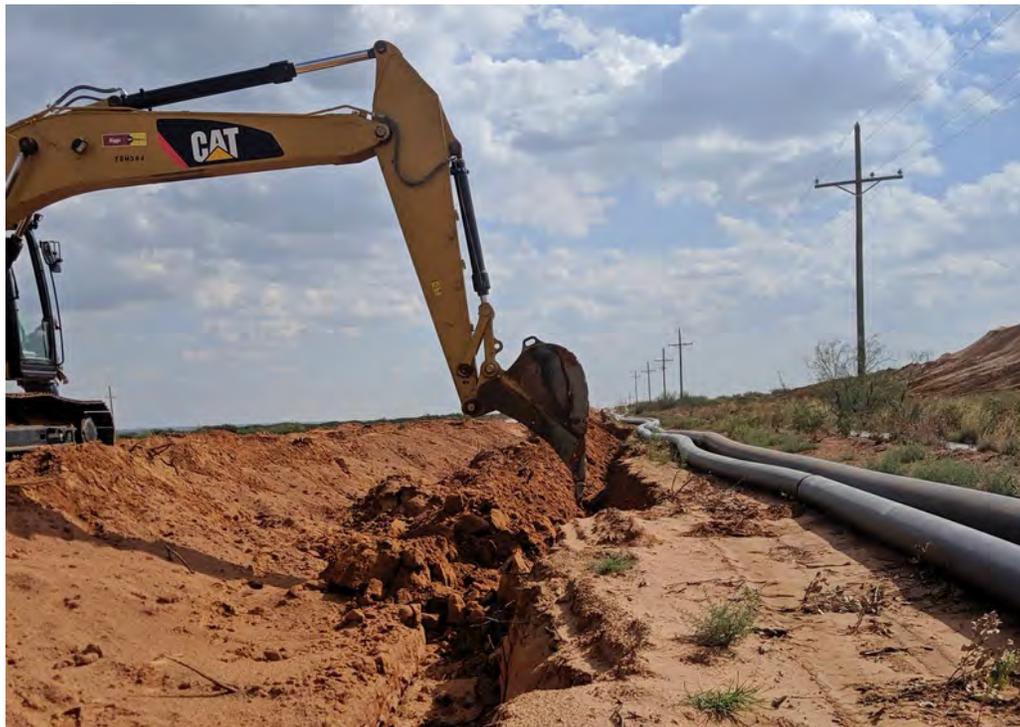
Figure 3: Excavation of the release within the pipeline trench. Photograph is viewing south from sample point T-02 (S-09). GPS: 32.4470472 N, -103.6041028 W. Time/Date: 2019-09-16 15:13:13

If soil confirmation sample results exceeded 600 mg/kg chloride at the excavation walls, the excavation wall was extended horizontally and resampled. Horizontal excavation continued until subsequent laboratory confirmation showed chloride below 600 mg/kg in the upper 4-feet.

Excavation depth was determined by 5-point composite sampling of the base. Vertical excavation continued until the base of the excavation exhibited chloride less than 600 mg/kg at 5.5 feet bgs or less. Below 4-feet, allowable chloride concentrations per Table 1 of 19.15.29 NMAC is $<20,000$ mg/kg.

Excavated soil was transported to R360 for proper disposal. Clean backfill soil was purchased from Merchant Livestock Company under a Surface Use Agreement.

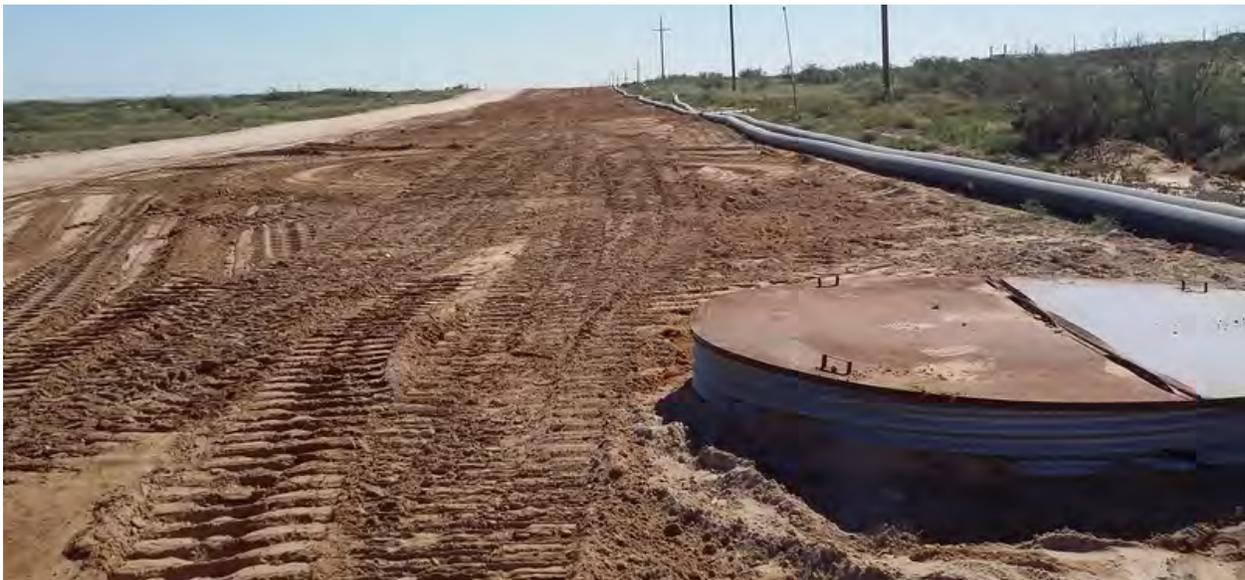
Figure 4, below, shows final restoration after seeding and surface contouring to blend with the surrounding topography.

Figure 4: Final backfill and reclamation of pipeline-right-of-way. Photograph viewing south from the Source area. Date/Time: 2019-10-17 14:07:52. GPS: 32.4459915 N, -103.6039734 W.

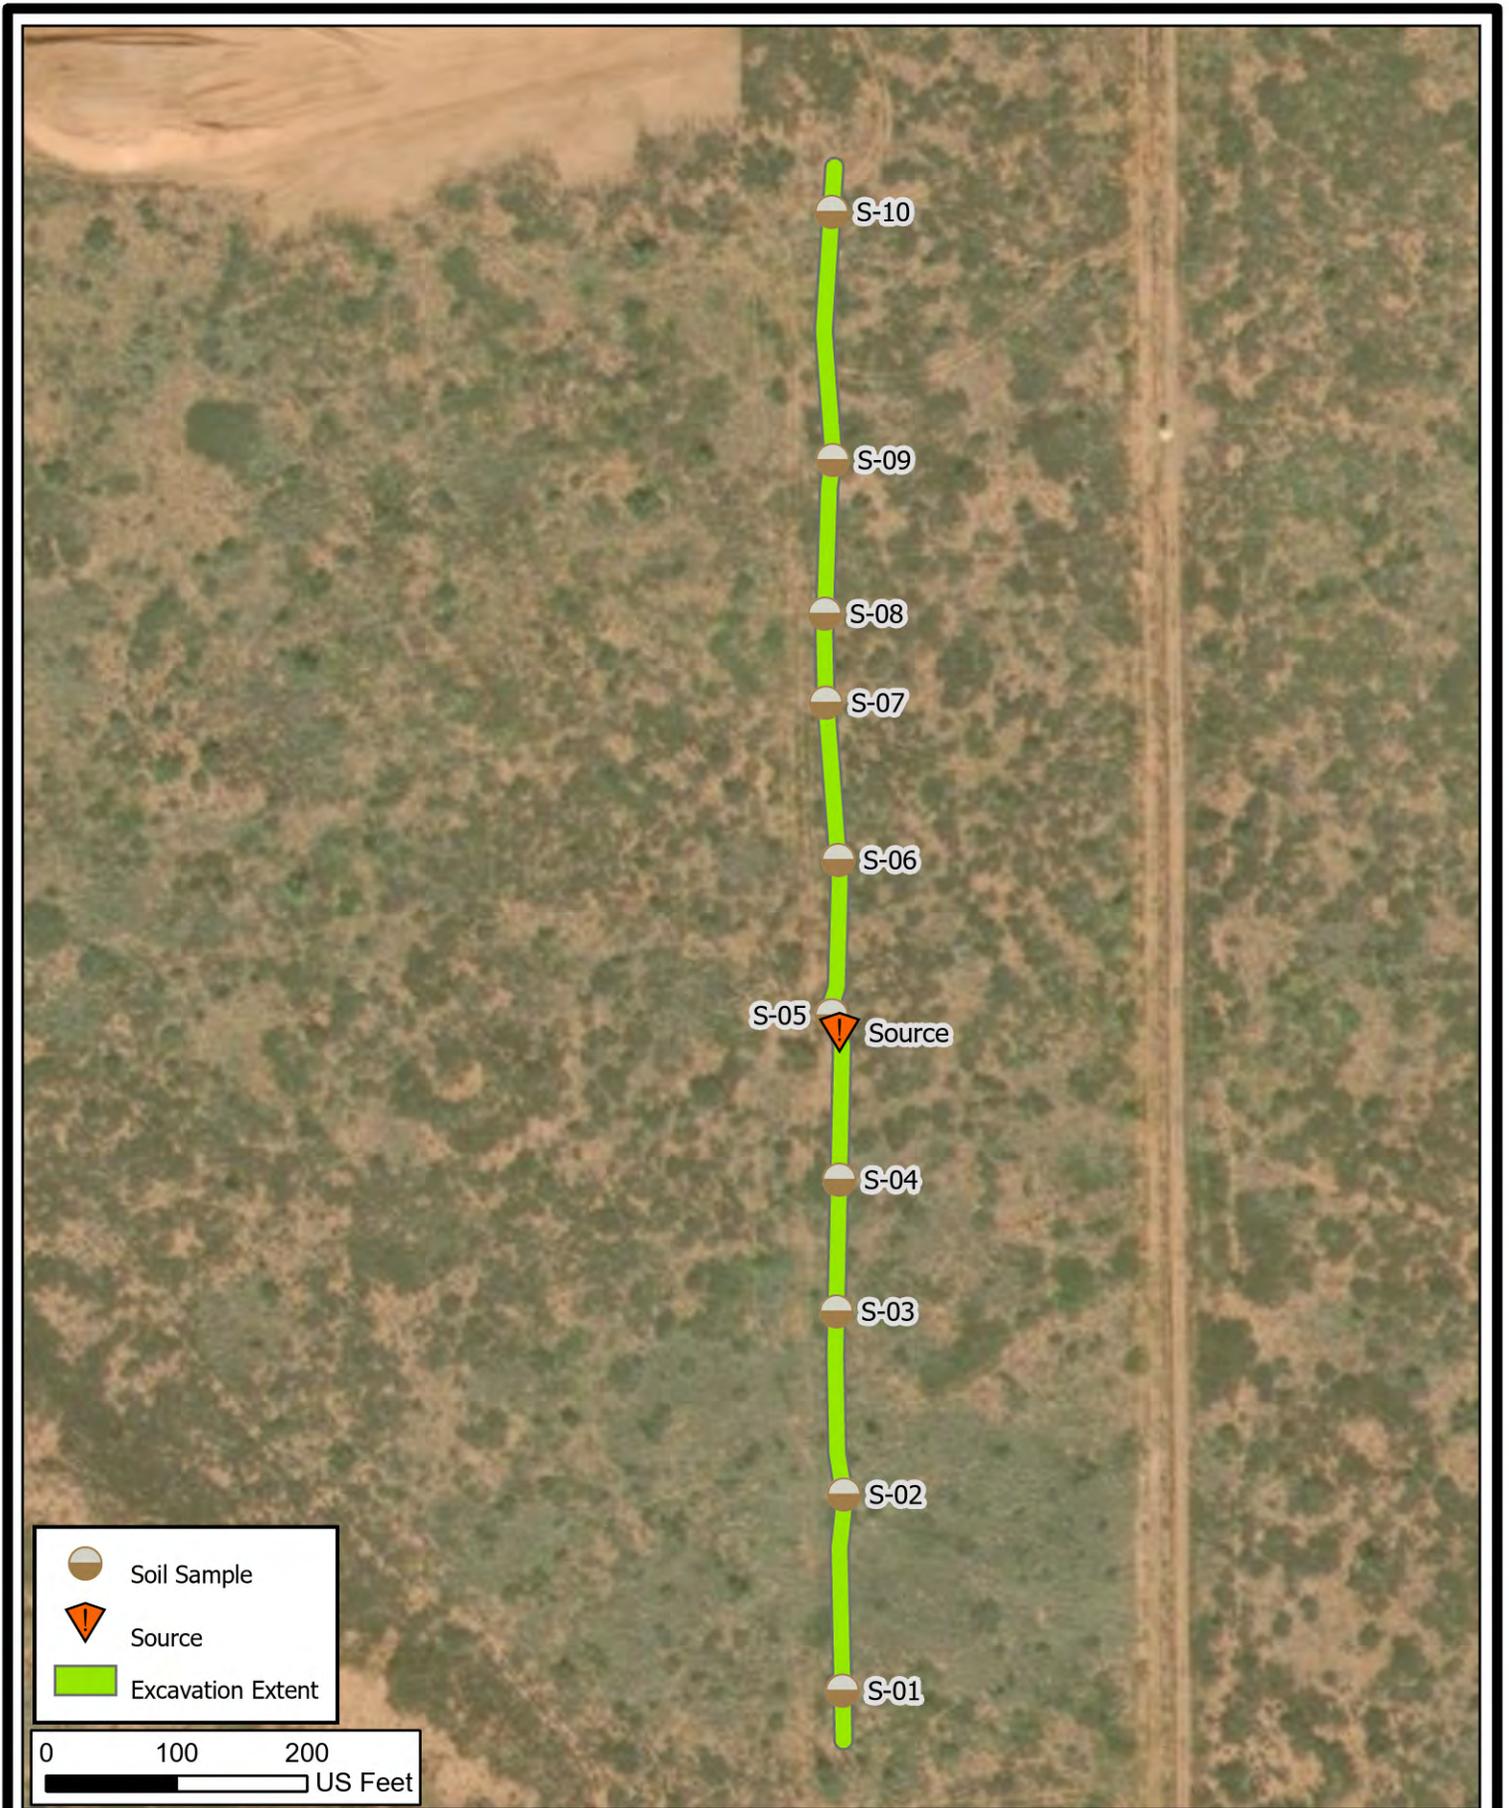
<u>R.T. Hicks Consultants, Ltd</u> 901 Rio Grande Blvd NW Suite F-142 Albuquerque, NM 87104 Ph: 505.266.5004	Final Confirmation Sample Locations Relative to Excavation Extent	Plate 12
		Advance Energy Partners Hat Mesa LLC 1RP-5655 ROC Mesa Water System	Oct. 24, 2019

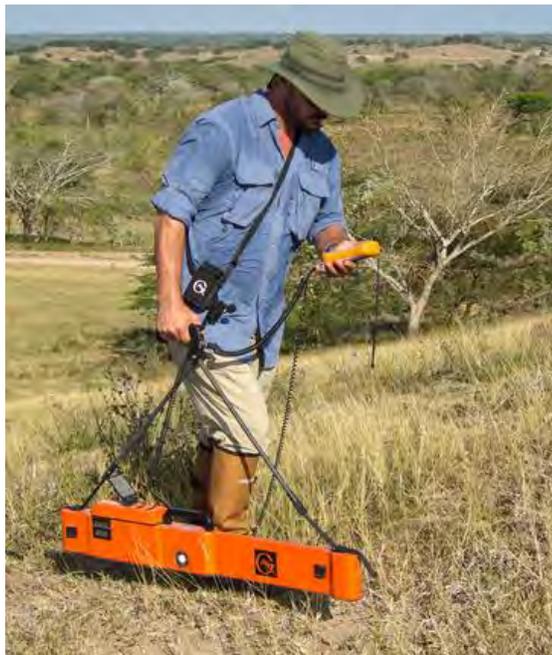
Electromagnetic surveys (EM Survey) are commonly used to measure electrical conductivity (EC, “soil salinity”) in soils. Employing a Geonics EM38 (Exhibit 1), field personnel can effectively delineate the horizontal extent of a produced water release by measuring EC and monitoring for EC changes between background and higher EC readings. Increasing EC measurements suggest that the edge of the release extent is approaching.

Exhibit 1: Measuring EC with the EM38 in the vertical position.

The EM38 detects EC from the surface to a depth of approximately 4-feet. EC measurements can be obtained in the vertical or horizontal positions. In the vertical position, EC readings are weighted toward the lower depths of 3 to 4 feet. In the horizontal position, EC readings are weighted toward the upper 0 to 2 feet. If a higher EC reading is obtained in the horizontal position than the vertical position, produced water has likely impacted the upper surface more than at lower depths. If a higher EC reading is obtained in the vertical position than the horizontal position, produced water has likely impacted lower soils than the upper surface soils.
