# Remediation Summary and Site Deferral Request

September 16, 2019

White Federal Com #001H  
(2RP-5470)

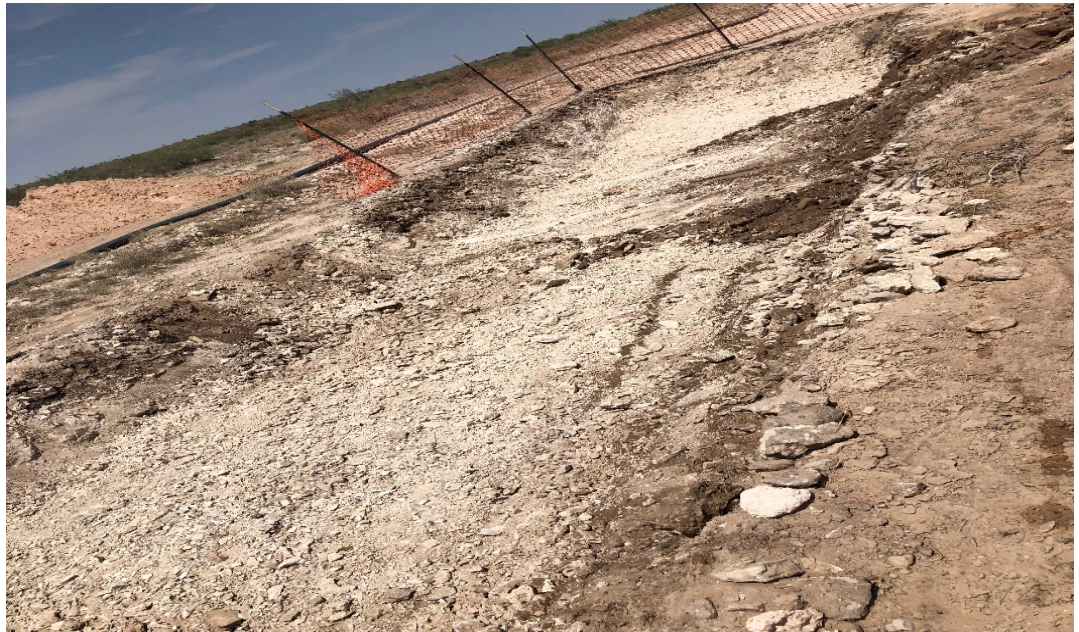
### Photograph No. 3

**View of excavated area.**

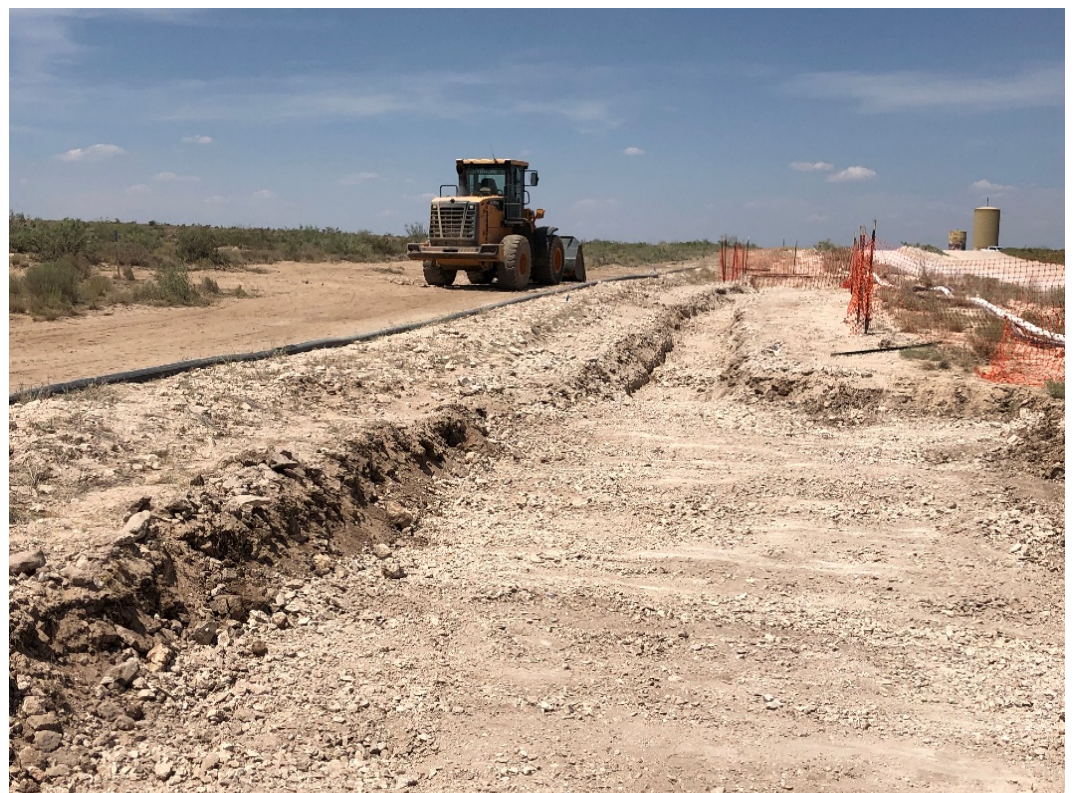
### Photograph No. 4

**View of excavated area.**

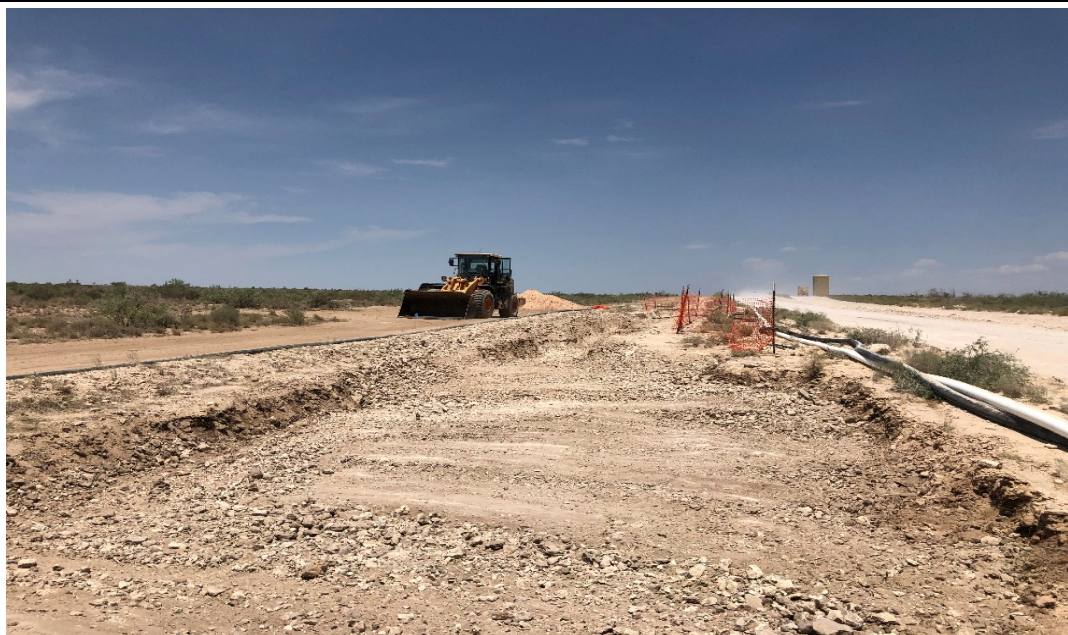
**Photograph No. 5**

**View of  
excavated area.**

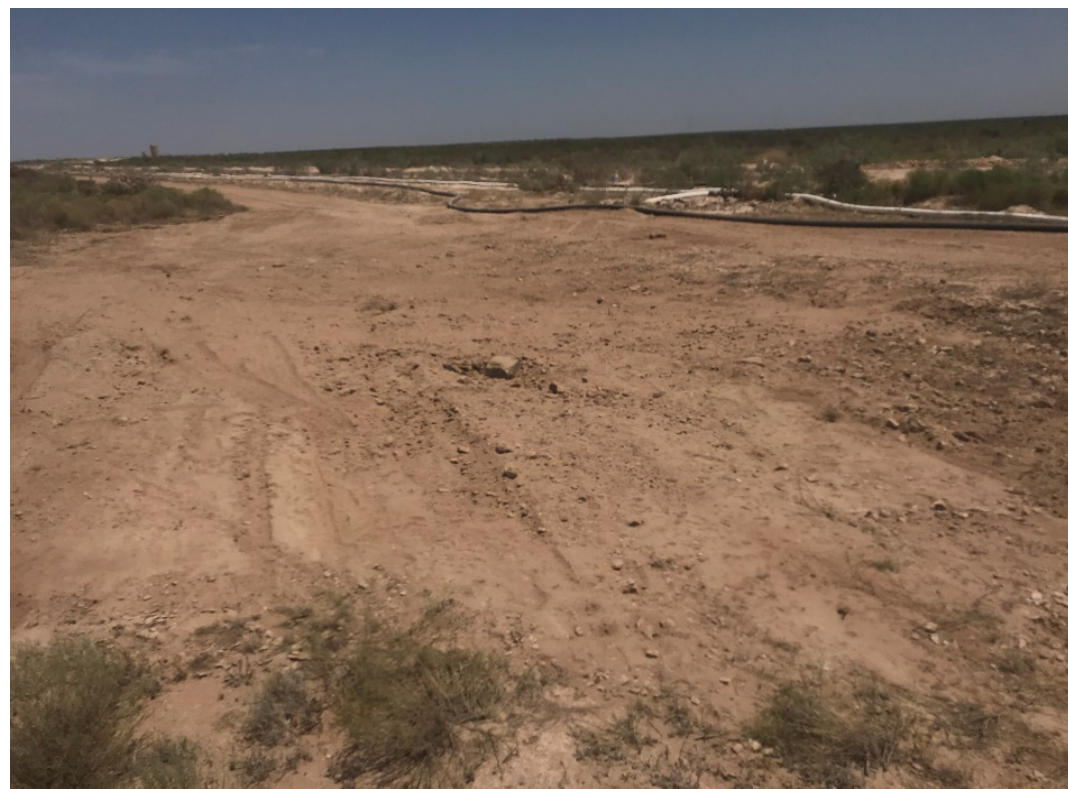
**Photograph No. 6**

**View of the  
remediated area.**

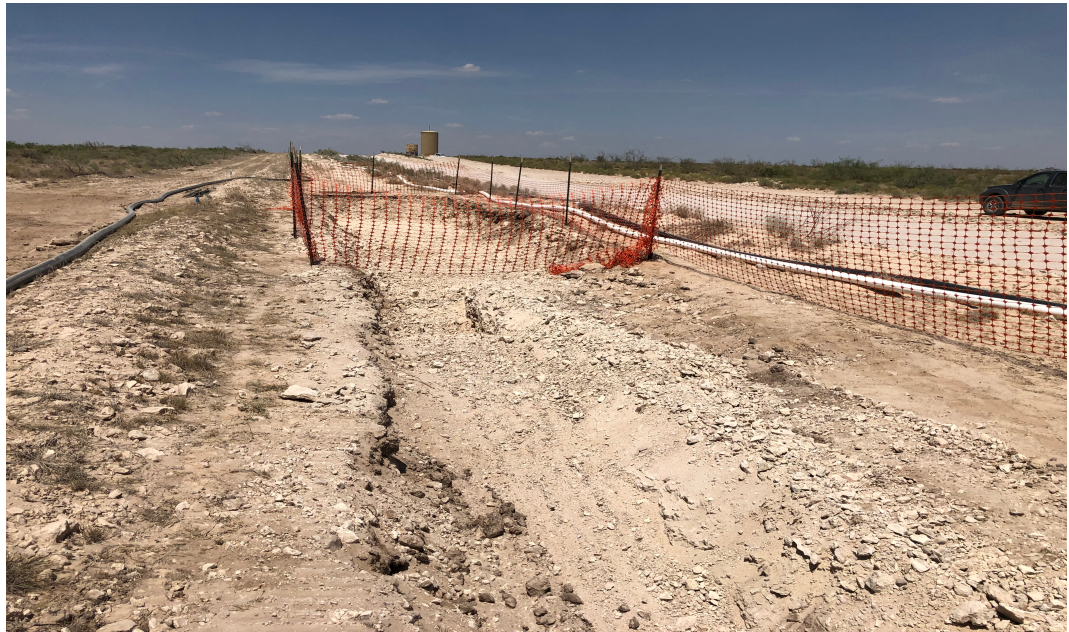
**Photograph No. 7**

**View of  
excavated area  
adjacent to  
requested  
deferral area.**

The sidewall represented by soil sample SW-E1-1.25 has been advanced laterally to the east to the maximum extent practicable. Two (2) surface flowlines lie immediately adjacent to the sidewall, which are immediately adjacent to a high traffic lease road. The distance from the excavated sidewall represented by soil sample SW-E1-1.25 and the adjacent high traffic lease road is approximately seven (7) feet. The soil sample represents approximately fifty (50) linear feet of sidewall. COG maintains further lateral excavation of the affected area represented by soil samples SW-E1-1.25, SW-E1B-1.25, and SW-E1C-1.25 in the affected pipeline corridor and adjacent high traffic lease road pose a risk which could result in potentially hazardous conditions and/or property damage. Based on laboratory results, the presence of a rock layer at approximately one (1) foot bgs which limits potential vertical migration of the contaminants of concern, the proximity to flowlines, and the high traffic lease road, COG requests remediation, restoration, and reclamation of the area represented by soil samples SW-E1-1.25, SW-E1B-1.25 and SW-E1C-1.25 be deferred until the equipment is removed during other operations and/or at time of abandonment, whichever occurs first. The area is approximately fifty (50) feet by seven (7) feet, or three-hundred and fifty (350) square feet.
