DELINEATION WORKPLAN

OXY – PURE GOLD B FEDERAL #4 (Leak Date: 10/17/18)

RP # 2RP-5049

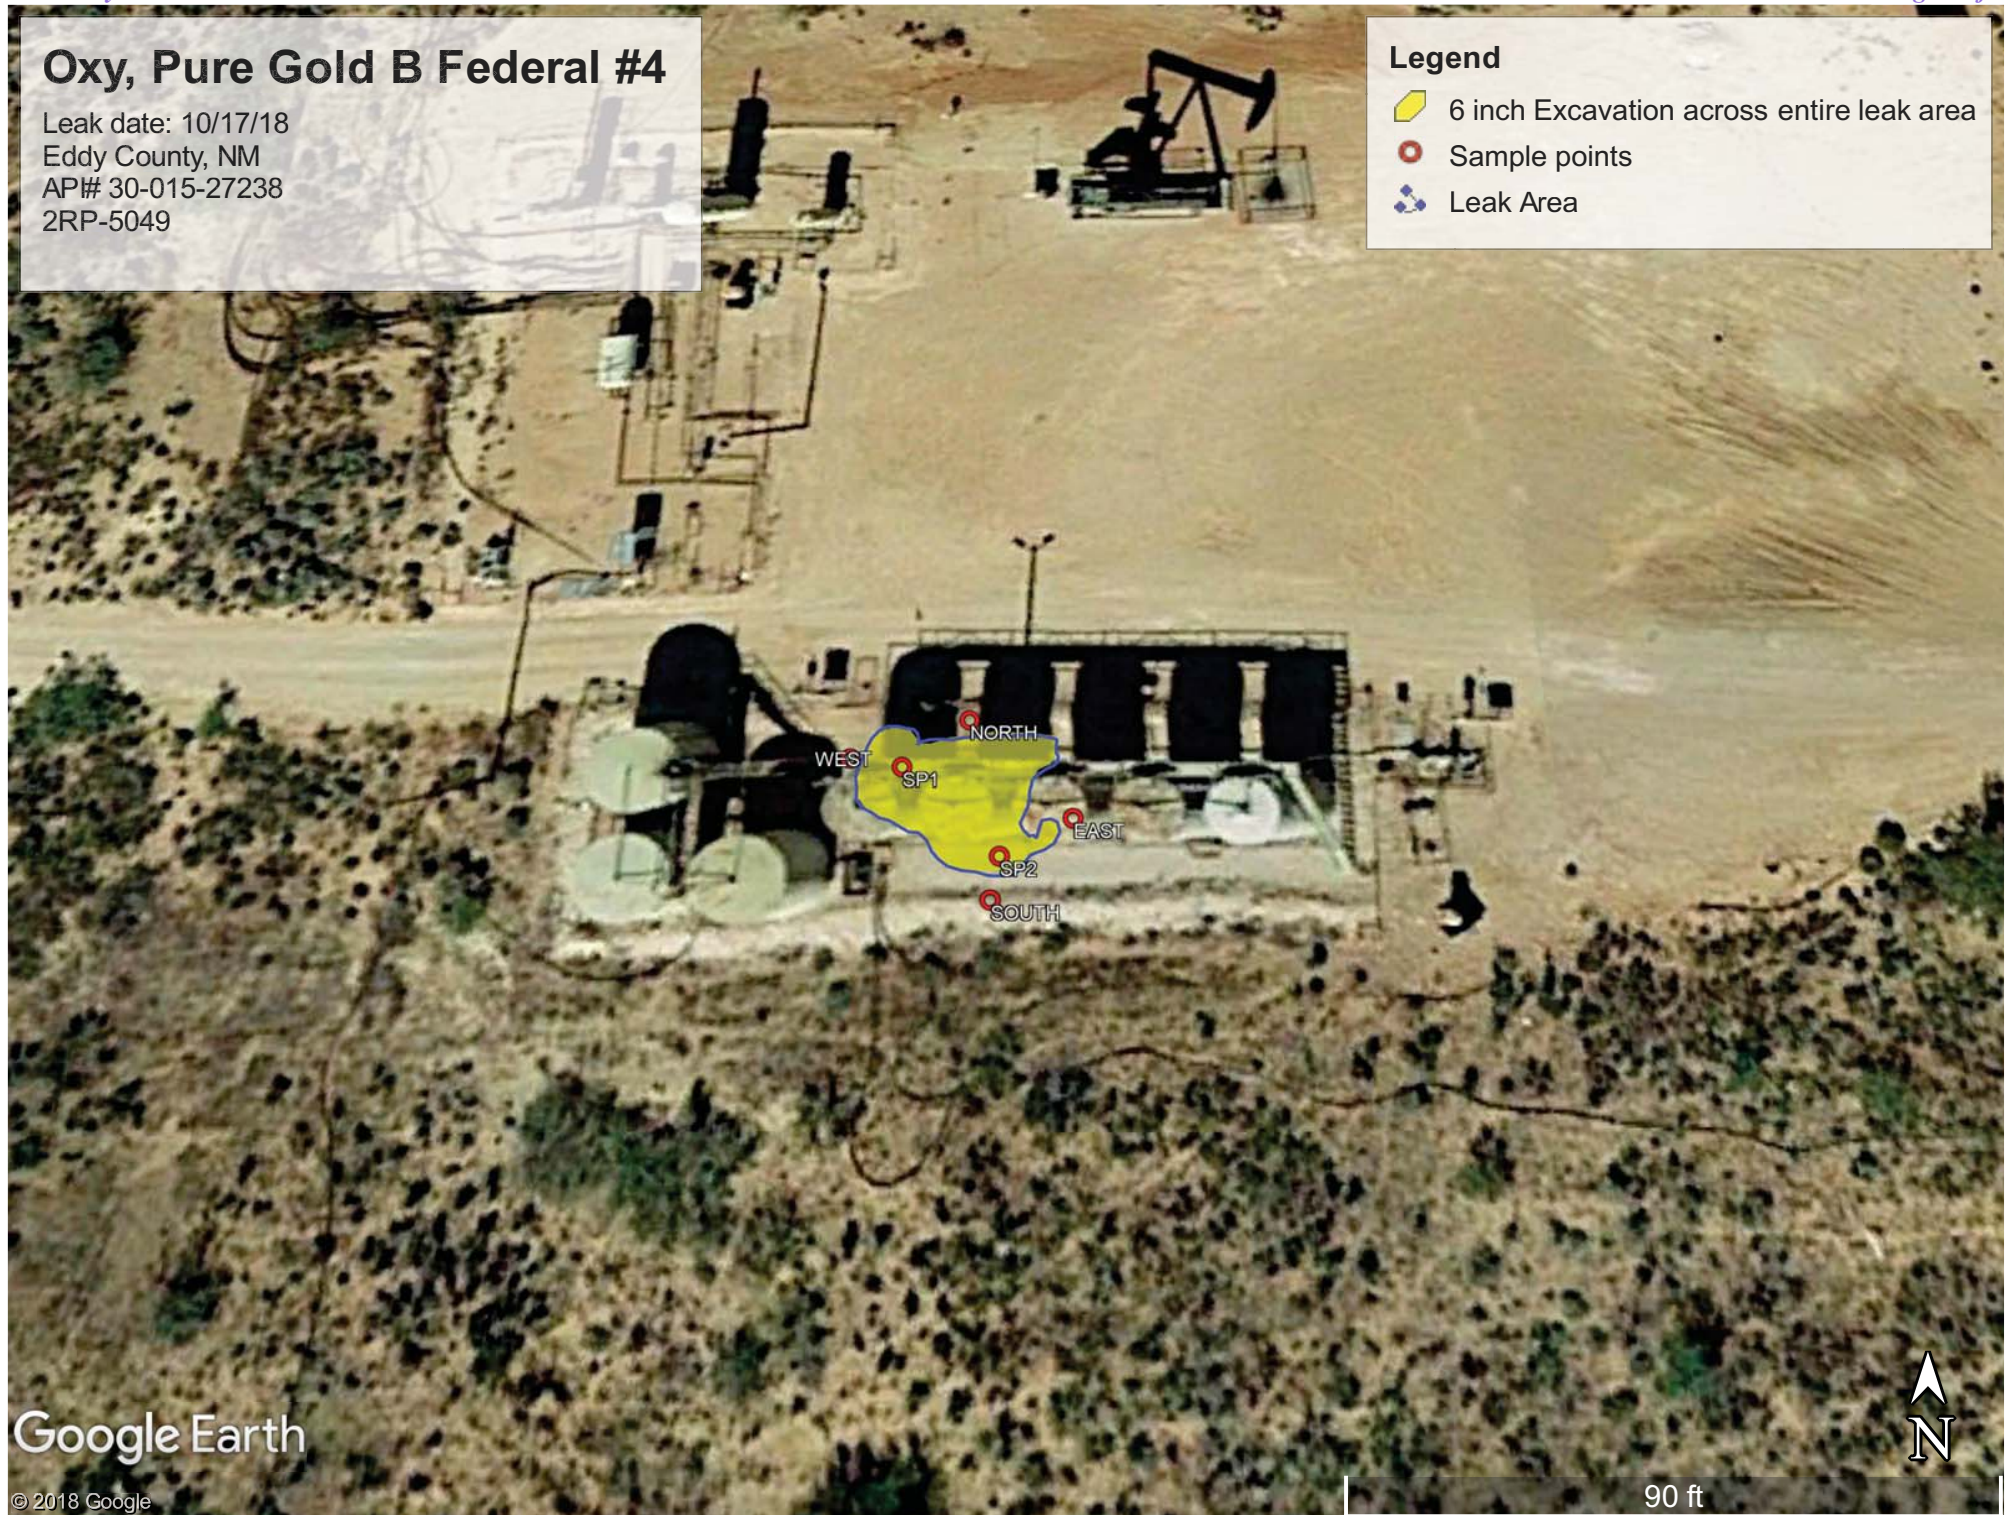
Oxy, Pure Gold B Federal #4

Leak date: 10/17/18
Eddy County, NM
AP# 30-015-27238
2RP-5049

6 inch Excavation across entire leak area
-

Sample points
-

Leak Area

OXY will excavate the spill area as depicted on the following site diagram. The entire leak area (YELLOW shade on diagram) will be excavated to a depth of 6 inches.

Bottom confirmation samples will be collected at no greater than 50 ft. intervals. Estimated volume of material to be removed is 15 cubic yards. The remediation will be completed within 90 days of plan approval.

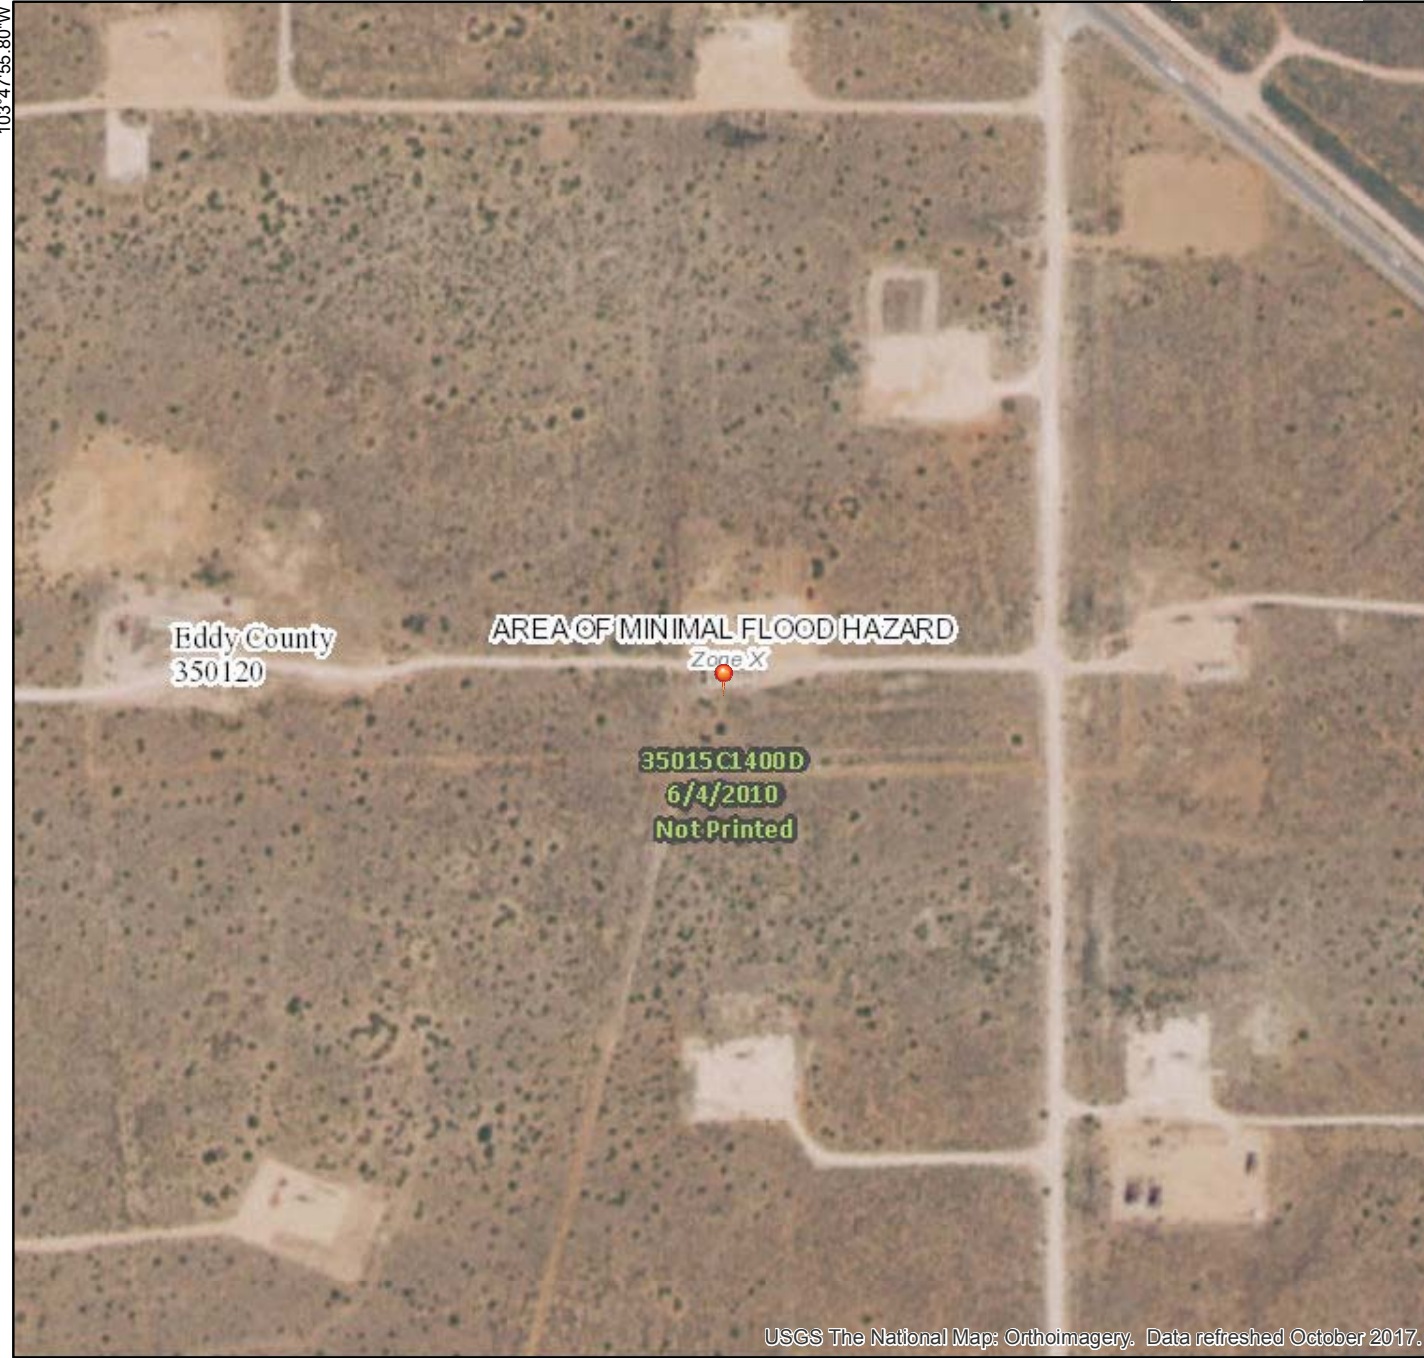
National Flood Hazard Layer FIRMette

The pin displayed on the map is an approximate point selected by the user and does not represent an authoritative property location.
