Incident ID	NAB1912843973
District RP	1RP-5460
Facility ID	
Application ID	pAB1912836147

**RE: LINER INSPECTION REPORT
CHISO 14 STATE 8711 #3H TANK BATTERY (1RP-5460)**

BTA Oil Producers, LLC
Chiso 14 State 8711 #3H Tank Battery (1RP-5460)

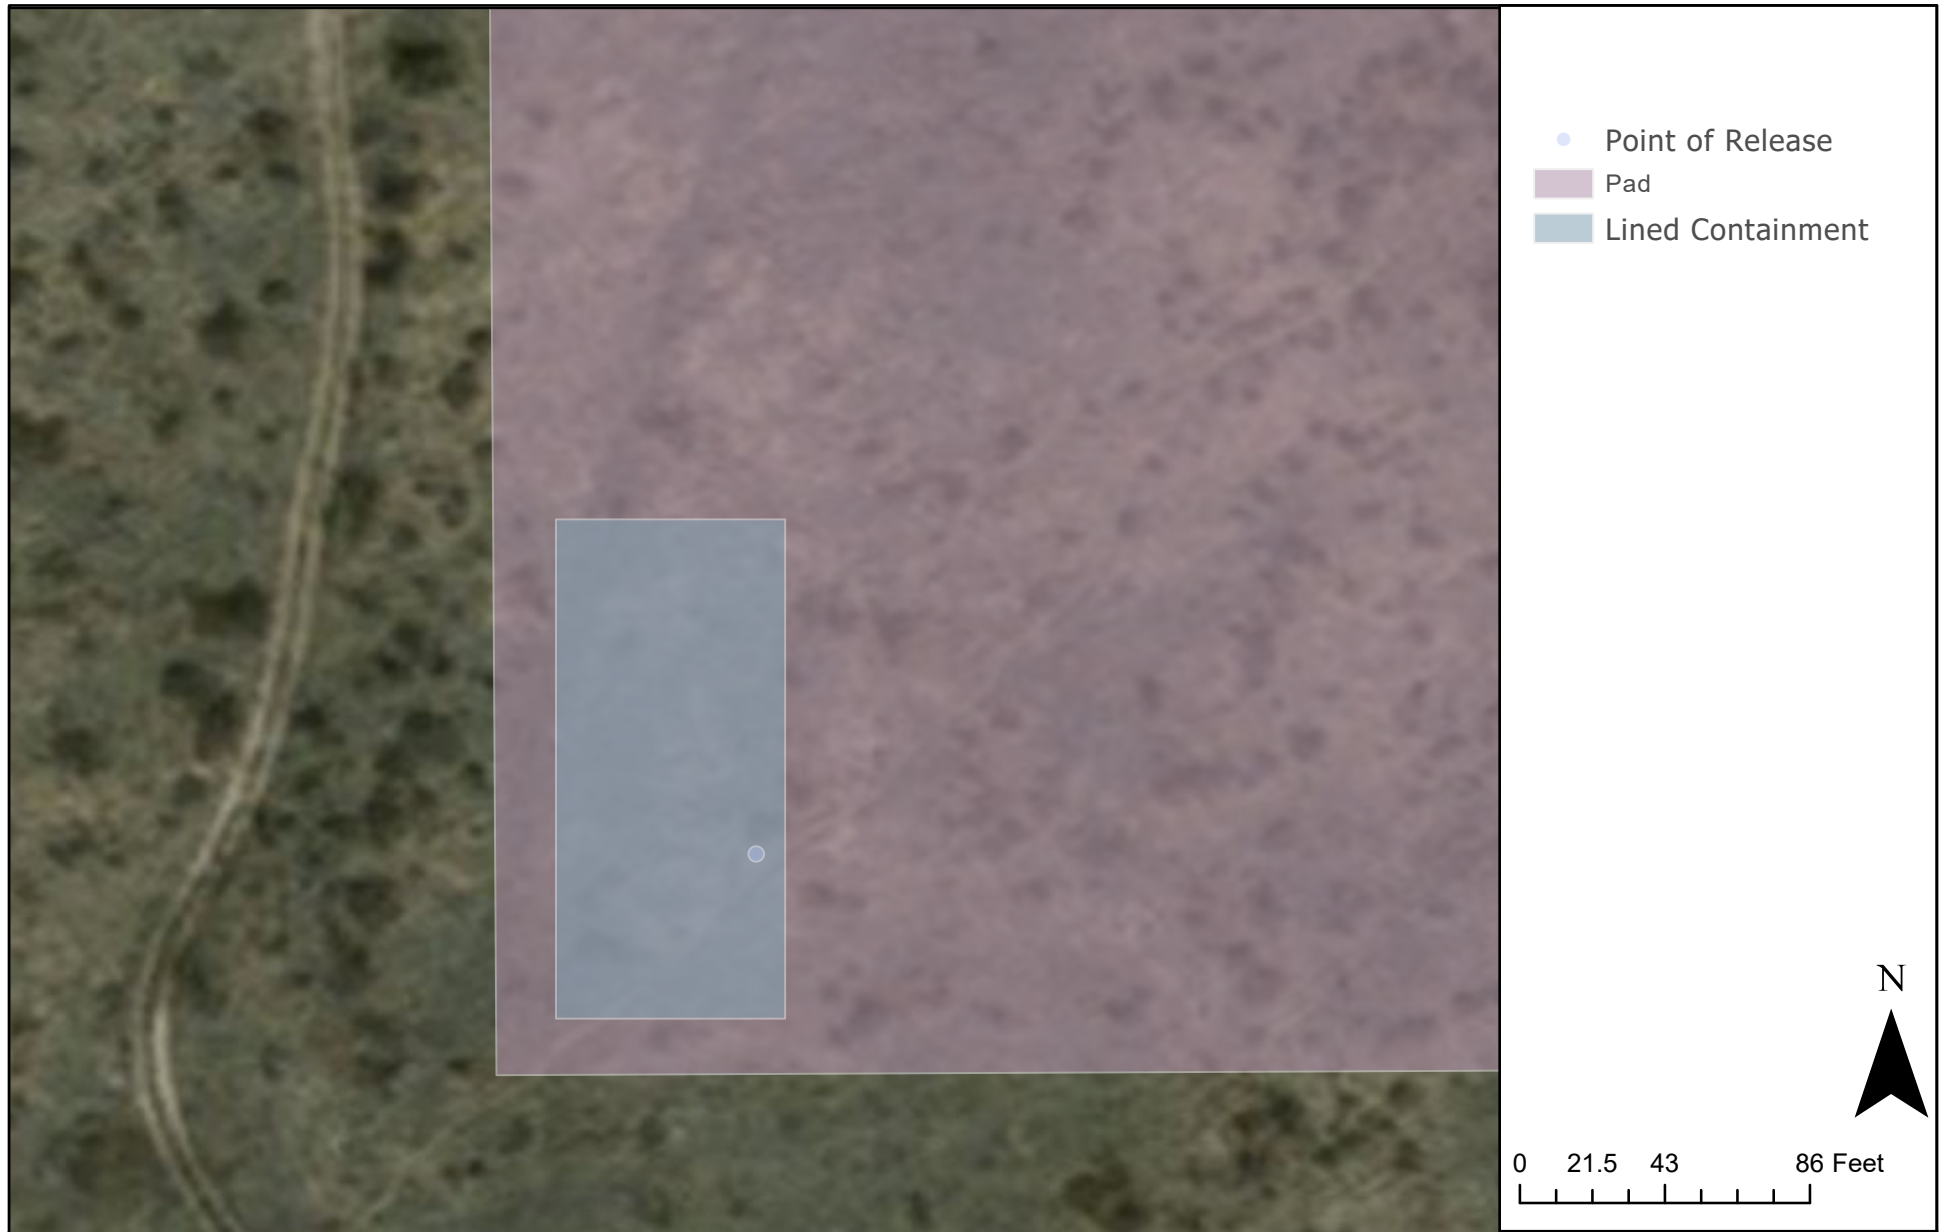
Figure 2

Site and Sample Locations
 Chiso 14 #3 & #4 Tank Battery BTA Oil Producer, LLC
 Lea County, New Mexico

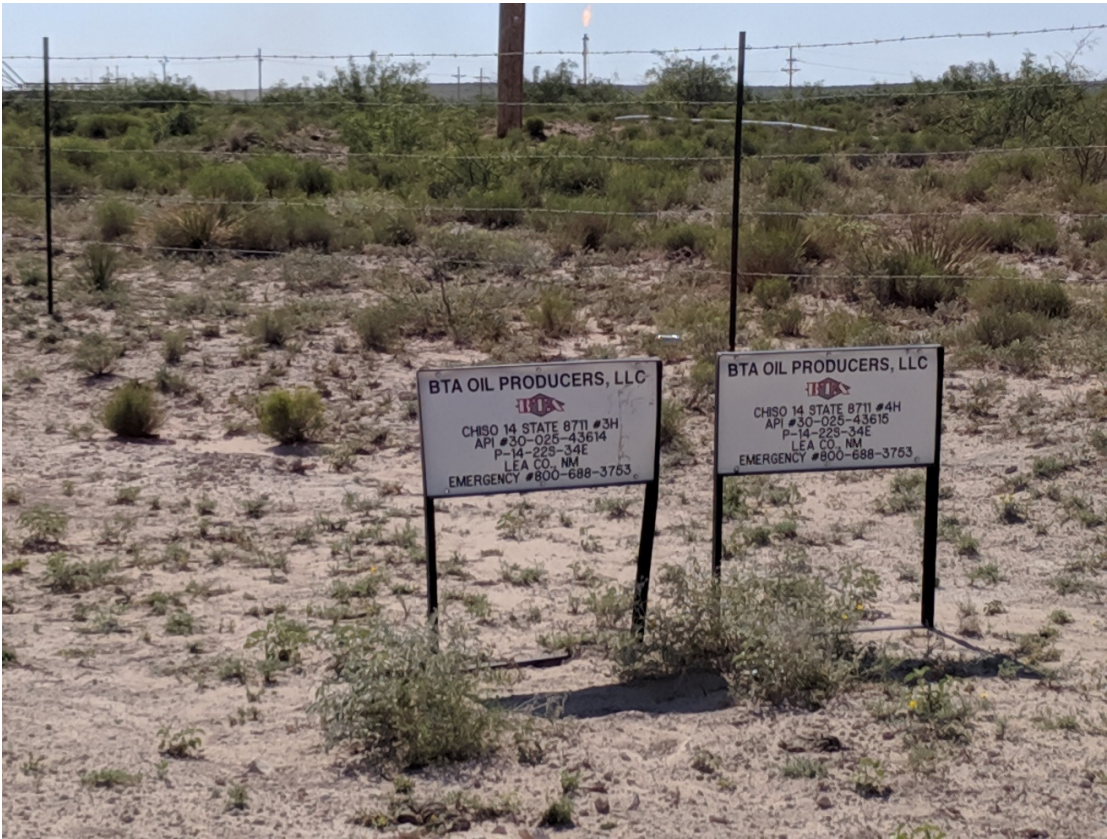
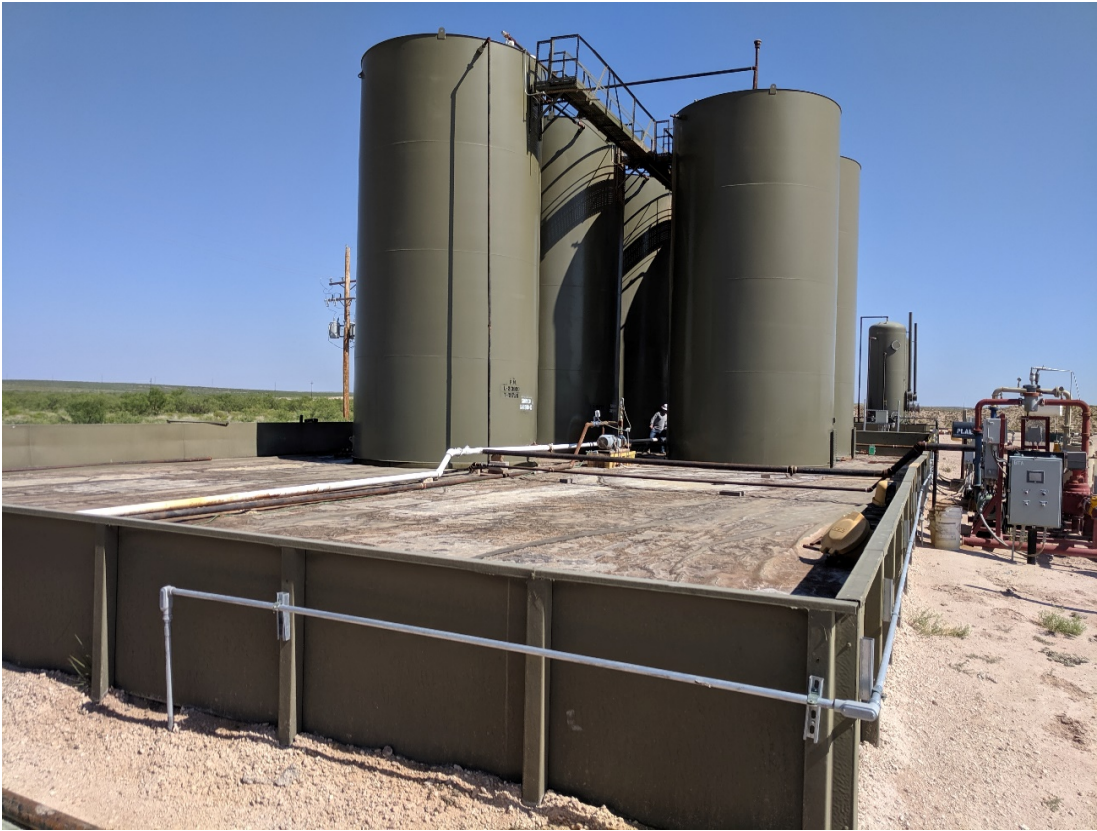
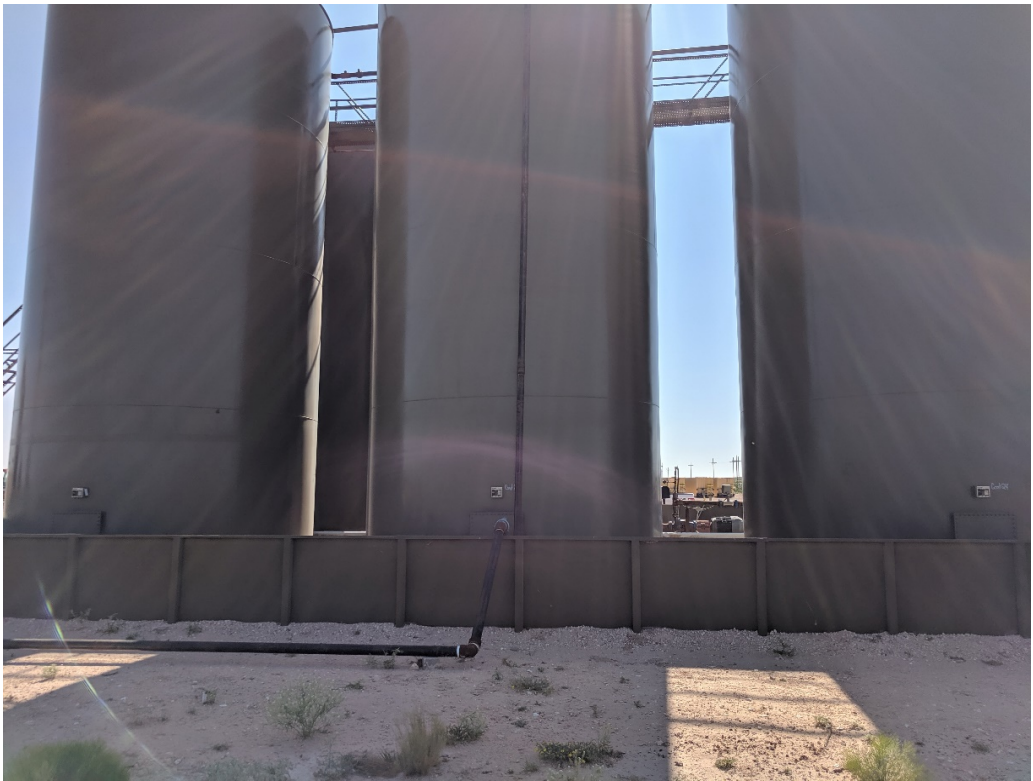
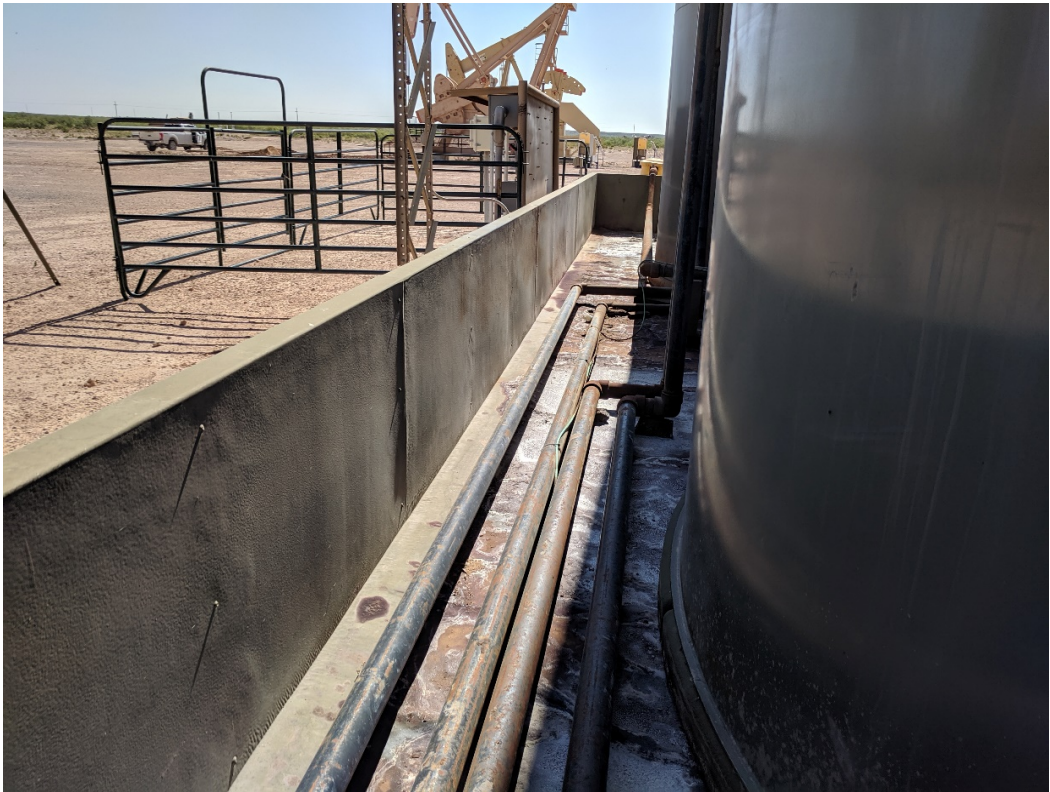
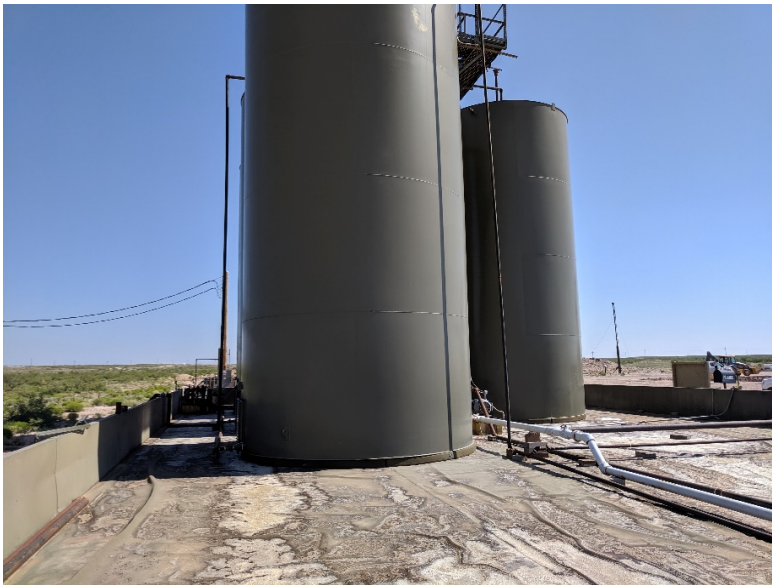
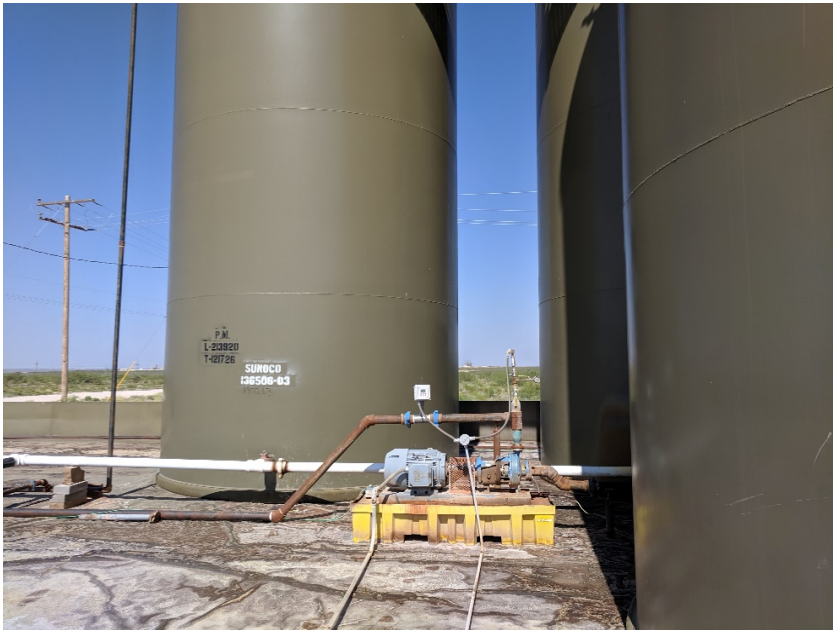
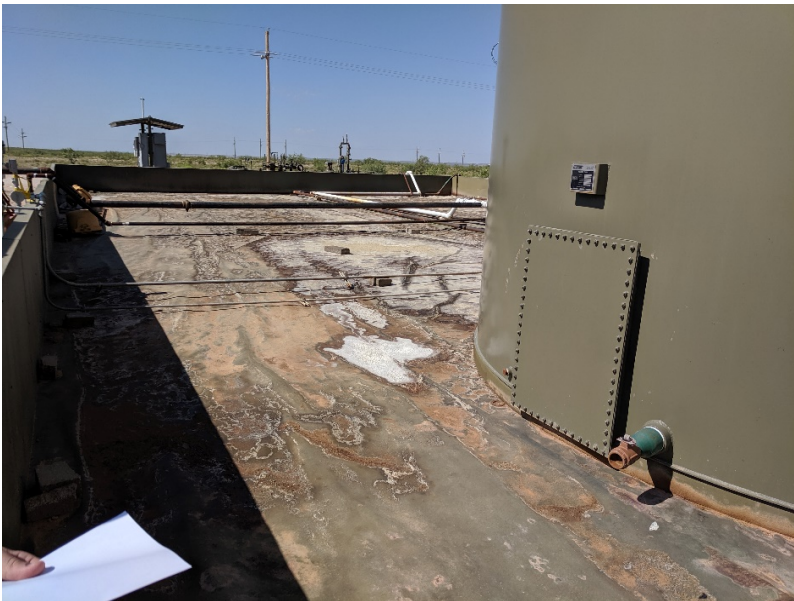
Appendix A
PHOTO LOG & FIELD NOTES

At the request of BTA, SMA conducted a liner integrity inspection per the requirements of 19.15.29.11.A(5)(a) NMAC. NMOCD was notified on July 8, 2019 that the liner inspection was to occur, and SMA conducted the liner inspection on July 11, 2019. After a thorough visual inspection of the liner within the tank battery containment, the liner appeared to be intact and had the ability to contain the leak in question. The tank from which the release occurred was identified, and SMA verified that the release did not occur outside of the lined containment. A photo log and field notes of the inspection is included in Appendix A.

SMA recommends no further action for this release.
