LT Environmental, Inc.

November 26, 2019

**RE: Closure Request  
Corral Canyon Central Tank Battery  
Remediation Permit Number 2RP-5550  
Eddy County, New Mexico**

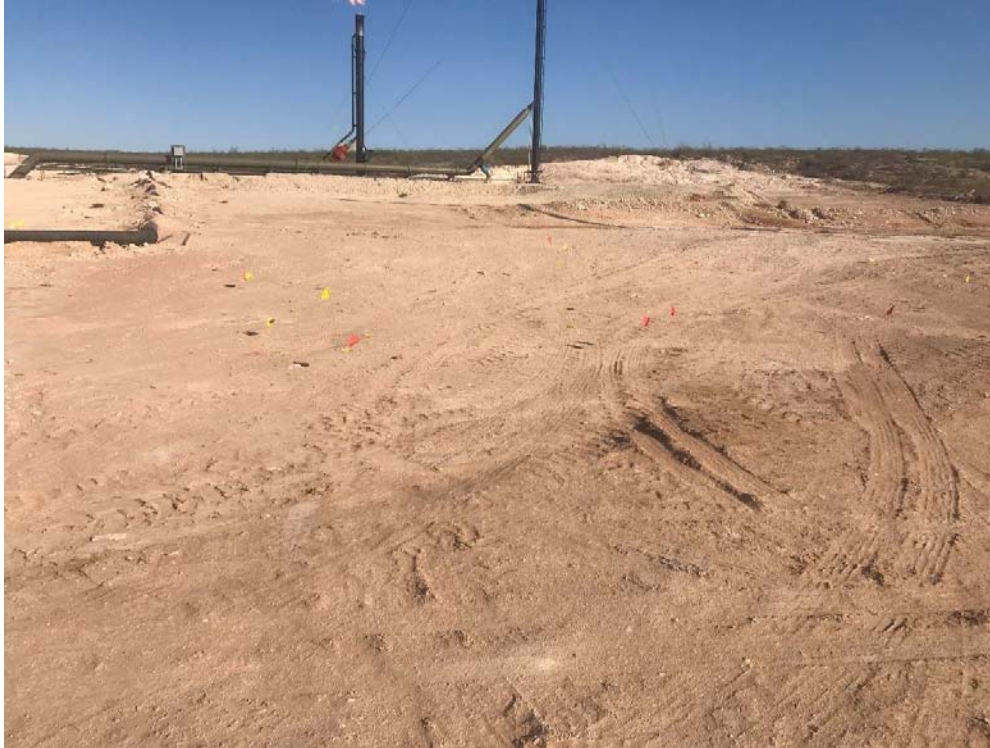
**Photograph 1:** View from the south to the north

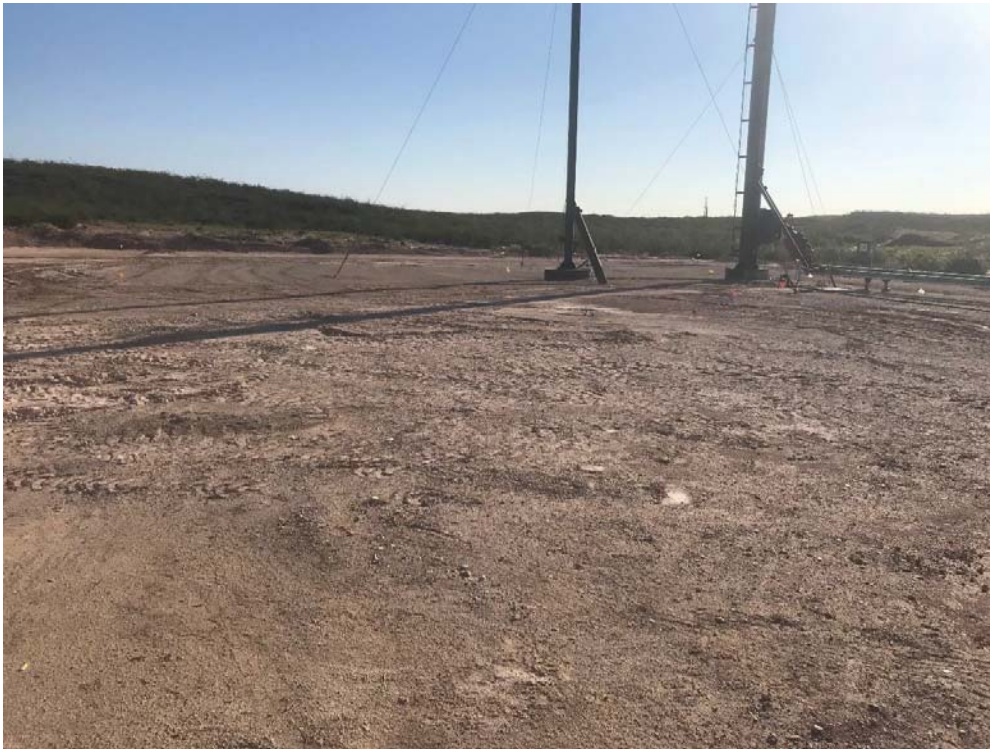
**Photograph 2:** View from the west to the east
