## **Remediation and Closure Report**

West Red Lake Unit Water Station #001  
Talon Project # 701307.124.01 \*2RP-5643

Subject: **Remediation and Closure Report**  
WRLU Water Station #001\*2RP-5642  
Eddy County, NM

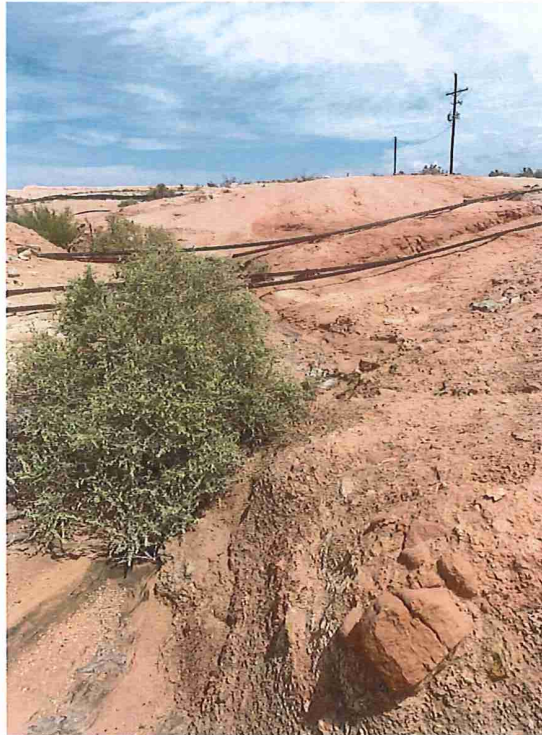
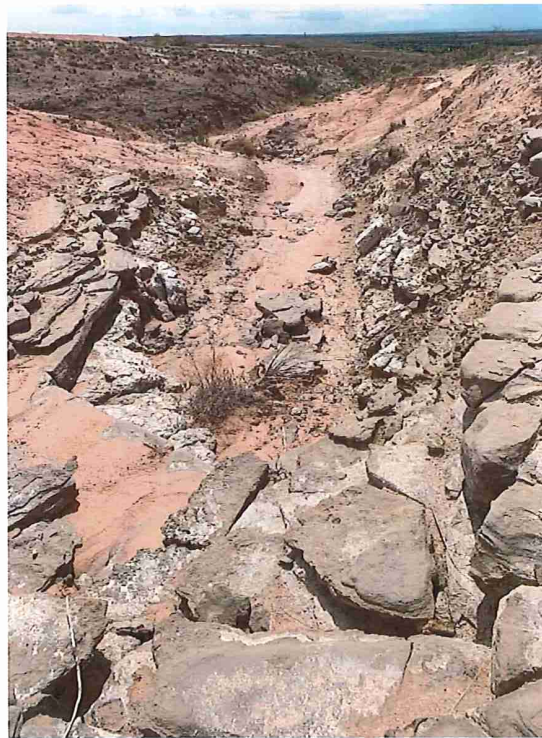
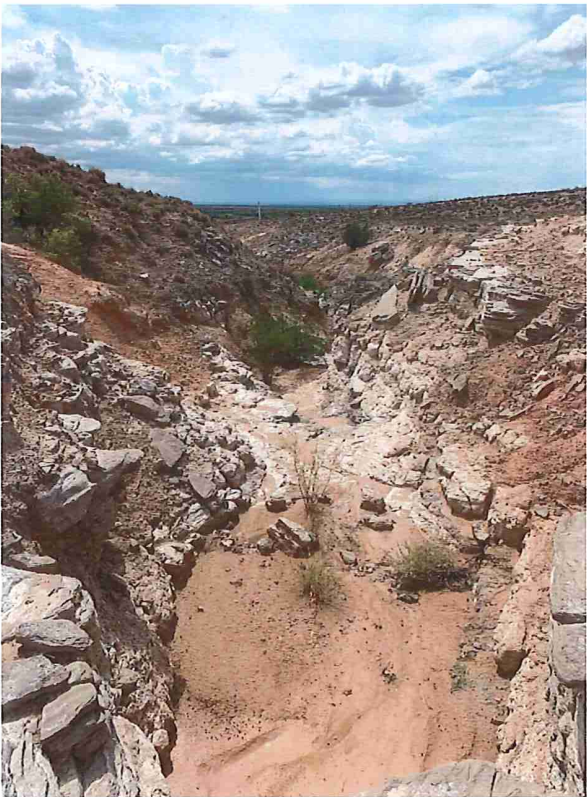
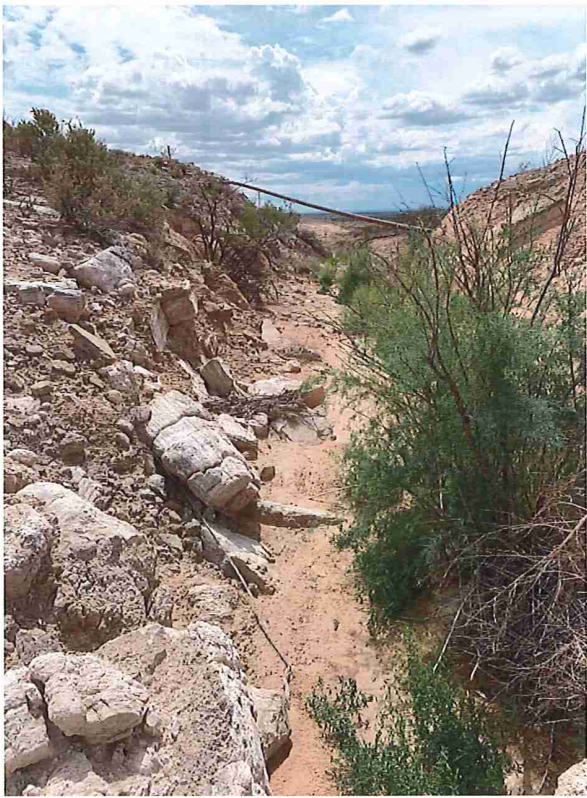
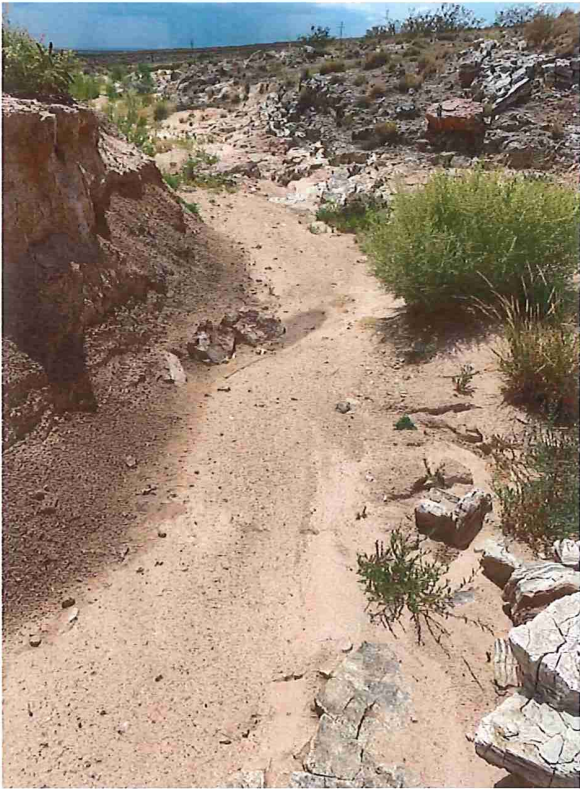
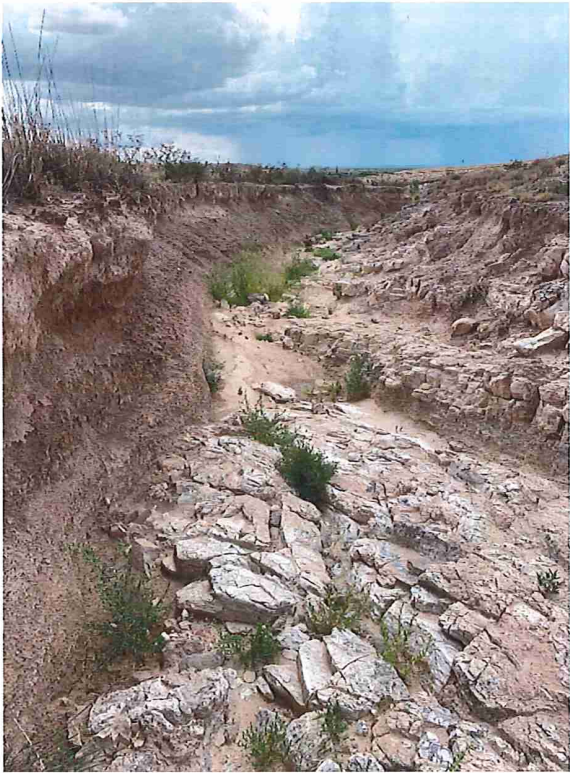
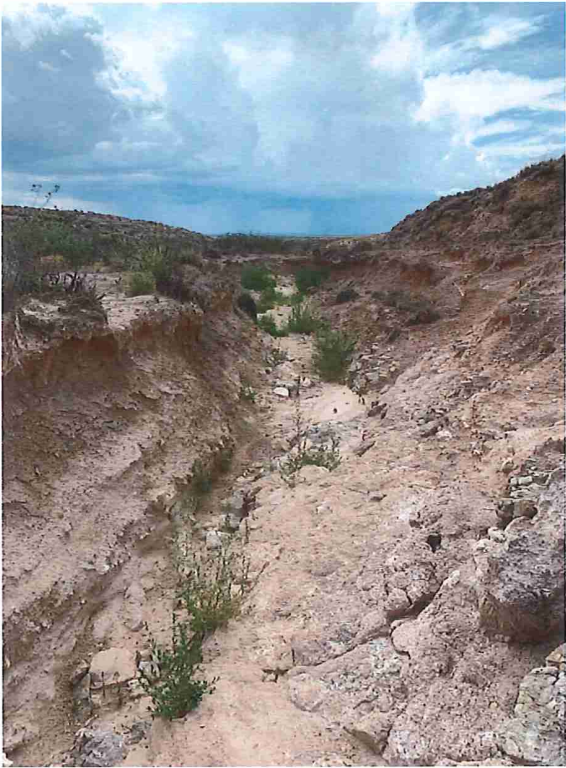
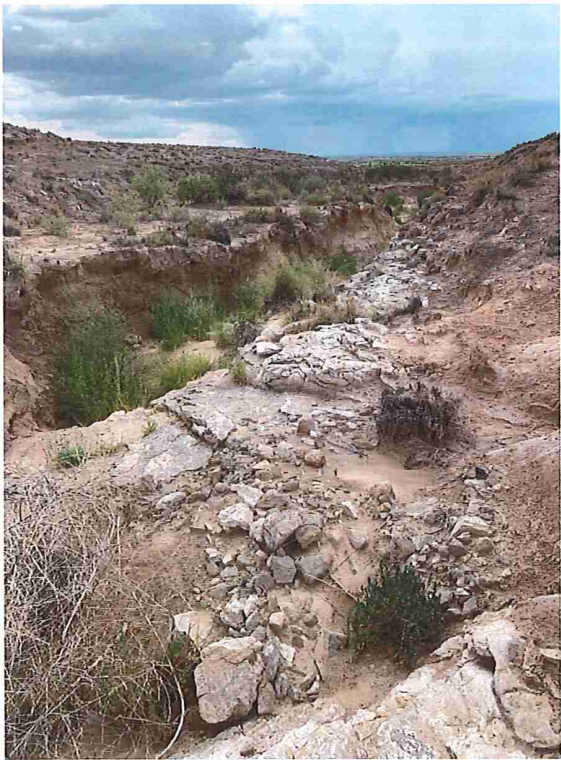
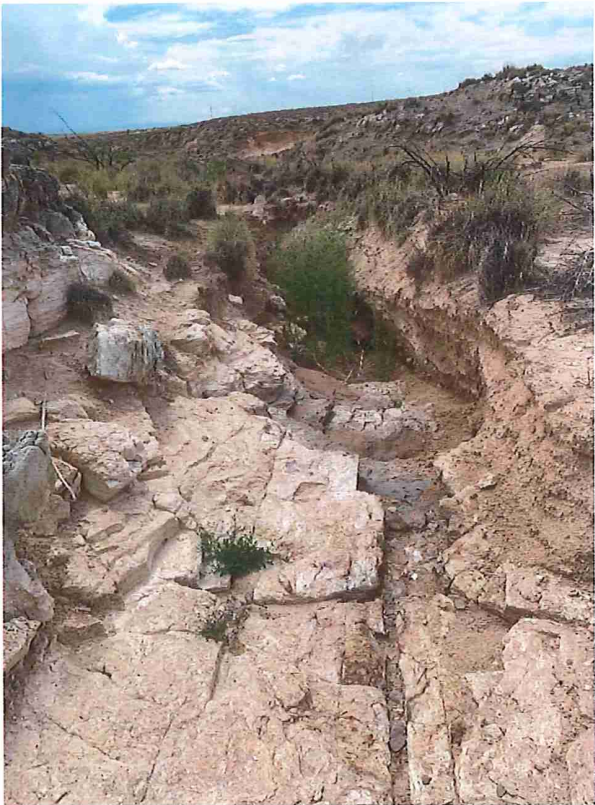
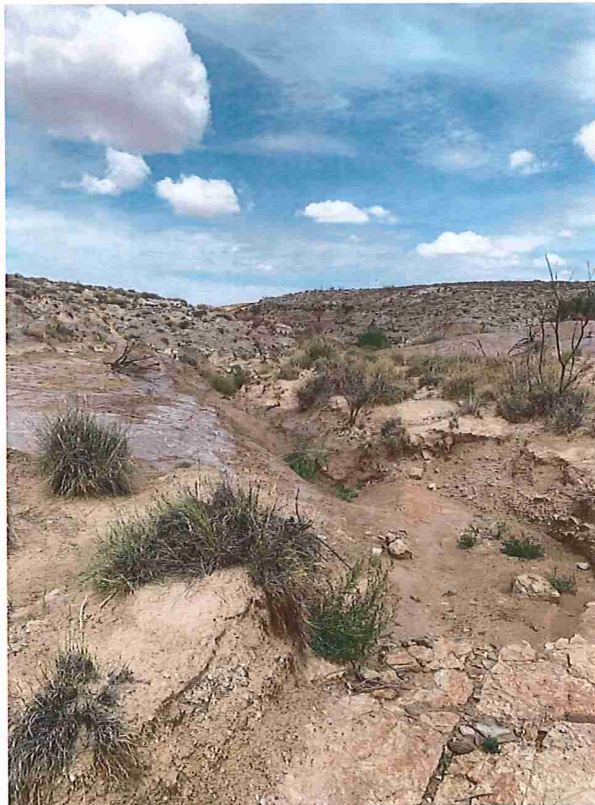
**WRLU Inj Line Spill Path**

On August 8, 2019, a 2 7/8" IPC injection line was discovered to be leaking due to corrosion. A total of 90 barrels (bbls) of produced water were released and the fluids ran down a ravine. No fluids were recovered.

- The pasture and ravine were inaccessible to equipment. Following a phone meeting with NMOCD, verbal approval was given to flush the ravine with fresh water. This area was flushed with eight (8) 120 bbl water trucks containing fresh water. The runoff water was recovered by vac trucks from the constructed sump (see site map) and properly disposed of. The constructed sump will subsequently be disposed of as well. Pictures of the water flush are attached in [Appendix IV](#).
- Samples were collected from the trucks containing freshwater to verify the chloride content of the flush water.
- On September 22, 2019, a rainstorm occurred acting as a natural flush. A water sample was retrieved on 9-24-19 from the rain filled sump and results are attached in [Appendix V](#).
- See [Appendix IV](#) for Photographic Documentation of remedial actions.
- A Final C-141 is attached in [Appendix III](#).

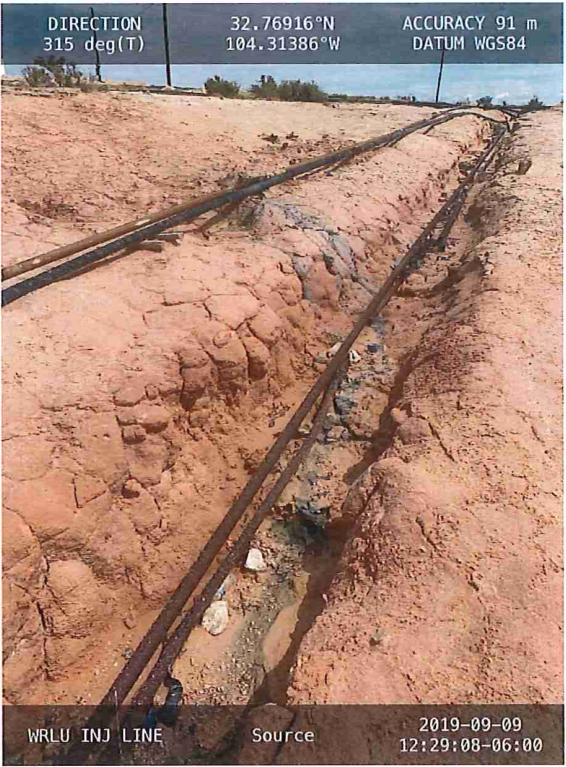
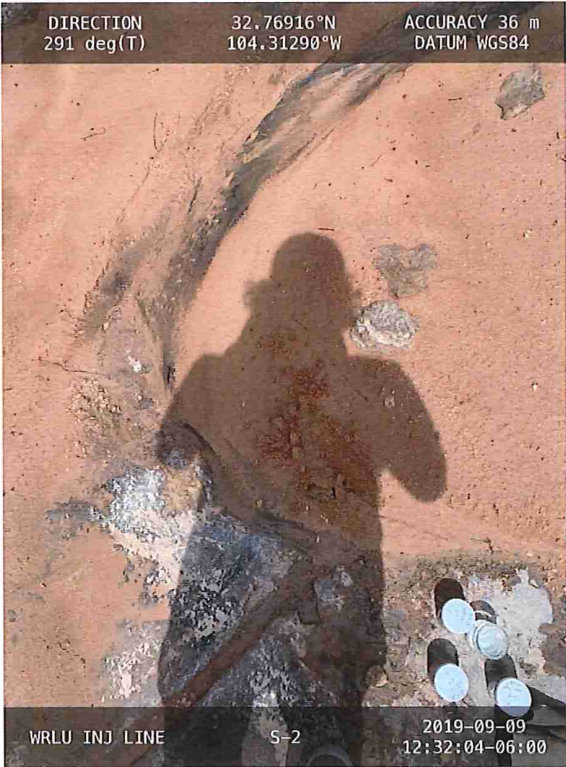
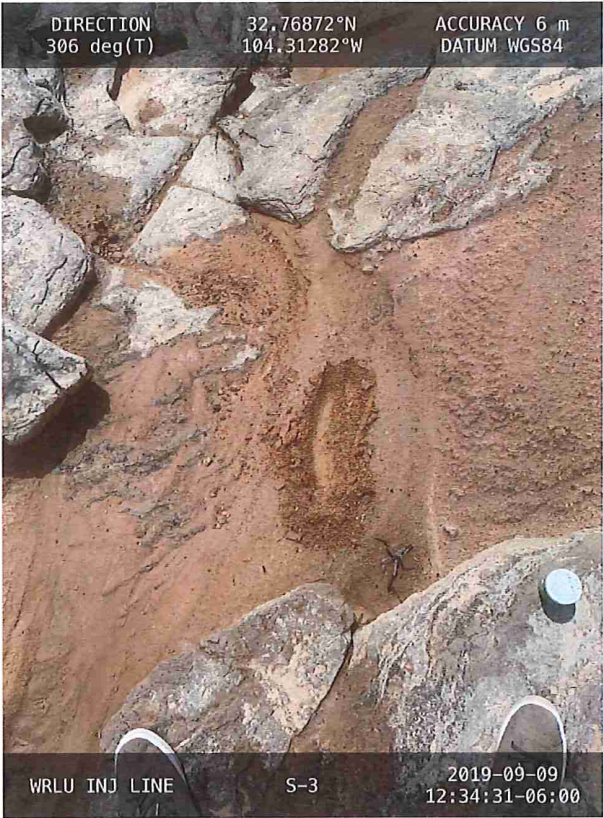
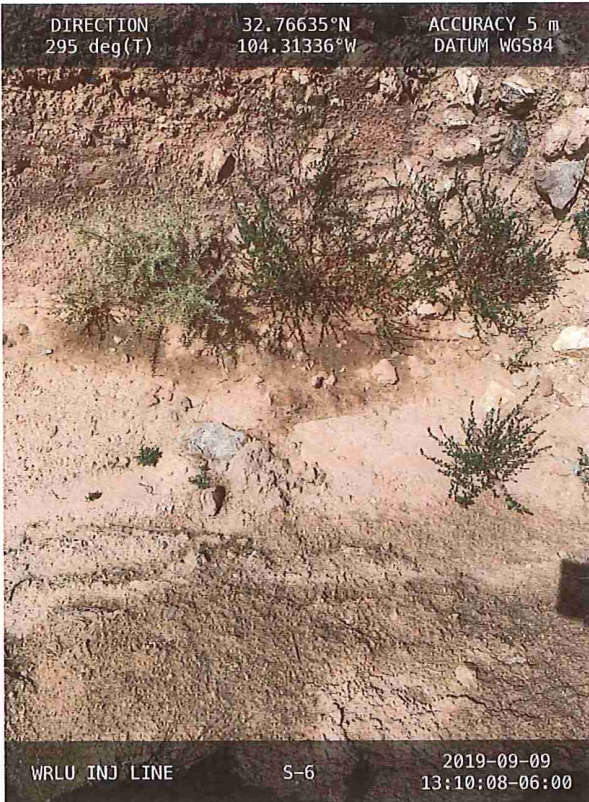
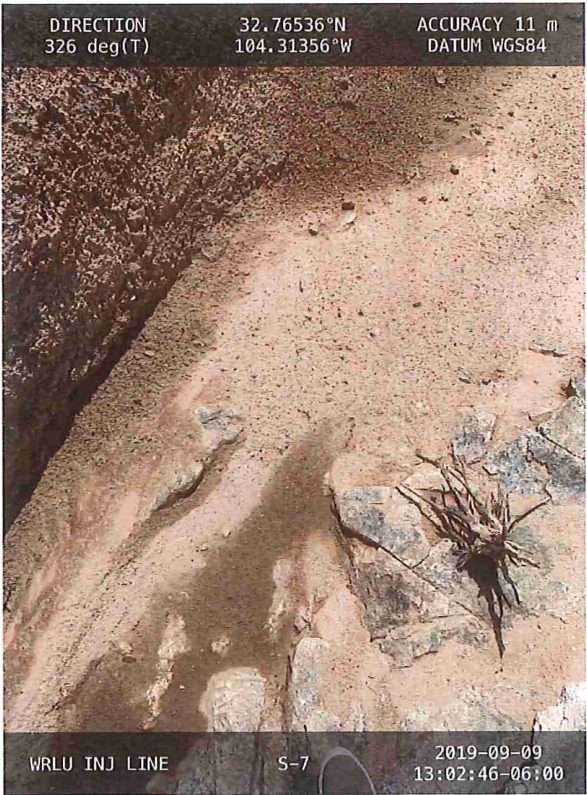
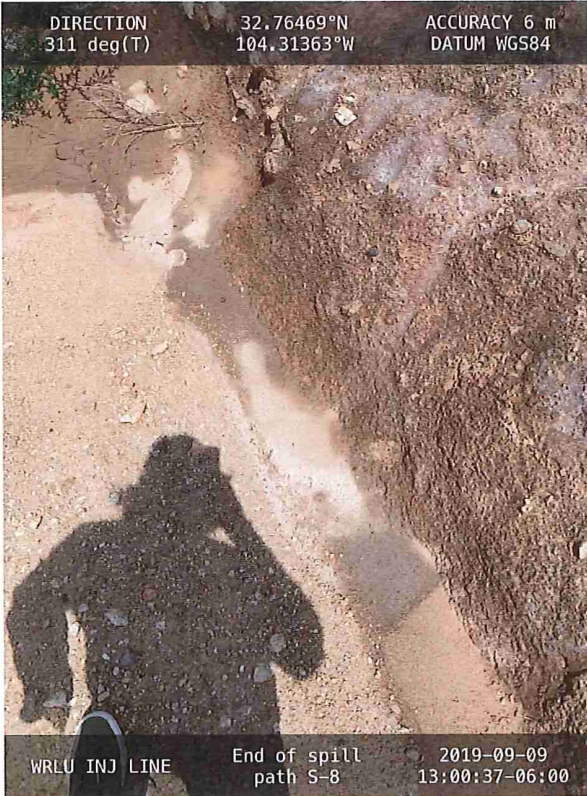
Sample Points

On August 9, 2019, Talon mobilized personnel to begin site assessment and soil sampling activities. Grab soil samples were collected in areas accessible within the ravine in the impacted areas utilizing a hand auger. Results from our initial sampling event are presented in the following data table. A complete laboratory report can be found in [Appendix V](#).

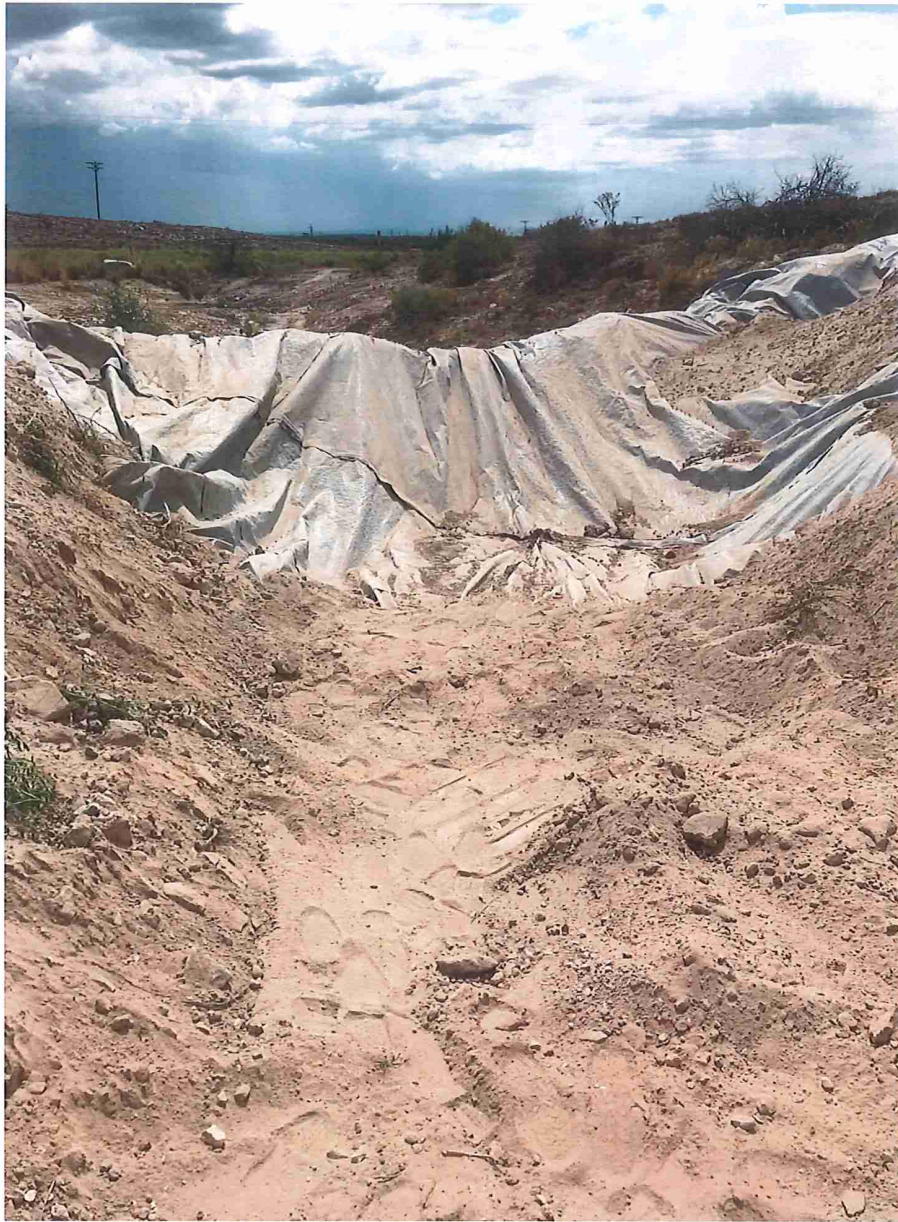
Sample ID	Sample Date	Depth (BGS)	Cl mg/kg
NMOCD Table 1 Closure Criteria 19.15.29 NMAC			600 mg/kg
Truck 1	9/13/2019		336
Truck 2	9/13/2019		308
Truck 3	9/13/2019		296
Truck 4	9/13/2019		476
Truck 5	9/13/2019		292
Truck 6	9/13/2019		280
Truck 7	9/13/2019		284
Sump	9/13/2019	Initial	1310
Sump	9/13/2019	After Flush	810

Sample ID	Sample Date	Depth (BGS)	Cl mg/kg
NMOCD Table 1 Closure Criteria 19.15.29 NMAC			600 mg/kg
3rd Sump Sample	9/24/2019	Sump	128
