# Initial Site Assessment/Characterization Report

Central Vacuum Unit Header 3 Trunkline  
New Mexico Oil Conservation Division  
(NMOCD) District RP #1RP-5706

Central Vacuum Unit Header 3 Trunkline  
Produced Water Spill Site  
Lea County, New Mexico  
NMOCD RP #1RP-5706

November 2019  
AECOM Project No. 60615071

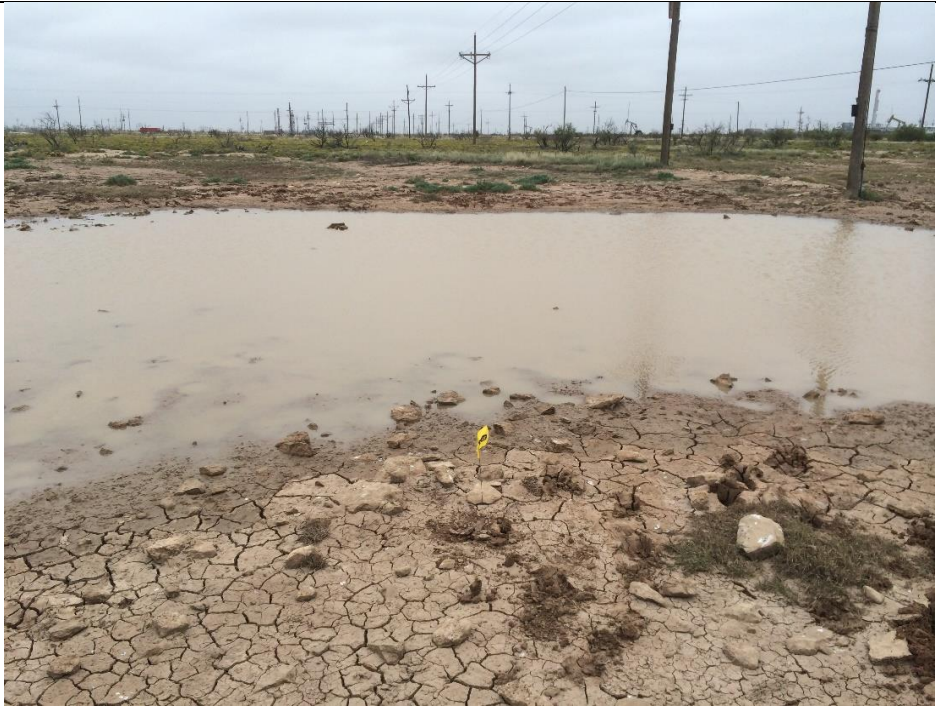
SPILL AREA	
<b>Photograph No.</b> 1

<b>Photographer:</b> J. Lovely	
<b>Date:</b> 10/24/2019	
<b>Comments:</b> Looking south from the location of boring CVUH3-3.	
SPILL AREA	
<b>Photograph No.</b> 2

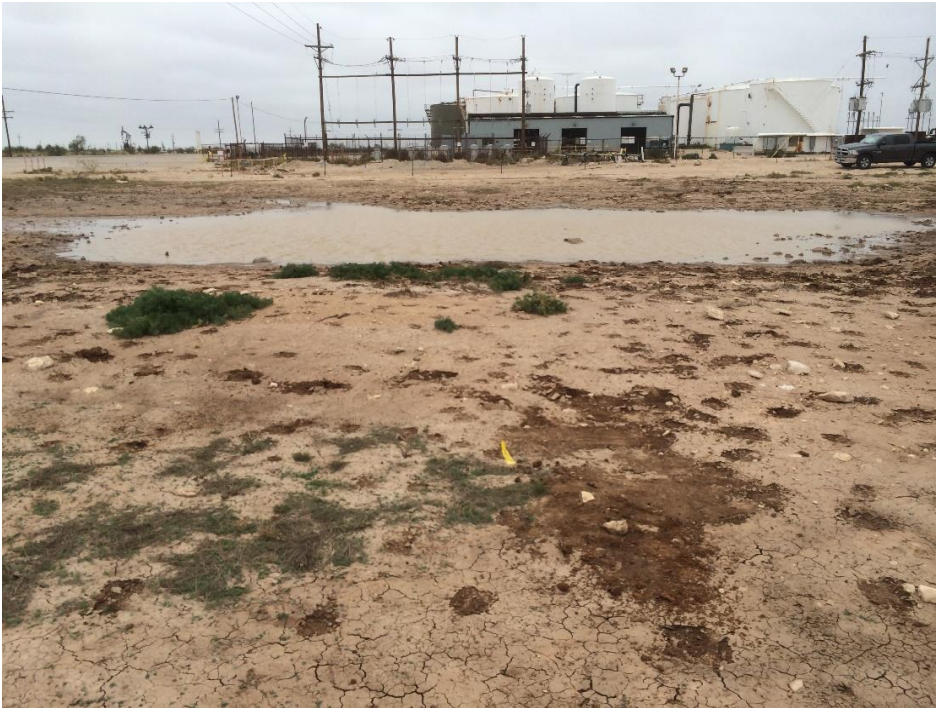
<b>Photographer:</b> J. Lovely	
<b>Date:</b> 10/24/2019	
<b>Comments:</b> Looking north from the location of boring CVUH3-5. Note the CVU Battery site immediately adjacent to the north.
