Release Notification

On September 23, 2019 a crude oil release occurred from a 4" gathering line at the Enterprise Thistle 44 Station. Crude surfaced and flowed approximately 460' south towards the facility fence. A hydrovac truck was dispatched to recover free liquid and to expose the pipeline for repair. On October 4, 2019 an additional release occurred on the 4" gathering line, approximately 40 feet west of the initial release. The second release area was excavated utilizing a hydrovac truck and a clamp was installed on the pipeline.

8.0 FINDINGS AND RECOMMENDATION

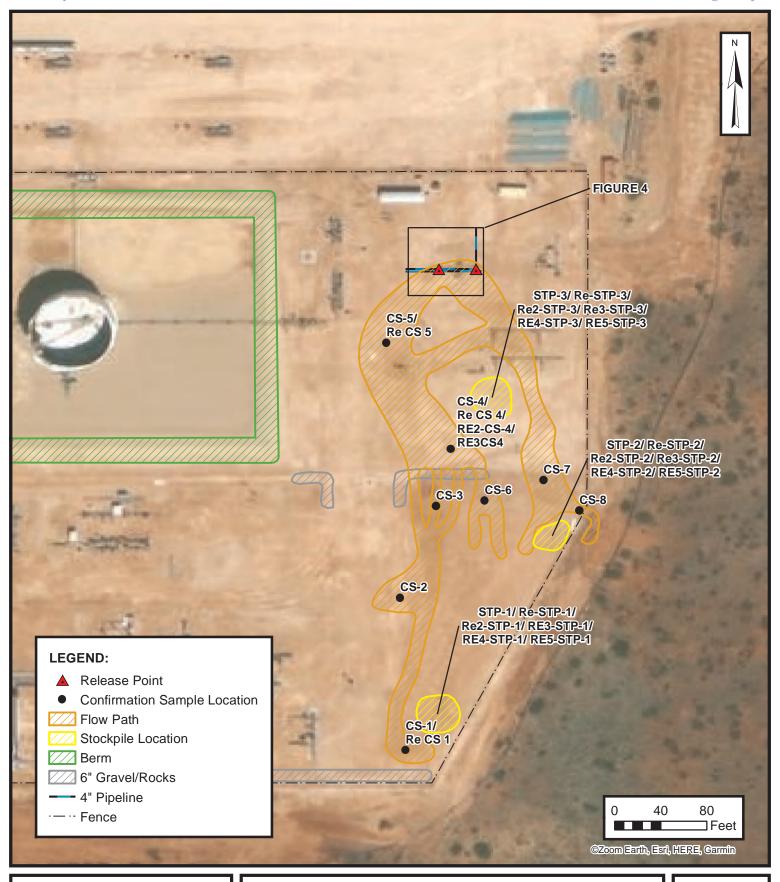
FIGURE

SITE MAP A

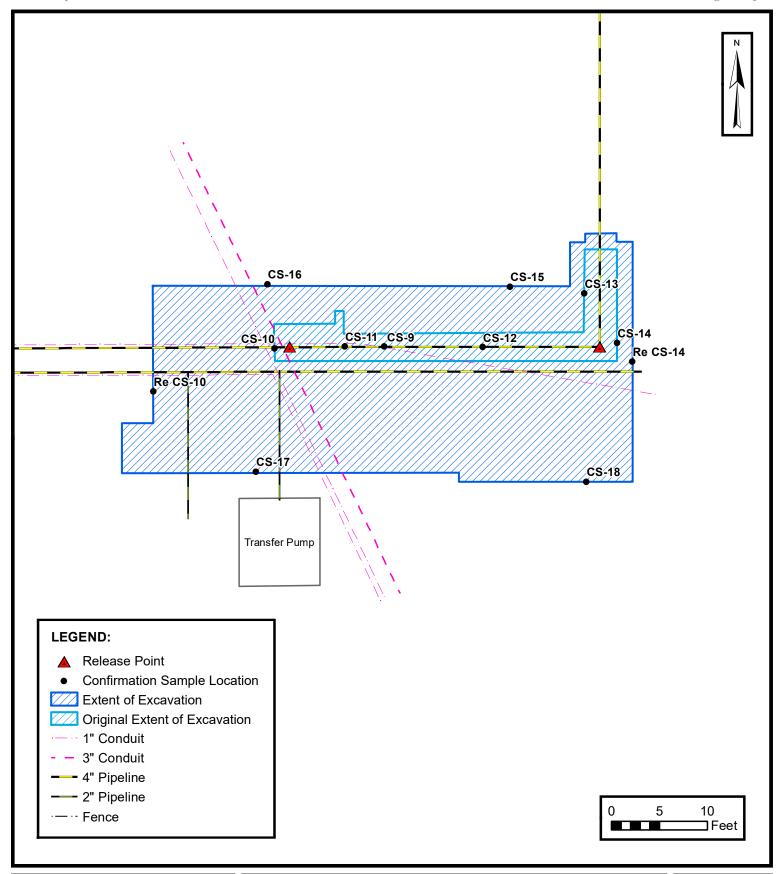
SITE MAP B

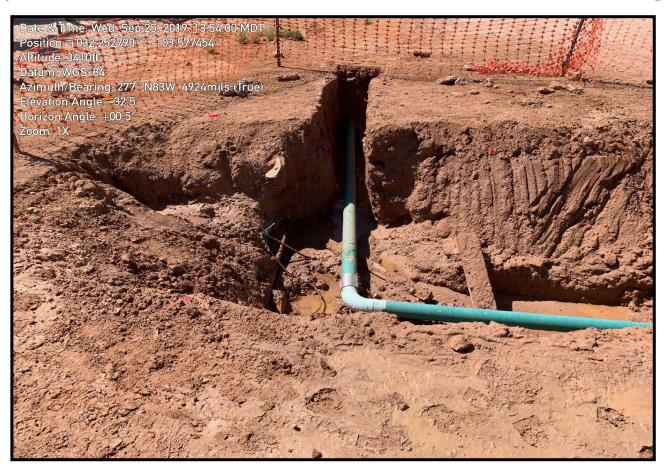
View of release point prior to response action activities, facing west.

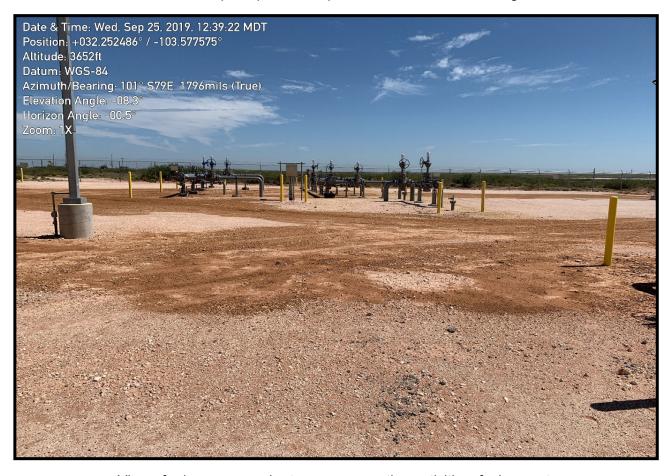
View of release area prior to response action activities, facing east.

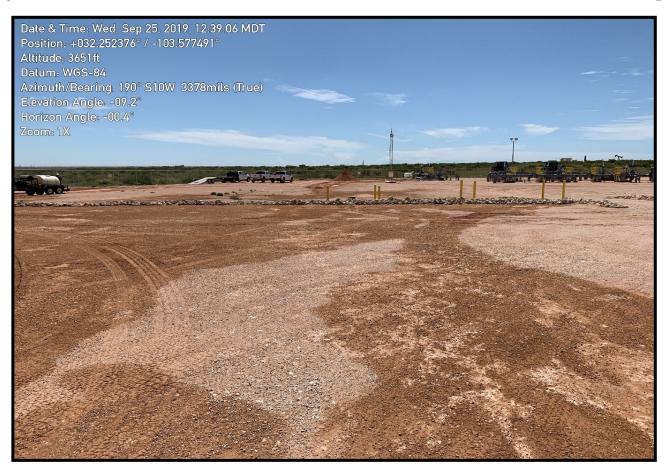
View of release area prior to response action activities, facing south.

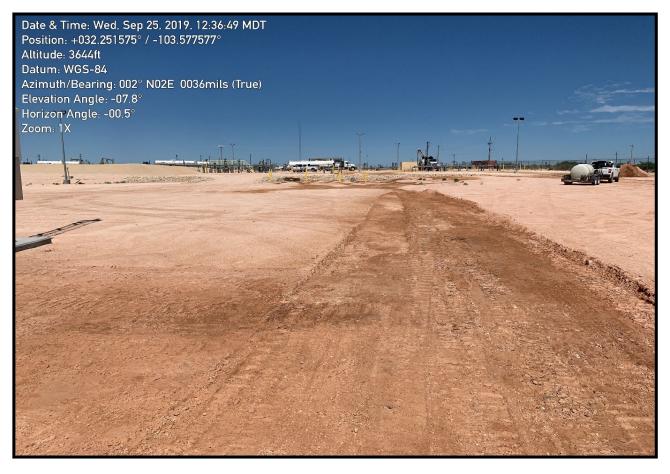
View of excavation area during response action activities, facing north.

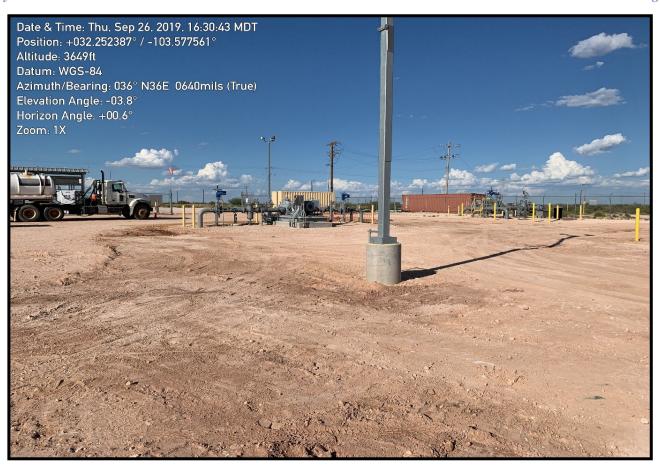
View of excavation area during response action activities, facing northeast.

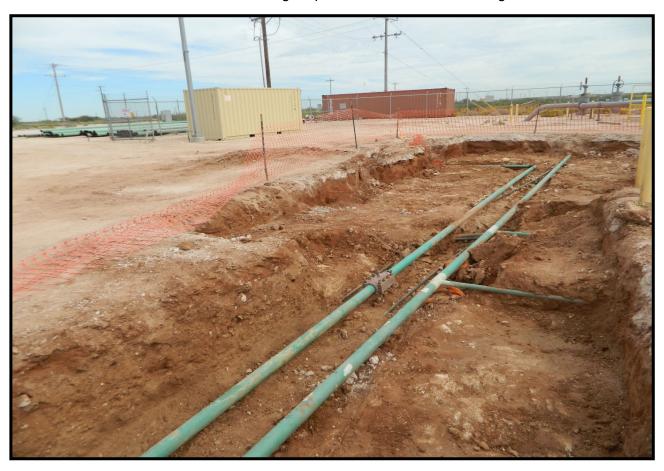
View of excavation area during response action activities, facing northeast.
