November 21, 2019

Vertex Project #: 19E-03610-001

Spill Closure Report: Dark Canyon (Carlsbad 960 SWD)
Unit I, Section 23, Township 23 South, Range 26 East)
API: 30-015-45033
County: Eddy
Incident Report: 2RP-5675

Prepared For: 3 Bear Delaware Operating – NM, LLC
1512 Larimer Street, Suite 540
Denver, CO 80202

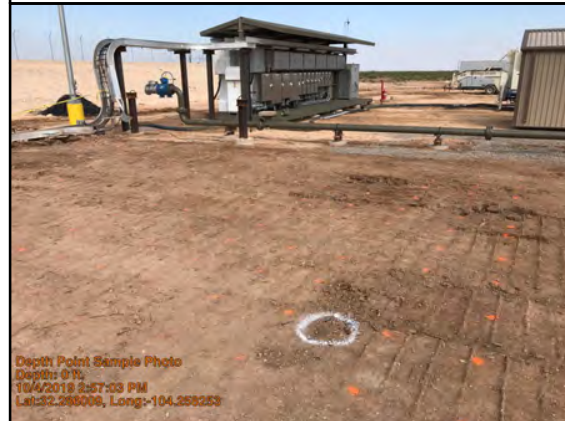
Sample Point ID: BH19-03

Depth: 0 ft.

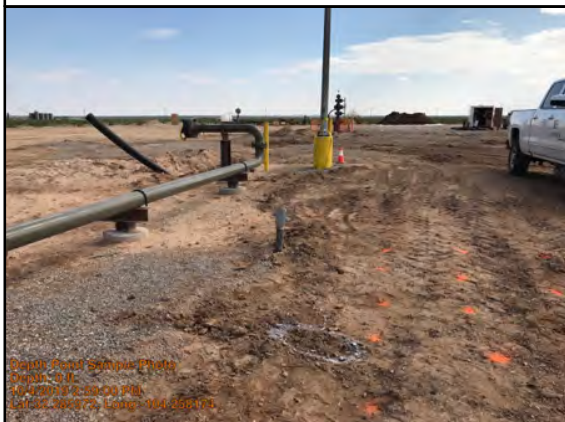
Sample Point ID: BH19-04

Depth: 0 ft.

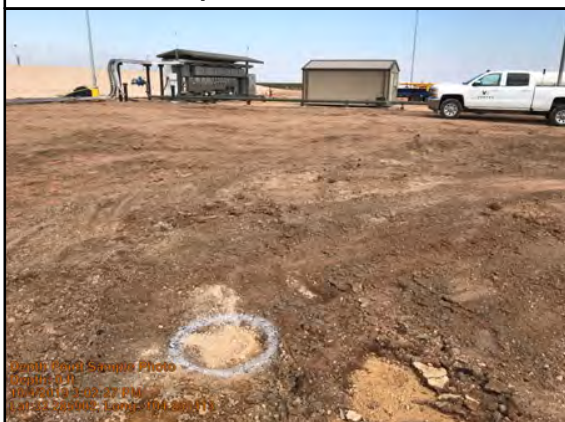
Sample Point ID: BH19-06

Depth: 0 ft.

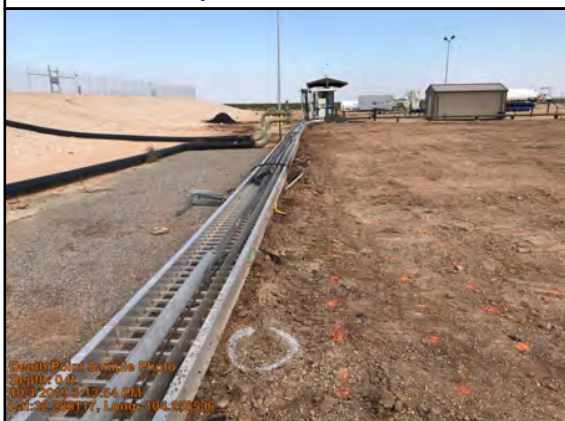
Sample Point ID: BH19-10

Depth: 0 ft.

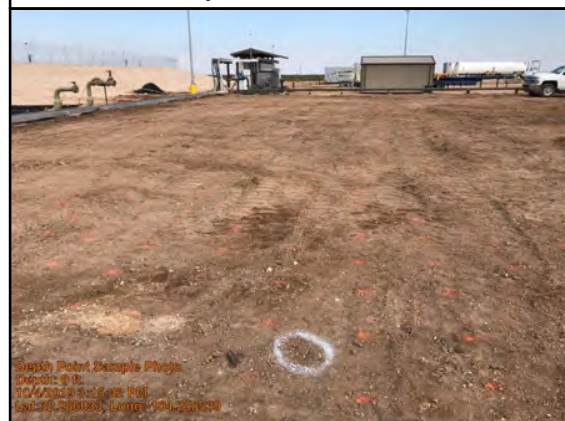
Sample Point ID: BH19-11

Depth: 0 ft.

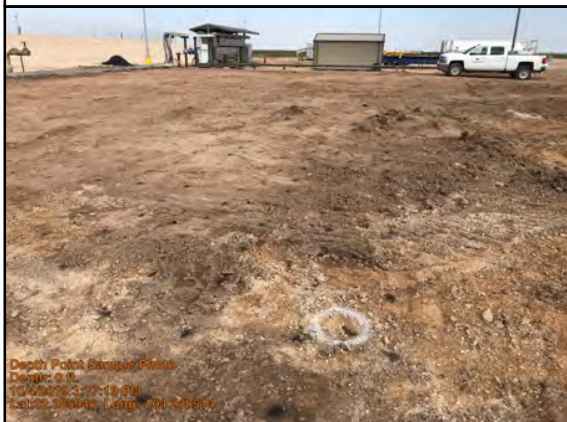
Sample Point ID: BH19-12

Depth: 0 ft.

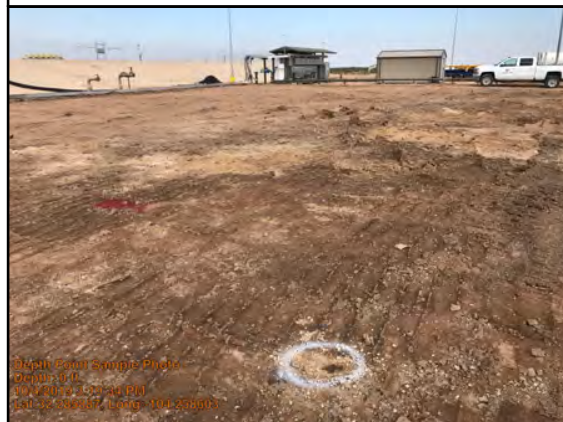
Sample Point ID: BH19-13

Depth: 0 ft.

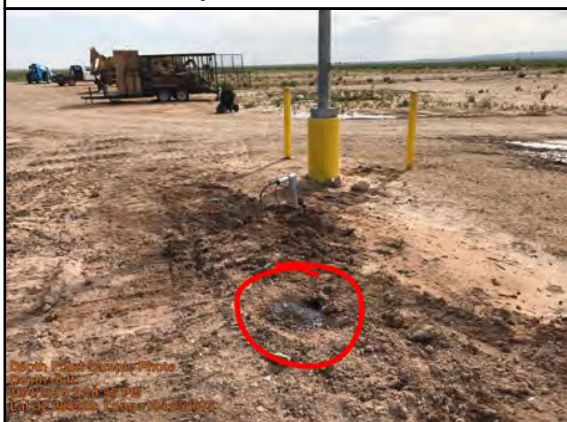
Sample Point ID: BH19-14

Depth: 0 ft.

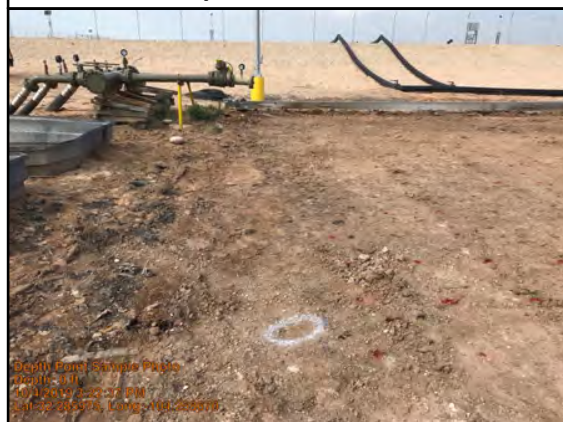
Sample Point ID: BH19-15

Depth: 0 ft.

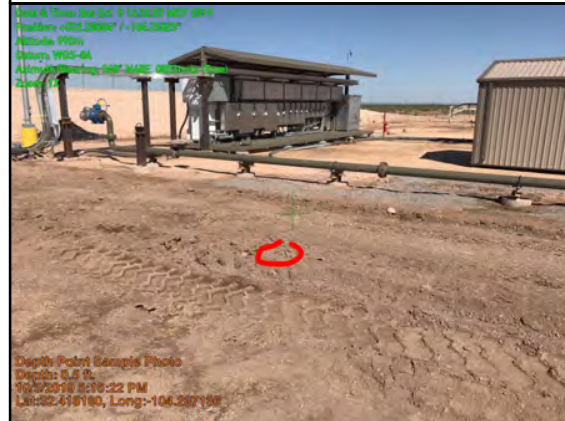
Sample Point ID: ES-Base19-04

Depth: 0.5 ft.
