## Release Notification

Site Name Denton No. 2 SWD well	Site Type: SWD wellhead
Date Release Discovered 11/5/18	API# 30-025-05270

Work Plan: 1RP-5270– Denton No.2 SWD Wellhead spill

## 1RP-5270 Denton No.2 SWD Sample Analysis

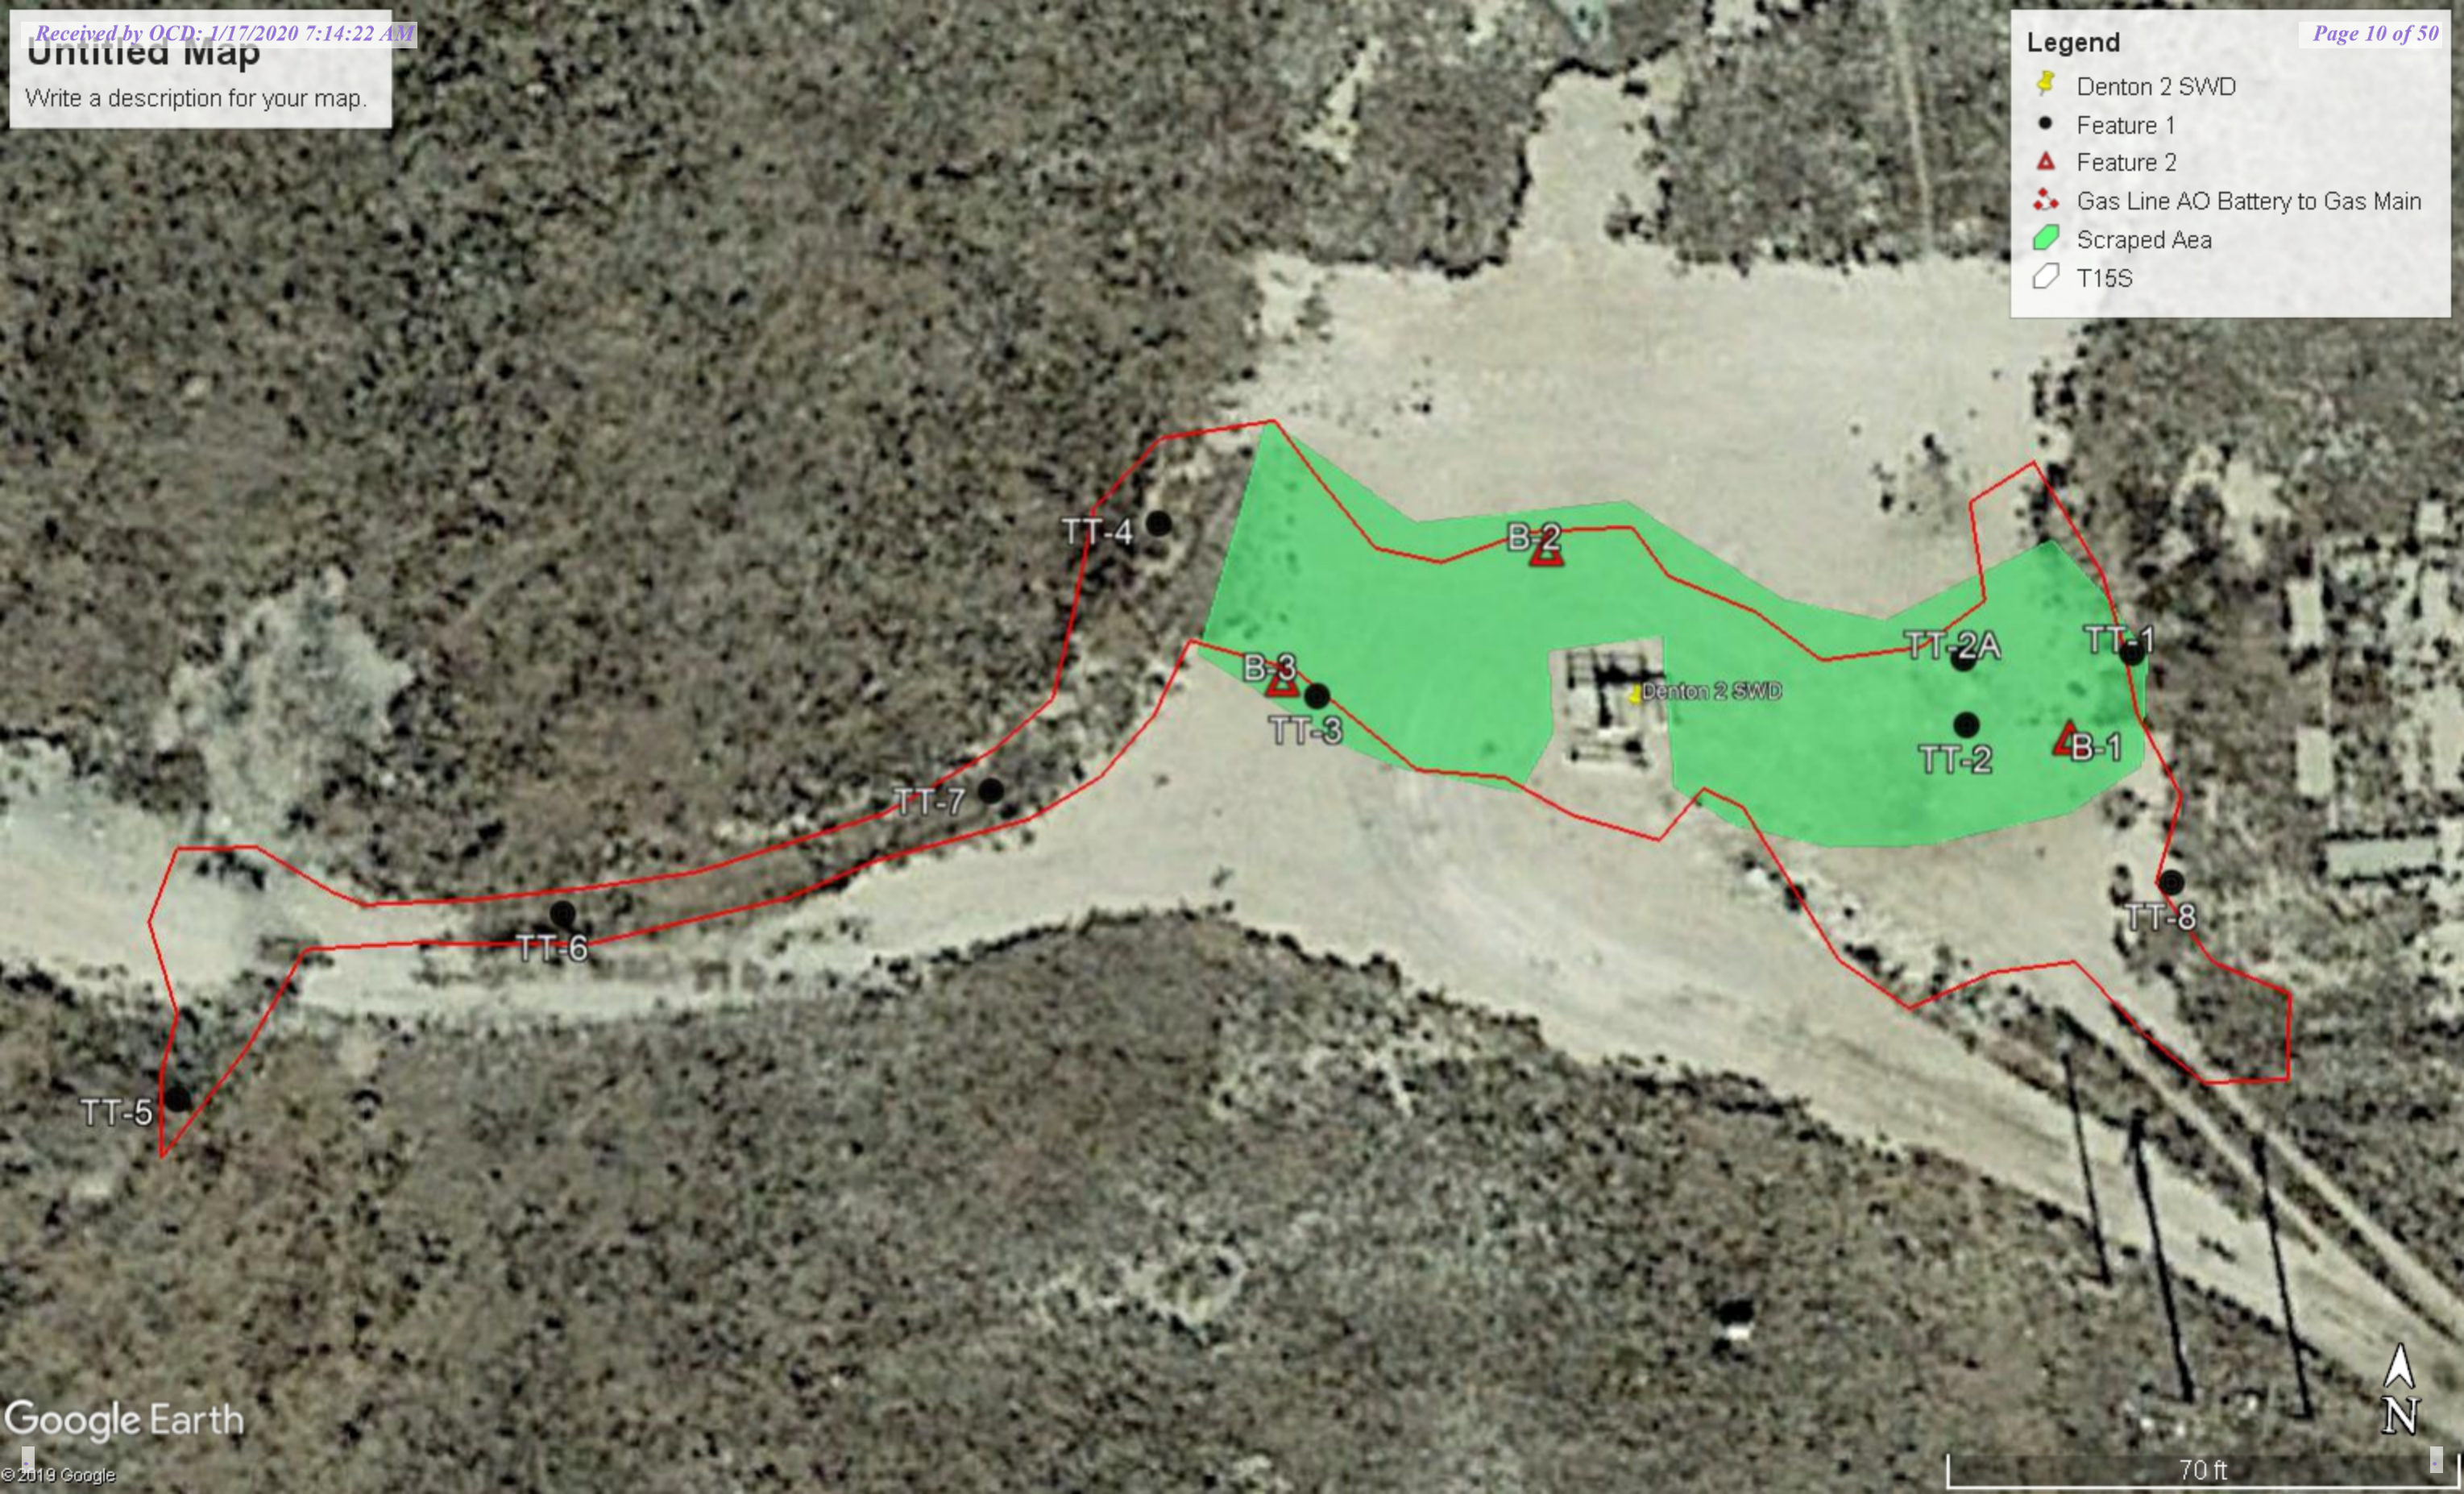
Untitled Map

On January 30, 2019, five trenches were opened with a backhoe and three samples from each trench were collected: surface, one foot, and the top of caliche. The surface of the caliche at this location varies from 2 to three below the surface. Laboratory analysis of the samples shows that chloride concentrations are high in the surface samples at TT-1, TT-2, and TT-3. All other sample concentrations are below 2,000 mg/kg chloride. A site plan showing these sample locations is included as an attachment.

On July 18, 2019, three borings were advanced with a hollow stem auger mobile drilling machine. Samples were continuously collected by hollow stem auger in two-foot increments. Four samples from each boring were submitted for laboratory analysis. The maximum concentration for these samples was 1,410 mg/kg chloride in B-2 at 0-2'. All other concentrations were low, and the deepest samples collected from each boring were 320 (B-1), 128 (B-2), and 112 (B-3) mg/kg chloride. A site plan showing these sample locations is included as an attachment.

Scraped Area
-

On October 31, 2019 SESI also removed approximately 4 inches of the surface pad material around the well that was above the 19.15.29.12 Table 1 limits in the areas of TT1-, TT-2, and TT-3. Approximately 20 cubic yards of material was removed, and stockpiled on plastic pending disposal. The removal of the material did not require replacement of pad material so no new material was imported and backfilled onto the pad.

Following removal of pad material, the surface at TT-1, TT-2, and TT-3 were field screened and re-sampled. Please note that these sample locations are now labeled SP-1, SP-2, and SP-3. Field screening results of these sample locations were less than 600 mg/kg. Laboratory results ranged from 980 to 1,800 mg/kg chloride; well below the Table 1 limits in 19.15.29.12 for groundwater 51 to 100 feet below ground surface.
