## CLOSURE REPORT

**Nailed It, Lateral Pipeline (Station 252+00)  
S36, T26S, R29E  
32.004861 N, -103.943759 W  
Eddy County, New Mexico**

December 13, 2019  
Ensolum Project No. 03B1511003

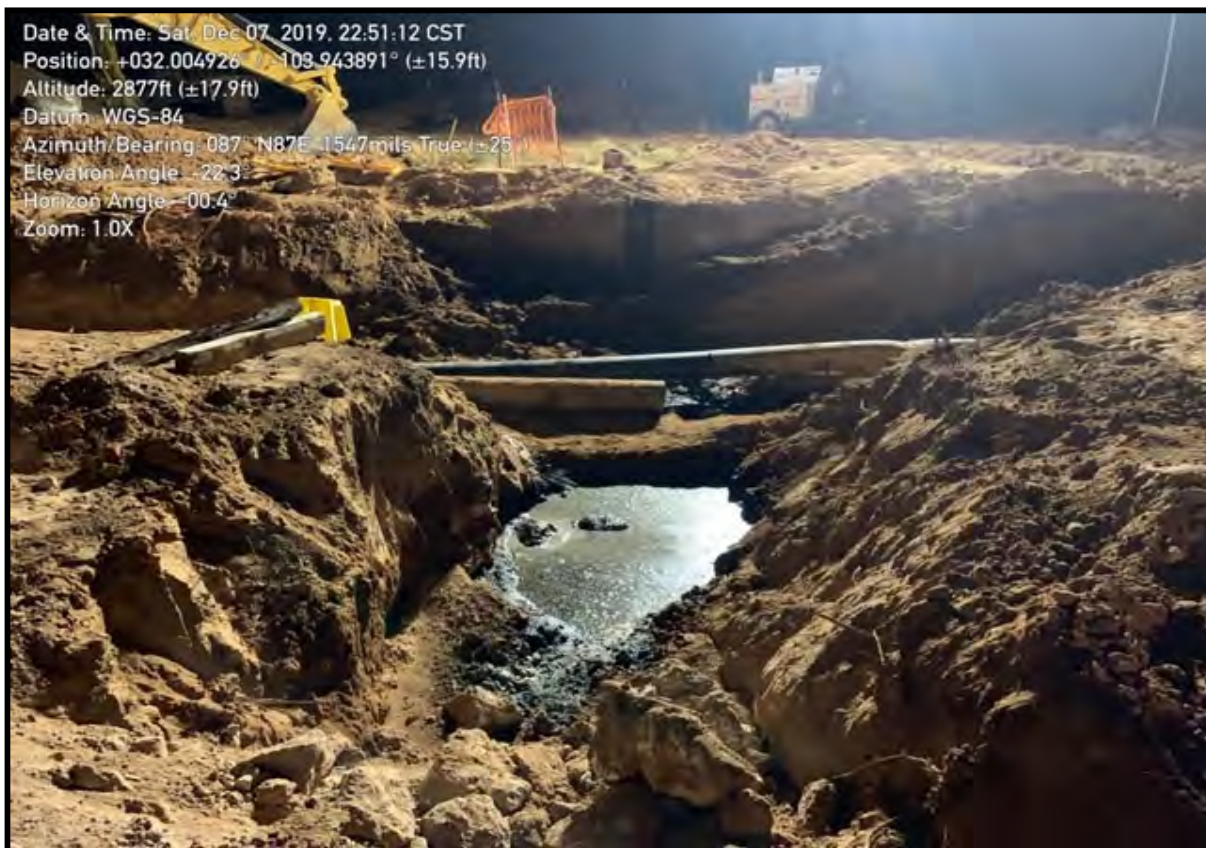
View of the release area prior to remediation activities, facing east.

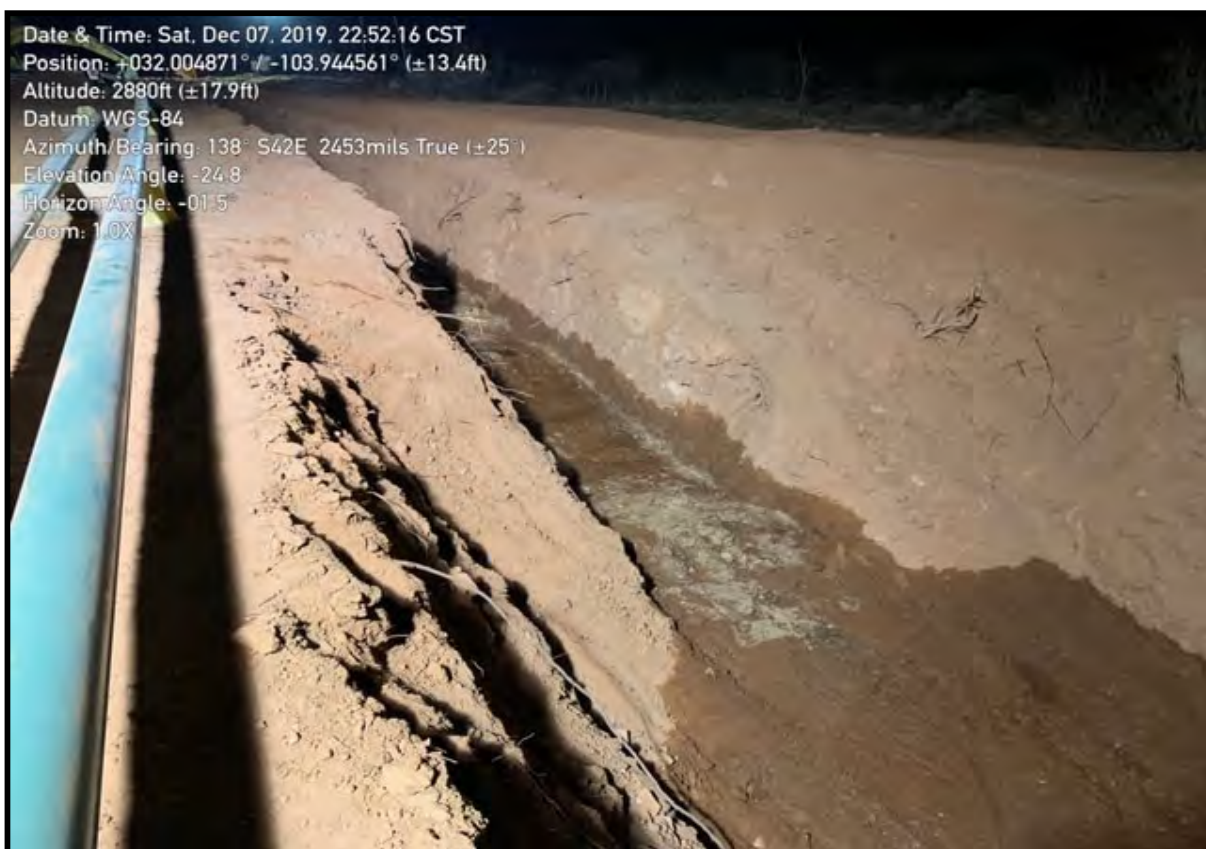
View of the release area prior to remediation activities, facing southeast.

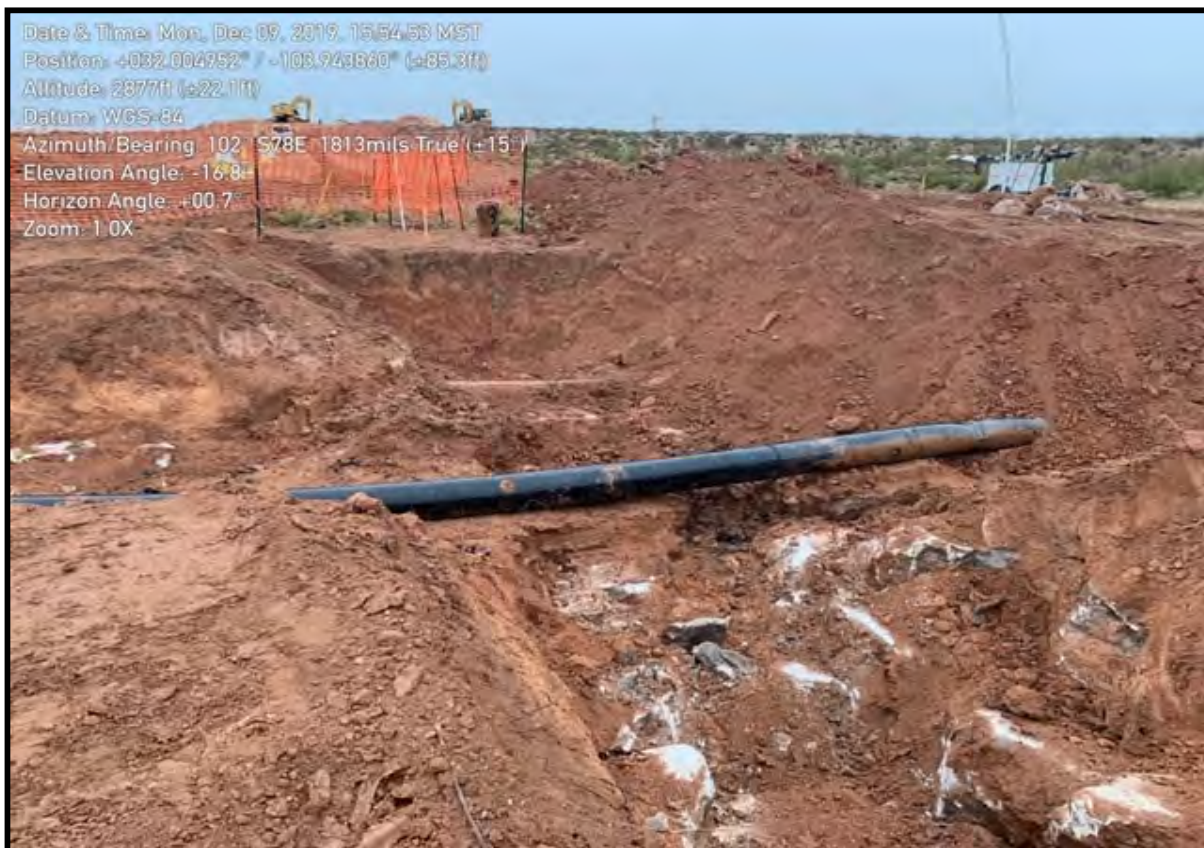
View of the release area during remediation activities, facing east.

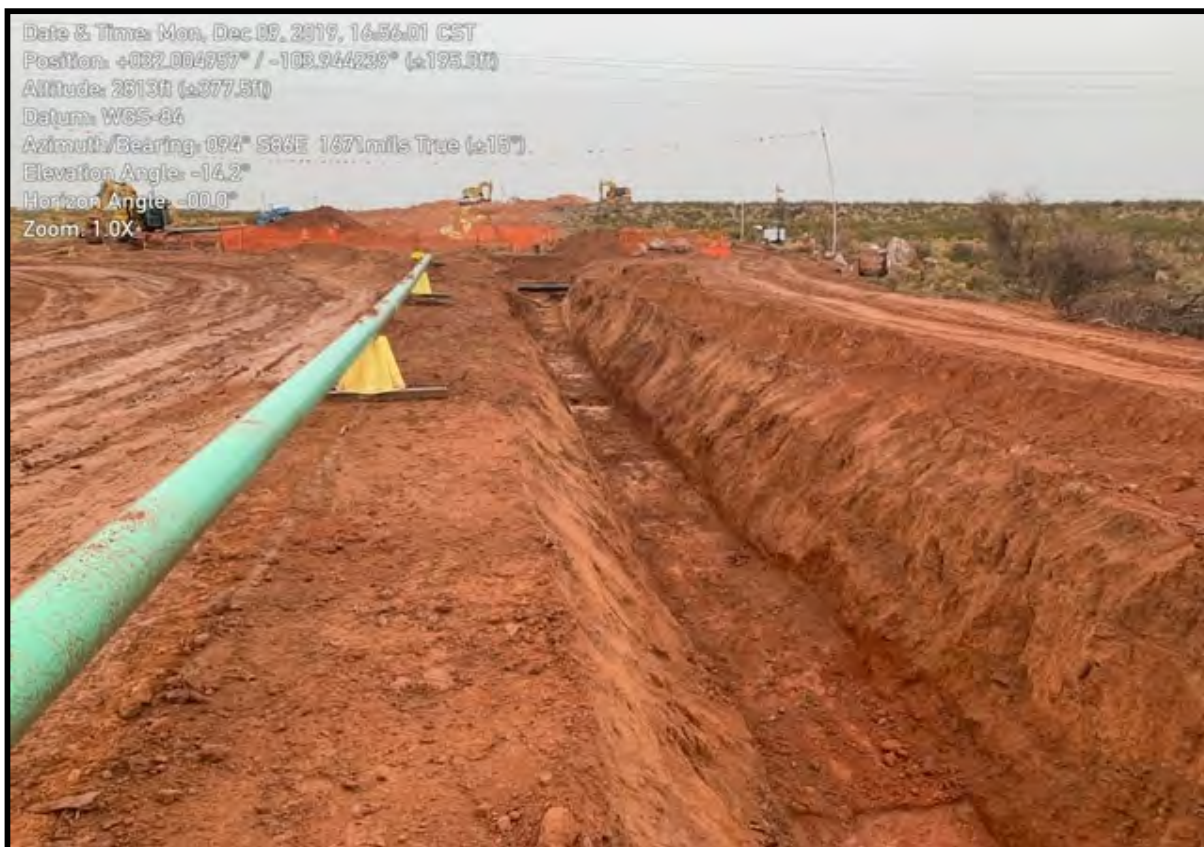
View of flow path during remediation activities, facing east.
