Release Notification

Site Name	Wolverine Comp. Station	Site Type	Compressor Station
Date Release Discovered	09/26/2019	API# (if applicable)	30-015-37700 (Muy Wayno State #001H)

RE: Closure Request
Wolverine Compressor Station- September 26, 2019 Release
Remediation Permit Number Not Assigned
PO Number: HVOPL-191008-C-1410
Eddy County, New Mexico

TABLE 1
SOIL ANALYTICAL RESULTS

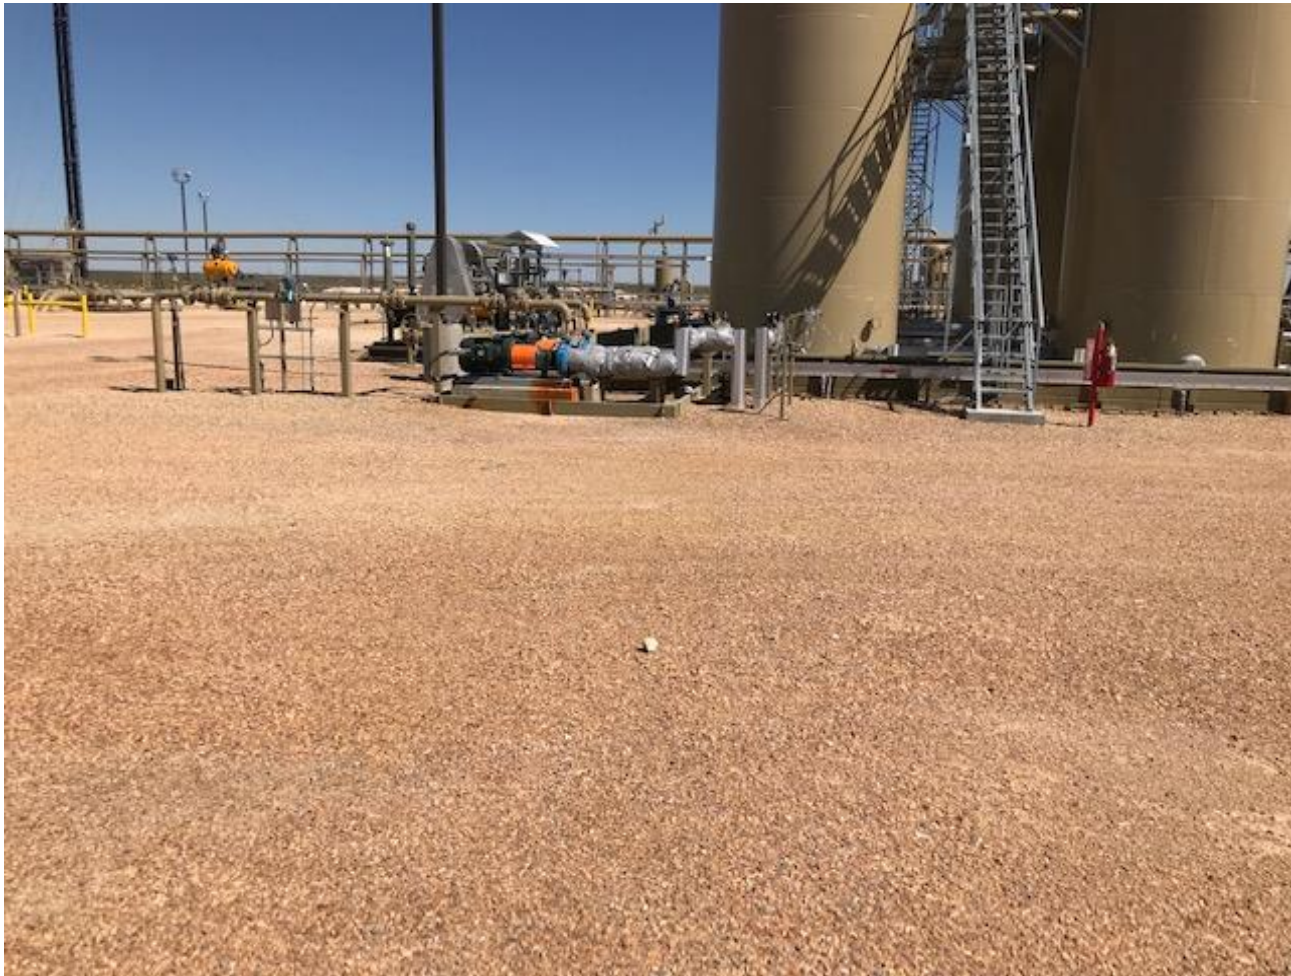
Based on laboratory analytical results for the preliminary soil samples SS01 through SS03, excavation activities did not appear warranted; however, additional assessment activities were scheduled to further confirm the presence or absence of impacted soil. Photographic documentation was conducted during the Site visit. Photographs are included in Attachment 2.

Eastern view of release area on caliche well pad during site assessment activities.

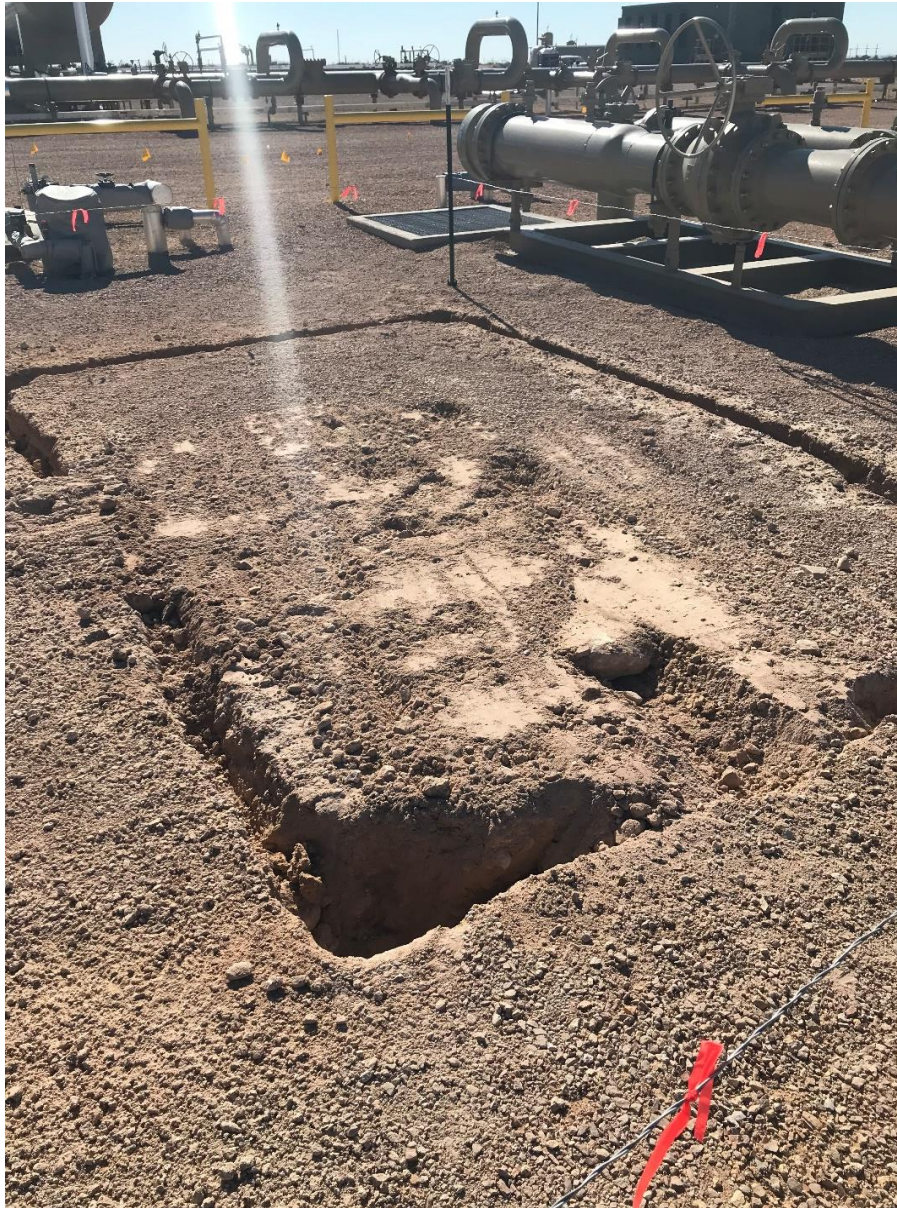
On December 17, 2019, LTE personnel returned to the Site to oversee additional soil assessment activities. One borehole (BH01) was advanced via hand-auger, to a depth of two feet bgs, within the release extent. Two potholes (PH01 through PH02) were advanced within the release extent using a track-mounted backhoe and soil samples were obtained at depths of two feet bgs. Borehole sample BH01 was advanced at SS01, and pothole samples PH01 and PH02 were advanced at SS02 and SS03 preliminary soil sample locations, respectively.

View of release area during delineation soil sampling activities.
