Site Name	PLU Phantom Banks 20-25-31 USA Battery	Site Type	Bulk Storage and Separation Facility
Date Release Discovered	8/20/2019	API# (if applicable)	30-015-40764 (Poker Lake CVX JV PB 6H)

PLU Phantom Banks 20-25-31 USA Battery (30-015-40764 Poker Lake CVX JV PB
6H)

On August 20, 2019, a seal on a produced water transfer pump failed, resulting in the release 10 barrels (bbls) of produced water into the lined tank battery containment. The pump was isolated until repairs could be made. A vacuum truck was dispatched to the Site to recover free-standing fluids; approximately 10 bbls of produced water was recovered. A liner integrity inspection was conducted. A 48-hour notification was provided to the NMOCD via email prior to the liner inspection. The liner was determined to have a hole. XTO reported the release to the NMOCD on a Form C-141 on September 4, 2019, and was assigned RP Number 2RP-5629 (Attachment 1). Based on the presence of active production equipment, XTO requested deferral of delineation and remediation on the C141. The NMOCD denied XTO's deferral request on November 8, 2019 and required XTO to obtain delineation soil samples beneath the liner.

Project: 012919270	XTO

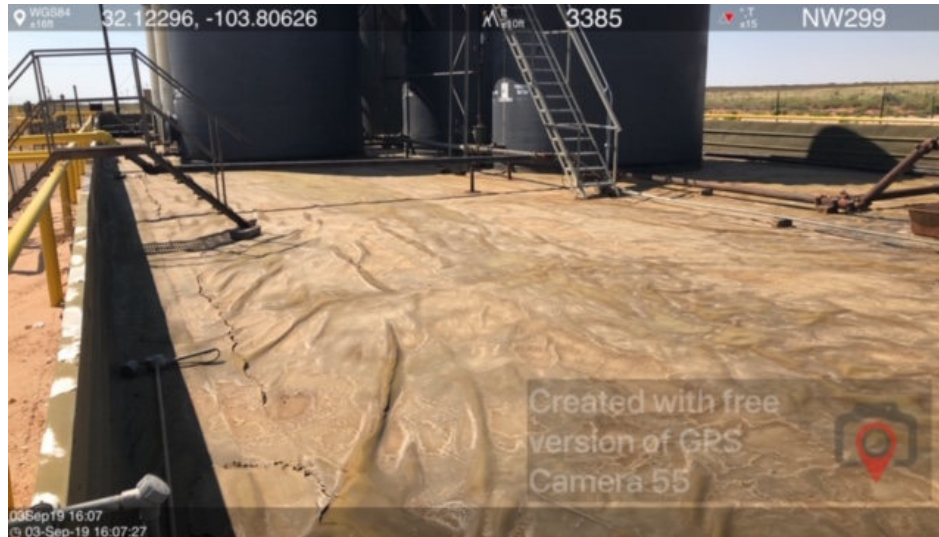
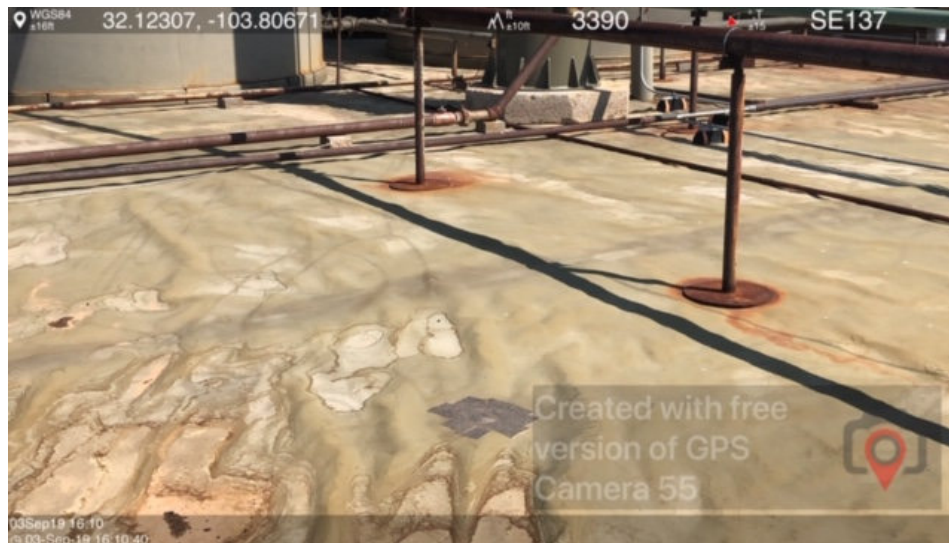
Spill Date: 8/20/2019

A seal on a produced water transfer pump leaked fluid into tank battery containment. The pump was isolated until it can be repaired. Vacuum truck returned all free fluid to tank. No fluids were seen outside/around containment area. A 48-hour advance notice of liner inspection was provided by email to NMOCD District 2. The liner was visually inspected and determined to be inadequate. Liner is scheduled for repair and returned to impervious condition. XTO requests deferral of potential impacts under liner until facility upgrades or is abandoned. It is XTO safety policy to restrict subsurface disturbance to within 3 ft of equipment. The containment is congested by lines, tanks, and equipment making it impossible to access for vertical delineation via heavy equipment or drill rig.

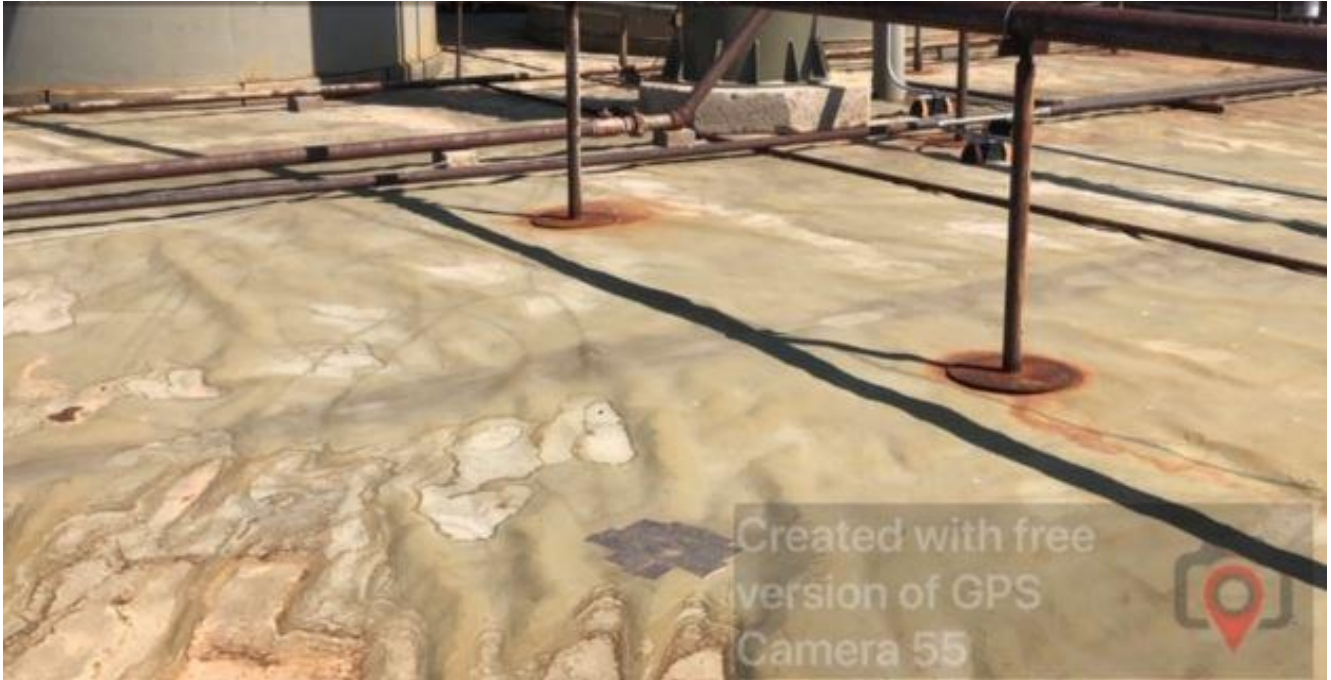
Southeastern view of lined tank battery containment and liner hole during soil sampling activities.

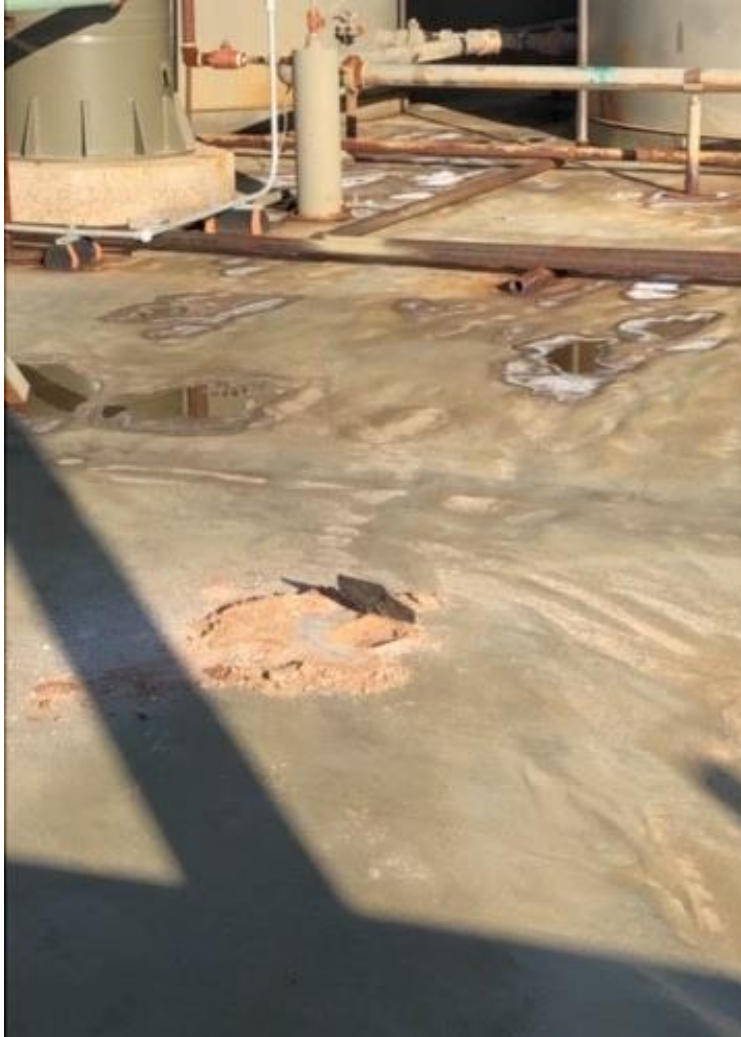
Southeastern view of lined tank battery containment and liner hole during soil sampling activities.
