Release Notification

Site Name Muy Wayno 18 Federal 121H	Site Type Production Well Facility
Date Release Discovered 4/11/2019	API# (if applicable) 30-015-44840

Mr. Mike Bratcher
New Mexico Oil Conservation Division
811 South First Street
Artesia, New Mexico 88210**RE: Closure Request
Muy Wayno 18 Federal 121H
Remediation Permit Number 2RP-5397
Incident Number NAB1912753854
Eddy County, New Mexico**

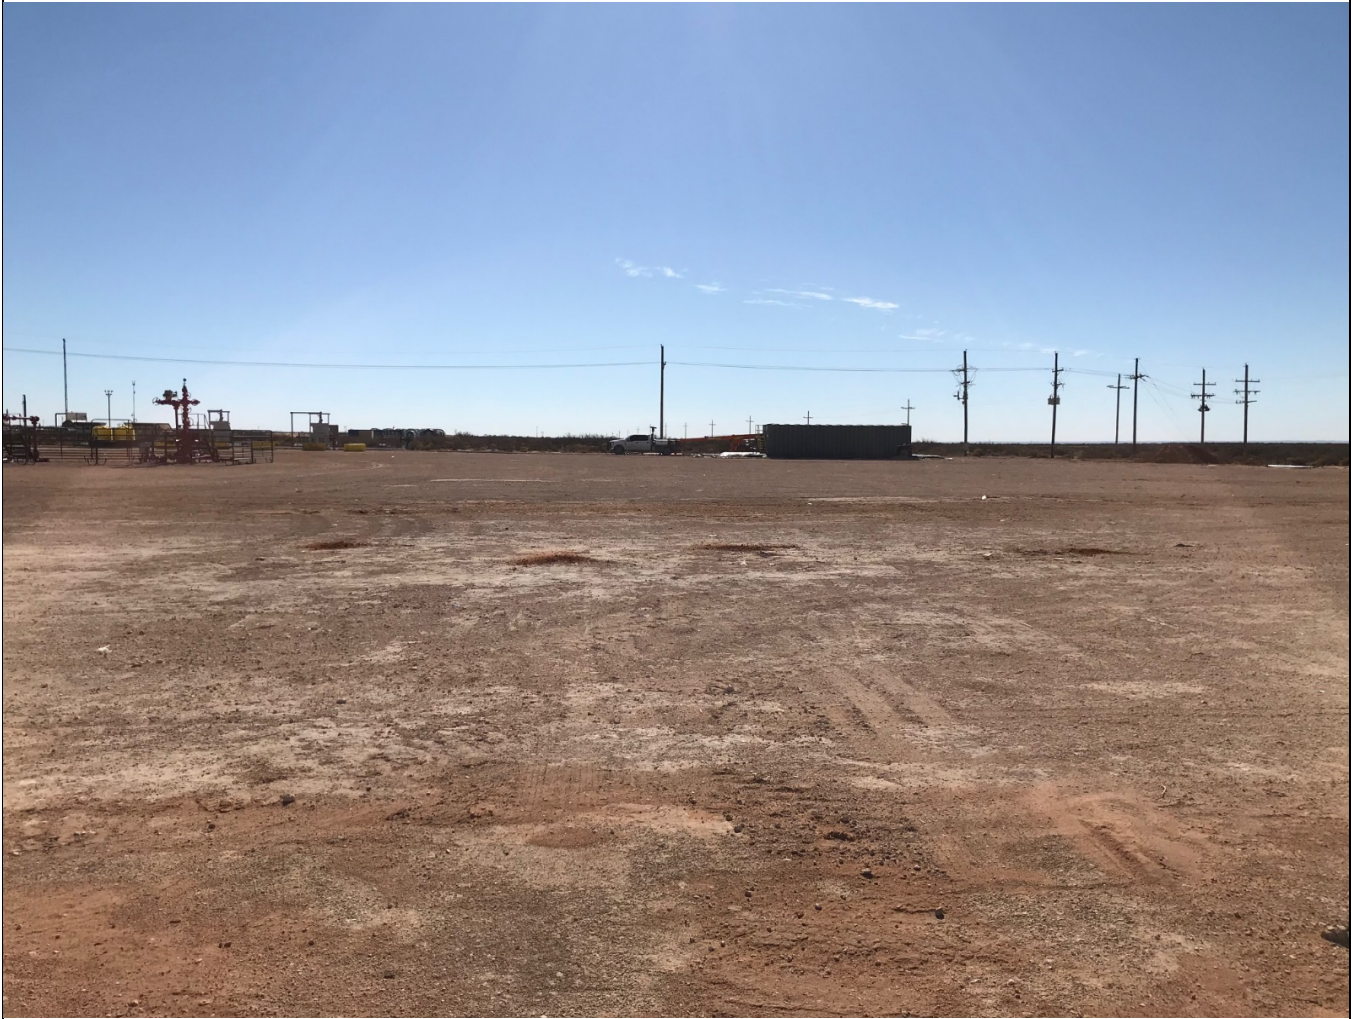
Southern view of release area during delineation soil sampling activities.

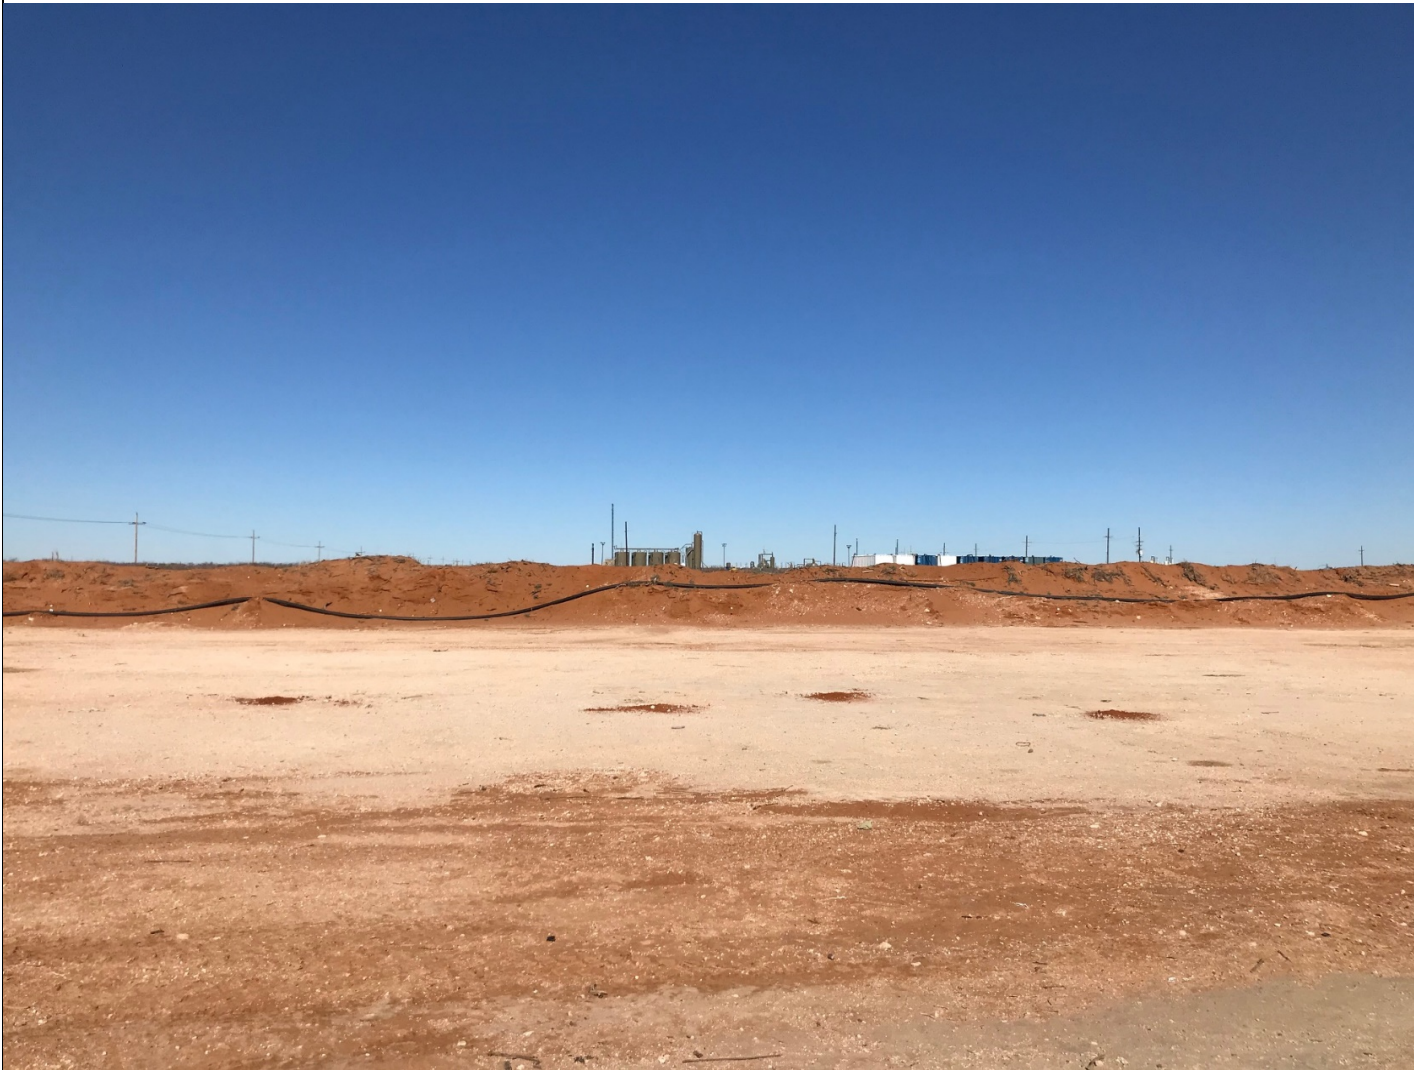
Northern view of release area during delineation soil sampling activities.
