Revised Remediation Summary and Site Closure Request

March 18, 2020

White Federal Com #001H
(2RP-5470)

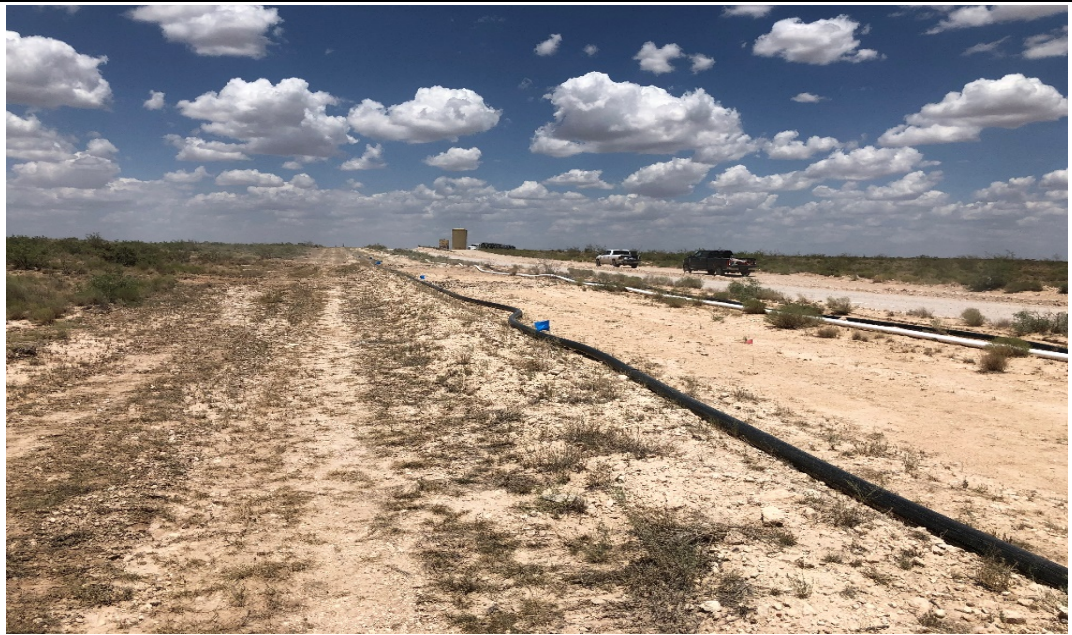
View of the
Release area
prior to
remediation.

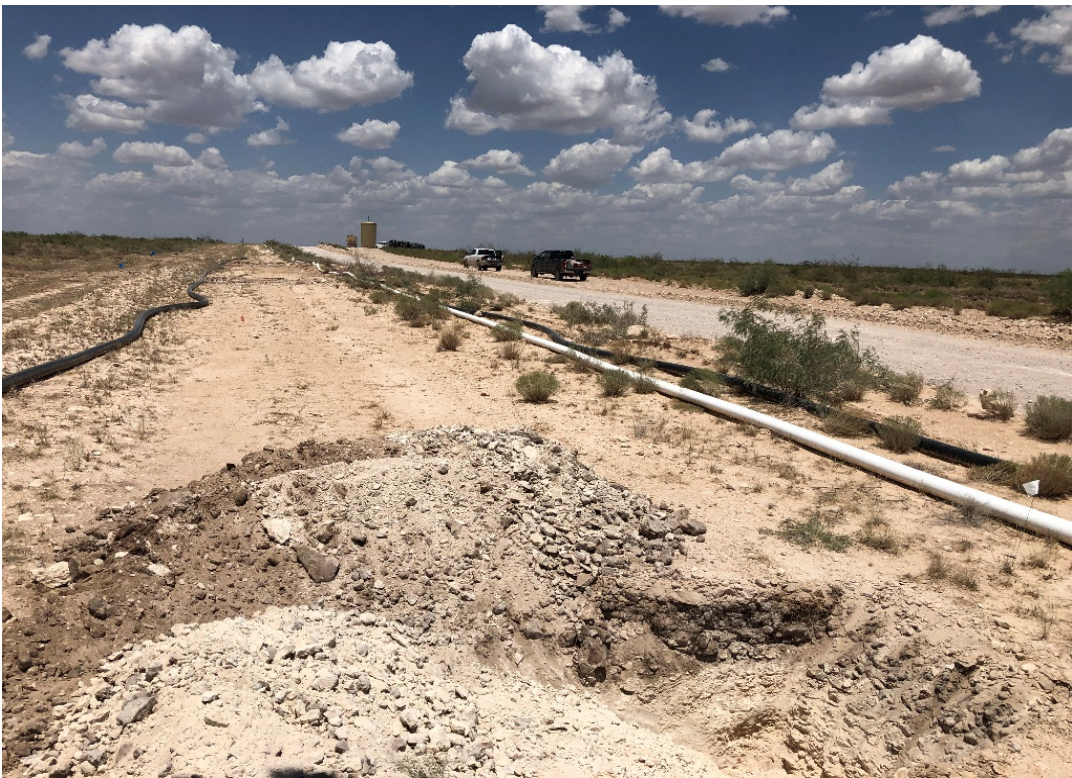
Photograph No. 2

View of
delineation
trench prior to
remediation.

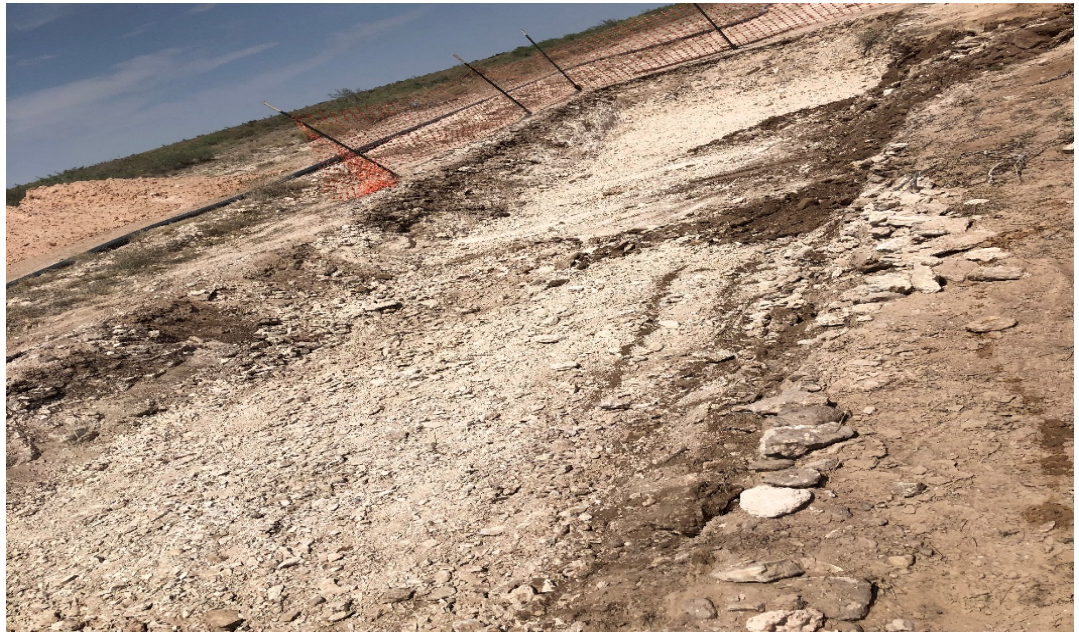
View of excavated area.

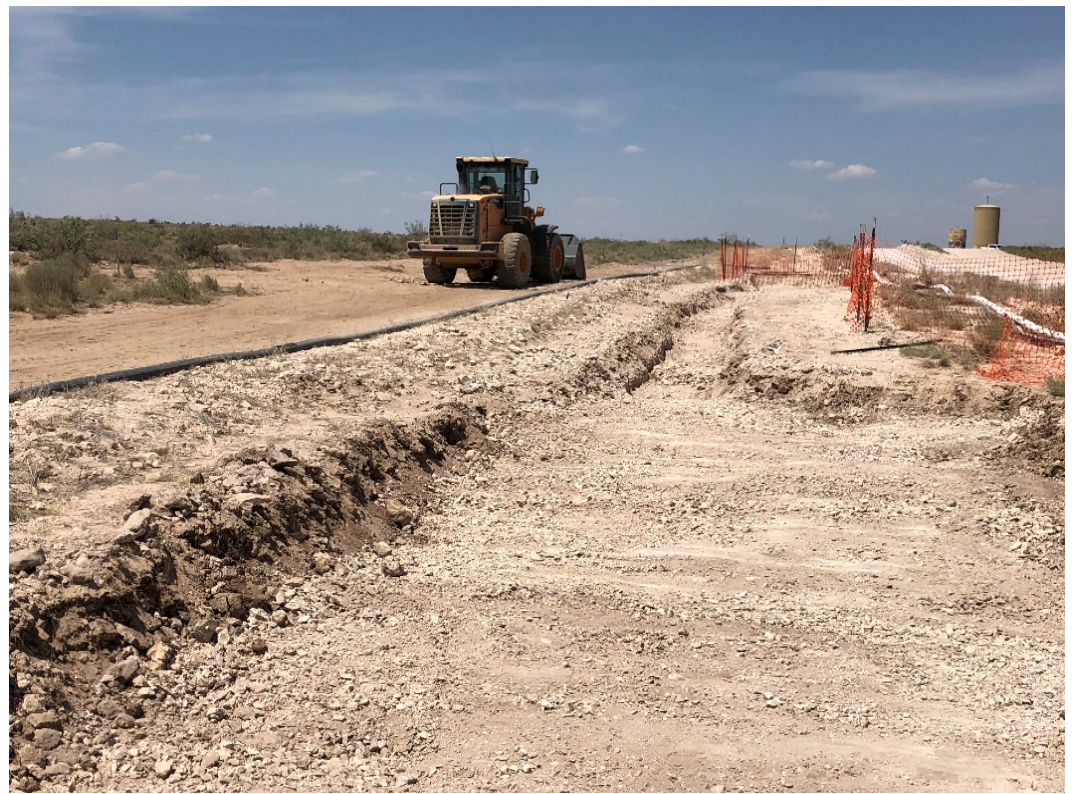
Photograph No. 4

View of excavated area.

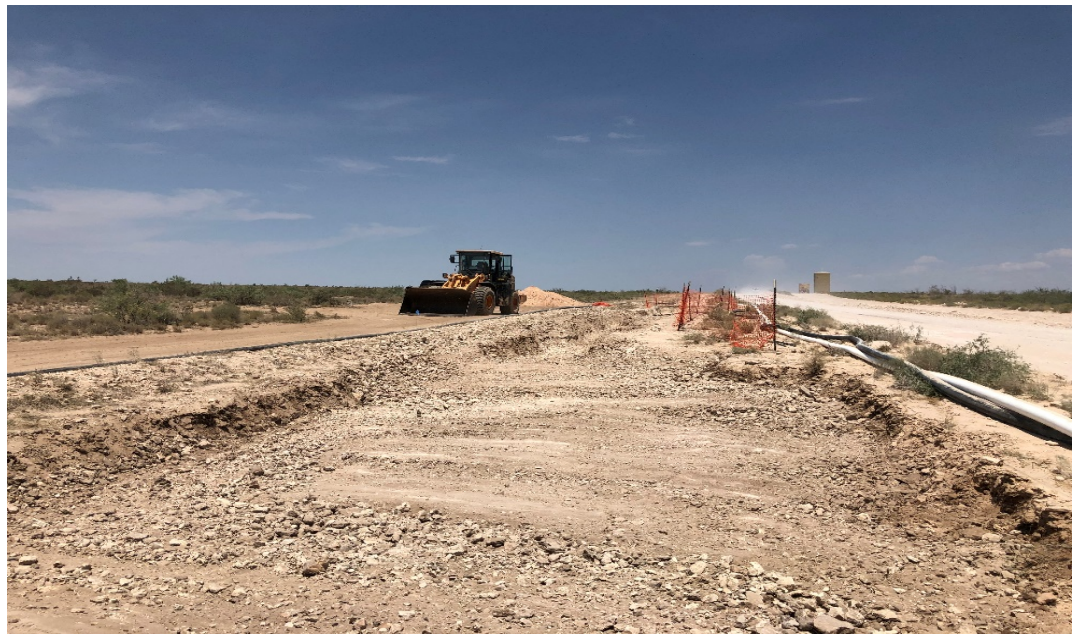
View of
excavated area.

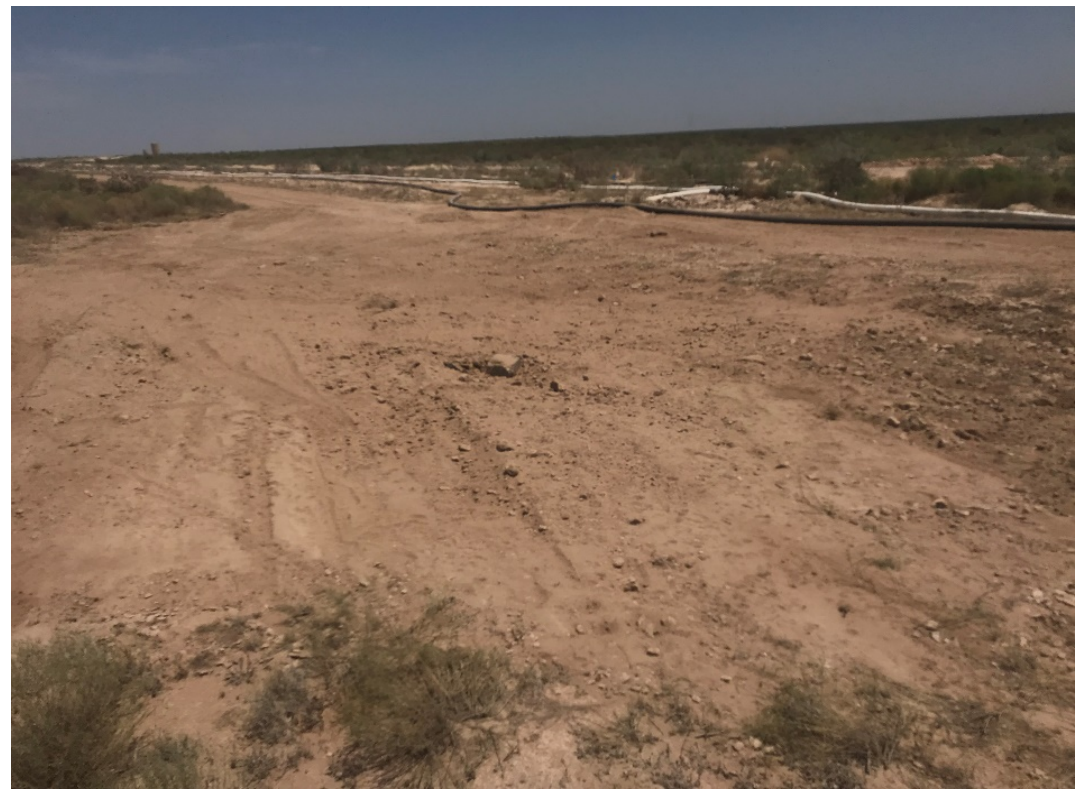
Photograph No. 6

View of the
remediated area.

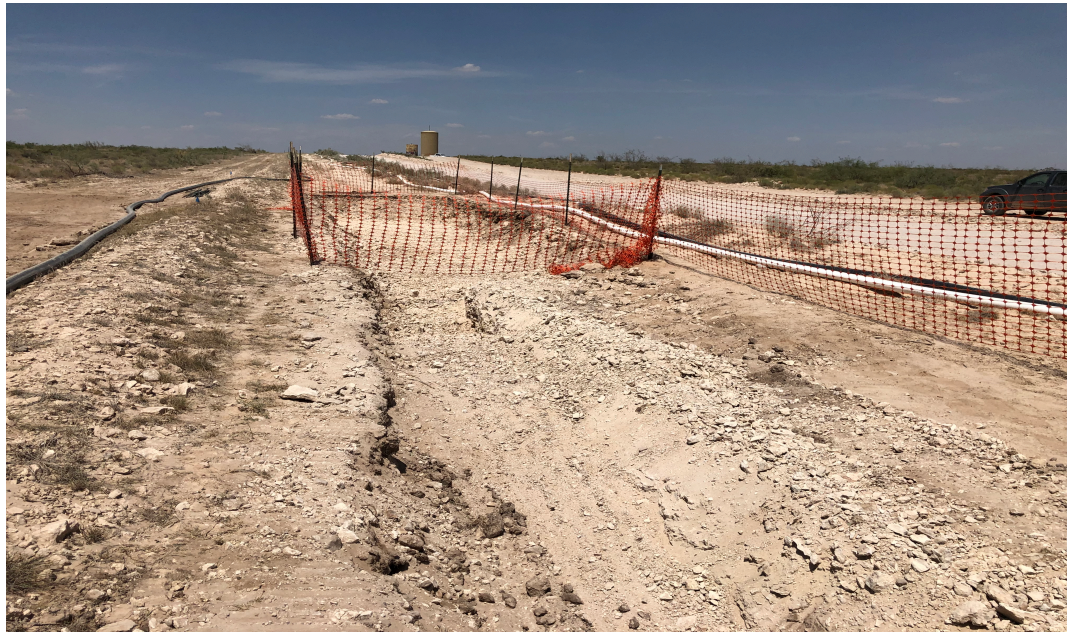
View of
excavated area
adjacent to
requested
deferral area.

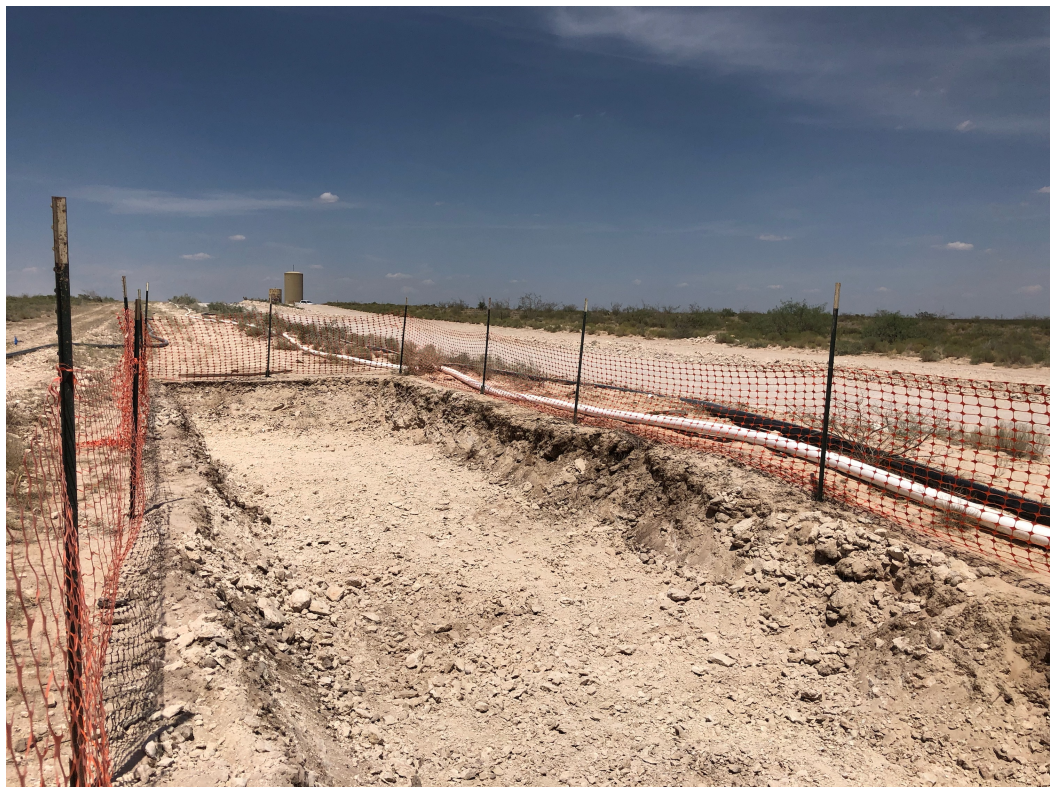
Photograph No. 8

View of
excavated area
adjacent to
requested
deferral area.
