Re: Closure Request

Kaiser-Francis Oil Co Williams Fee 2524 LBC #001H

NMOCD Incident #: nRM2003759623

RXSoil, Inc. is pleased to submit the closure request summarizing work done for the on-site remediation of treated produced water impacted soil for the above release, associated with the Williams Fee 2524 LBC #001H site located in Eddy County, New Mexico.

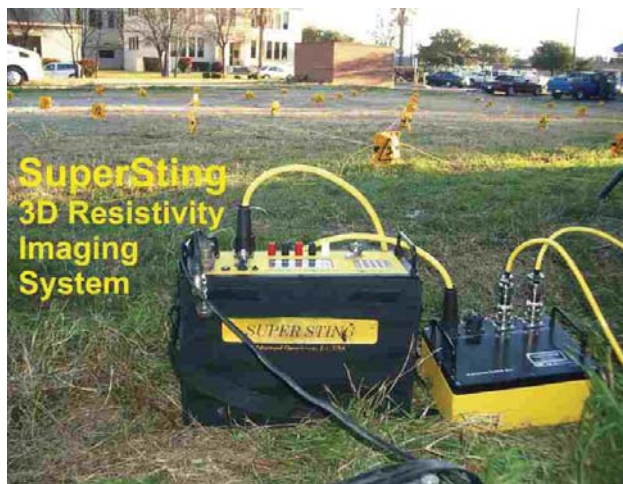
SuperSting R8 IP 8 channel Memory Earth Resistivity and IP Meter

The **SuperSting R8 IP** is a state-of-the-art multi-channel portable memory earth resistivity meter with memory storage of readings and user defined measure cycles. It provides the highest accuracy and lowest noise levels in the industry. This new instrument revolutionizes the field of resistivity imaging surveys by its capability to simultaneously measure up to 8 channels using a high power transmitter so that field data production can reach previously unheard of speeds. With the high power transmitter good data can be recorded in difficult locations where time-consuming stacking was the only alternative before. **SuperSting R8 IP** uses the new Multi-channel Swift Dual Mode Automatic Multi-electrode cable (patent 6,404,203) based on the successful design used in the single-channel cables. With this new cable it is now possible to efficiently record 3D data and use a virtually unlimited quantity of electrodes in a single layout. The electrode address is now a 16 bit number which sets range at about 65,000 electrodes! The controller for this new cable is completely built into the **SuperSting R8 IP** main instrument so there are no extra boxes to carry and connect in the field.

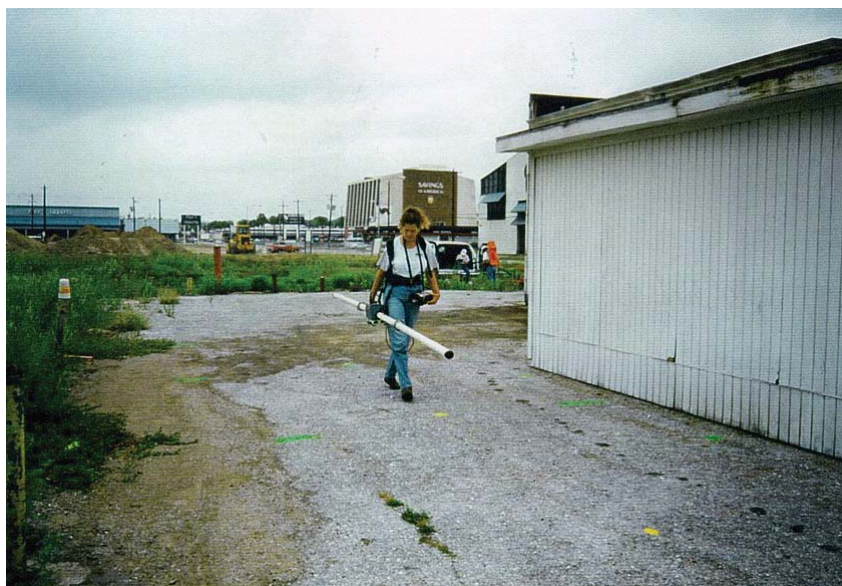
Advantages of this instrument over conventional resistivity methods are the speed with which surveys can be conducted, the precision with which small changes in conductivity can be measured and the capability of continuous readouts while traversing a survey area. The **EM-31** has the added ability of simultaneously mapping contaminant plumes and buried metals. These features make it ideal for most any type of geotechnical or groundwater contaminant survey.

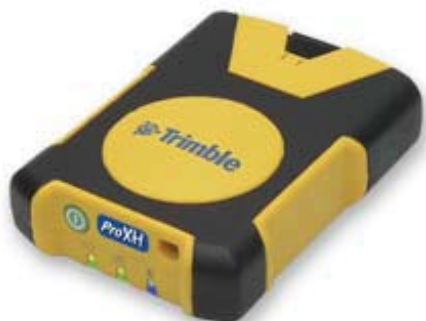
Pro-XH Receiver

Trimble's Zephyr™ external L1/L2 GPS antenna contains advanced technology for extremely low multipath, outstanding low elevation satellite tracking, and sub-millimeter phase center accuracy. Use the Zephyr antenna together with a GeoXH handheld or GPS Pathfinder® ProXH receiver for high-accuracy mapping and GIS data collection.

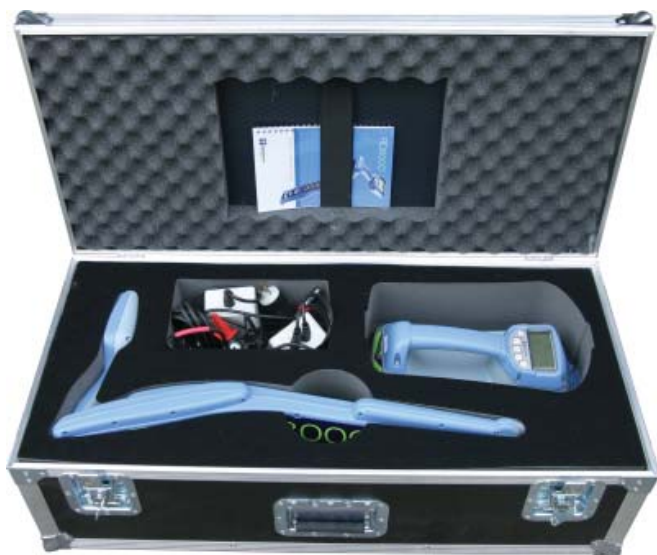
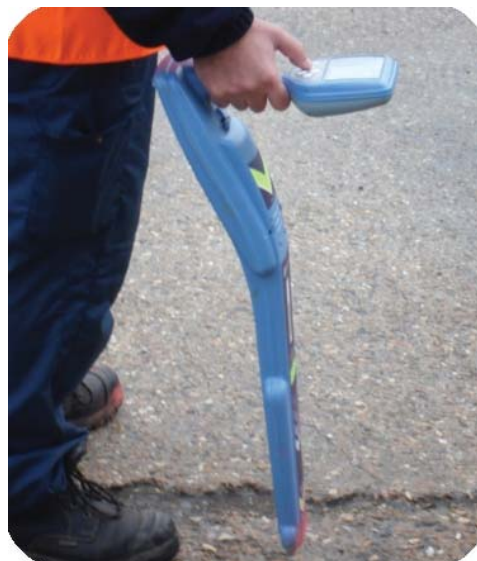
The Radiodetection RD8000 receiver is designed to locate buried pipes, lines, and cables. Several frequencies and modes of operation are available to suit specific locating needs. Available passive modes include: 50Hz, and 60 Hz power, radio, and 31 kHz CATV. Available active modes include ELF (98/128) Hz, 577 Hz, 512 Hz, 640 Hz, 870 Hz, 940 Hz, 8 kHz, 33 kHz, 65 kHz, 83 kHz, 131 kHz and 200 kHz for use with Radiodetection transmitters.

The Radiodetection RD8000 transmitter is designed to place signals on target lines. It can be configured to send 512 Hz, 640 Hz, 8 kHz, 33 kHz. It places a signal on the line through a direct connection, induction clamping, or broadcast modes.
