Subject: Liner Inspection and Closure Report
Belgian Shire 22 CTB
Eddy County, New Mexico

Devon Energy Production Company (Devon) (Client) retained HRL Compliance Solutions, Inc. (HRL) to conduct a liner inspection and prepare this closure report for the release at the Belgian Shire 22 CTB well pad (Site). The Site is located in Eddy County, New Mexico (Figure 1).

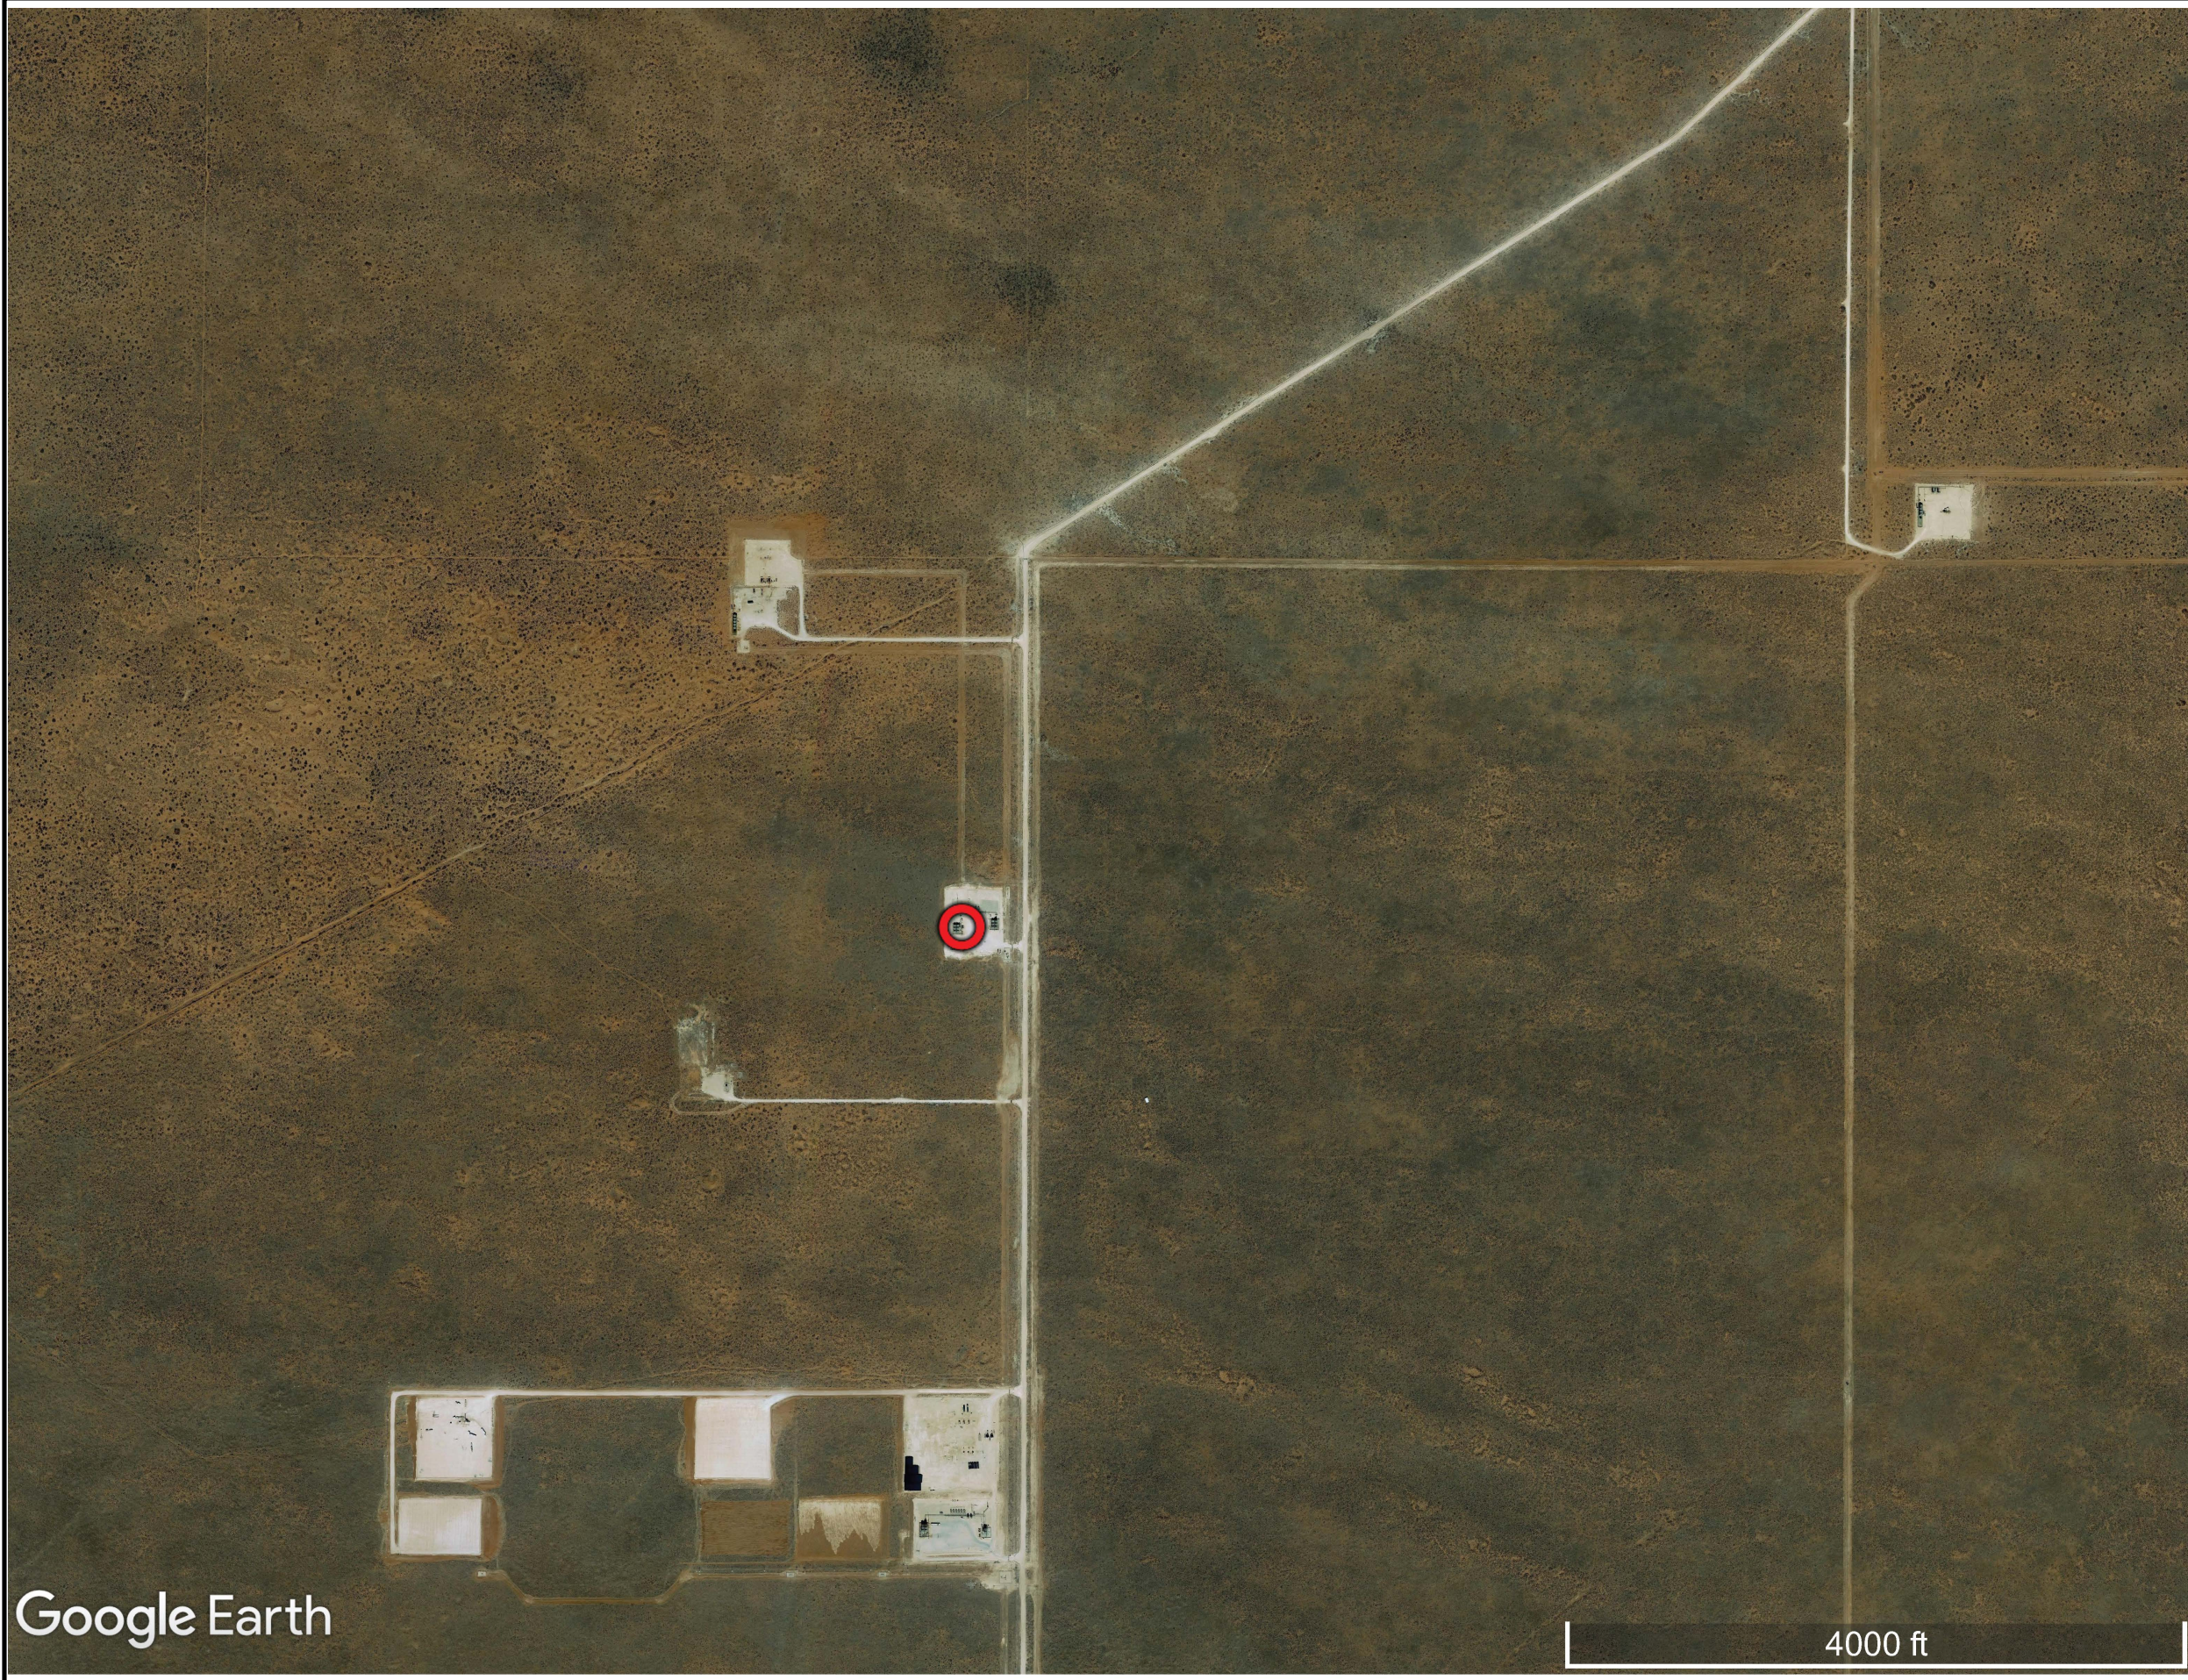
Figure 1: Site Location Map
Belgian Shire 22 CTB
32.116617, -103.758541
Section 22, Township 25 South, Range 31 East

A scaled diagram depicting the Site and nearby significant features has been prepared (Figure 1).

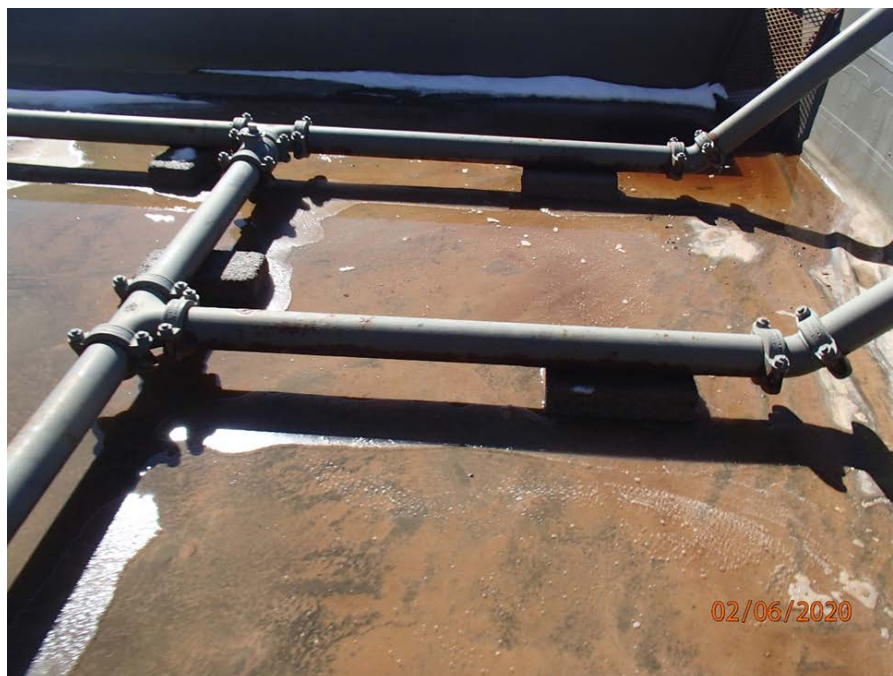
On February 6, 2020, after the released fluid was removed, HRL conducted an inspection to evaluate the integrity of the liner (Attachment B, Photographs). No tears or holes were observed in the liner and the liner was retaining precipitation. Based on this inspection, HRL has determined that the liner remains intact and had the ability to contain the release (Attachment C, Inspection Form).

View of the
liner retaining
precipitation.

The July 24, 2019 release of 127 barrels of produced water at the Site remained within the lined containment area. HRL has determined that the liner integrity remains intact and had the ability to contain the release; therefore, additional characterization of the soil and/or groundwater at the Site is not necessary. HRL recommends closure of this release.

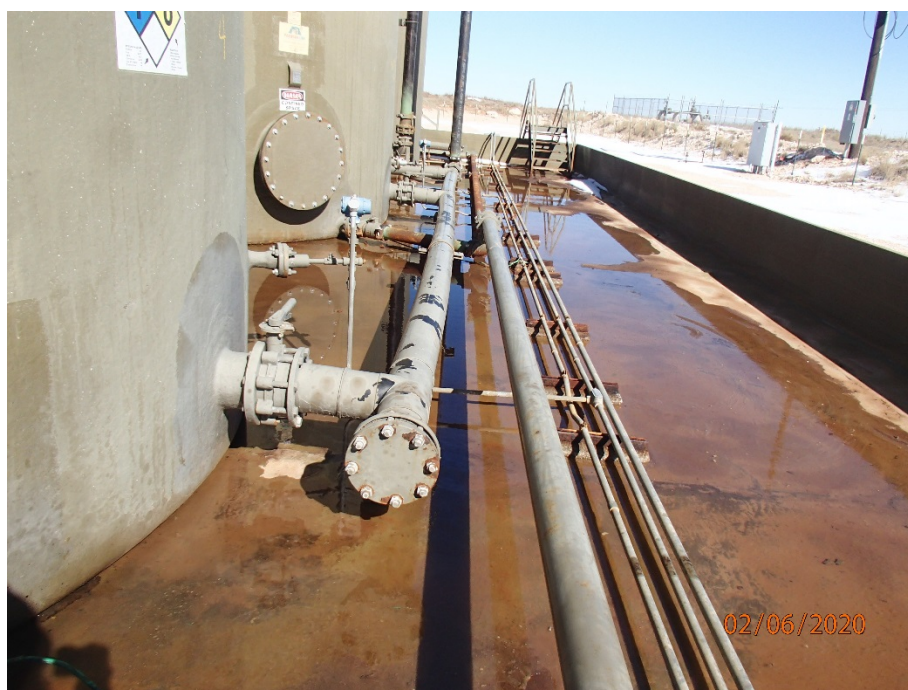
View showing
the liner was
almost
completely
filled with and
holding
precipitation.

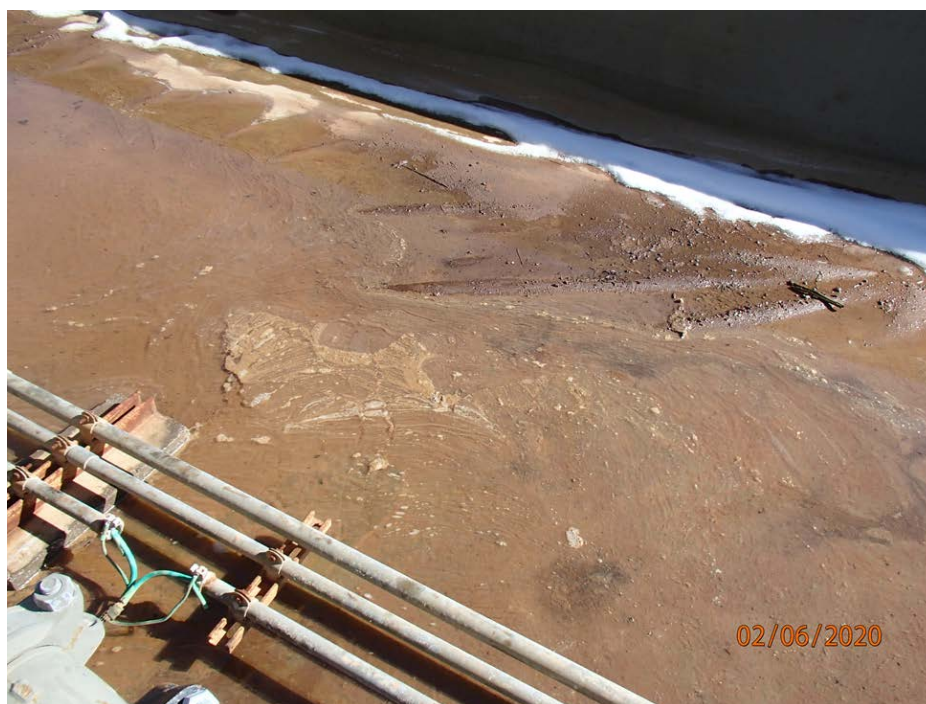
View of
buildup on
top of the
liquid being
held by the
liner.
