**1RP # Pending**  
**Characterization, Remediation & Closure Report**  
**Wool Head 20 State Com #703H**

**Prepared for**  
**Advance Energy Partners Hat Mesa LLC**  
**Houston, Texas**

**Prepared by**  
**R.T. Hicks Consultants, Ltd.**  
**Albuquerque, New Mexico**

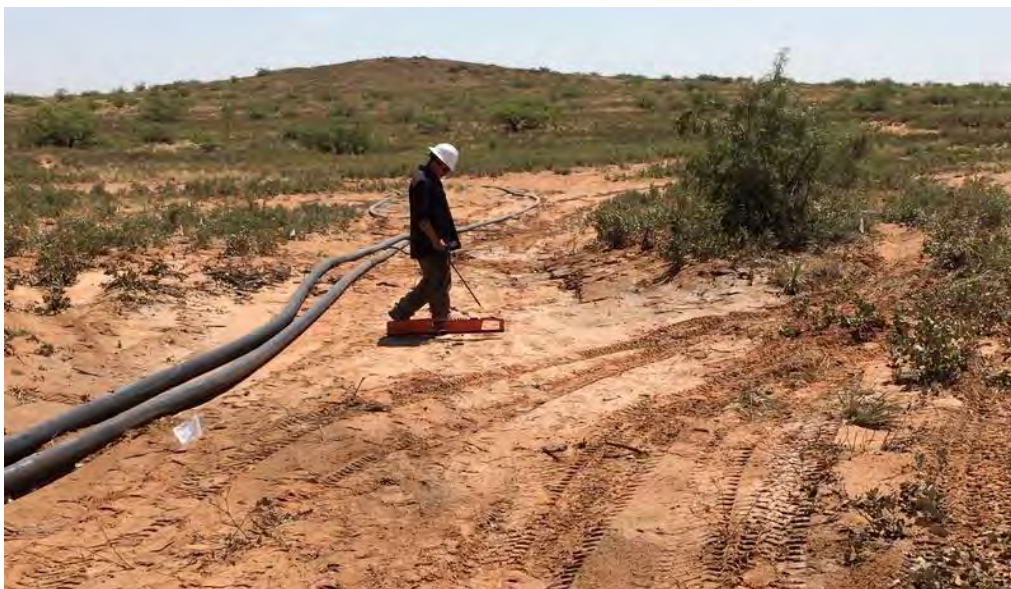
**Figure 1: Mr. Saenz conducting an EM Survey relative to the release extent. Moist soil is visible at the edge of the release extent. The white pin flag (photo lower left) identifies an edge of the release where EC = 20 dSm. GPS: 32.4493250 N, -103.6038361 W. Date/Time: 2019-10-29 11:55am.**

On September 29<sup>th</sup>, Mr. Parker and Mr. Saenz of R.T. Hicks Consultants identified the release extent with visual identification of moist soil and verified by conducting an electromagnetic (EM) survey with a Geonics EM-38 (see Appendix A for a discussion on EM surveys). The release extent was delineated to a temperature corrected electrical conductivity (EC) reading of 0.20 dS/m. As discussed in Appendix A, an EC reading of 0.20 dS/m correlates with chloride concentrations below 600 mg/kg. Plate 1 shows the final excavation extent relative to release and sample locations.

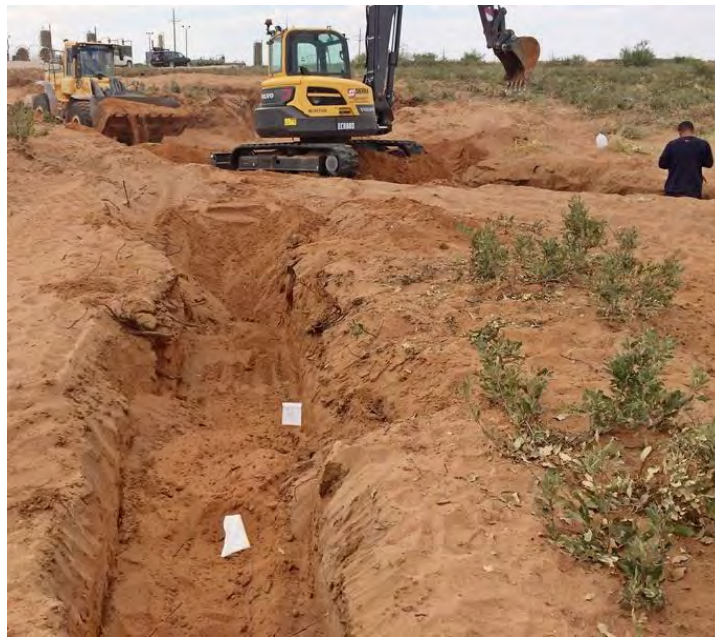
**Figure 2: Excavating along release extent viewing northwest from the south wall of sample S-09. GPS: 32.4490083 N, -103.6033694 W. Date/Time: 2019-09-04 15:02:18**

If soil confirmation sample results exceeded 600 mg/kg chloride at the excavation walls, the excavation wall was extended horizontally and resampled. Horizontal excavation continued until subsequent laboratory confirmation showed chloride below 600 mg/kg in the upper 4-feet.

Excavation depth was determined by 5-point composite sampling of the base. Vertical excavation continued until the base of the excavation exhibited chloride less than 600 mg/kg at 5.5 feet bgs or less. Below 4-feet, allowable chloride concentrations per Table 1 of 19.15.29 NMAC is  $<20,000$  mg/kg.

Excavated soil was transported to R360 for proper disposal. Clean backfill soil was purchased from Merchant Livestock Company under a Surface Use Agreement.

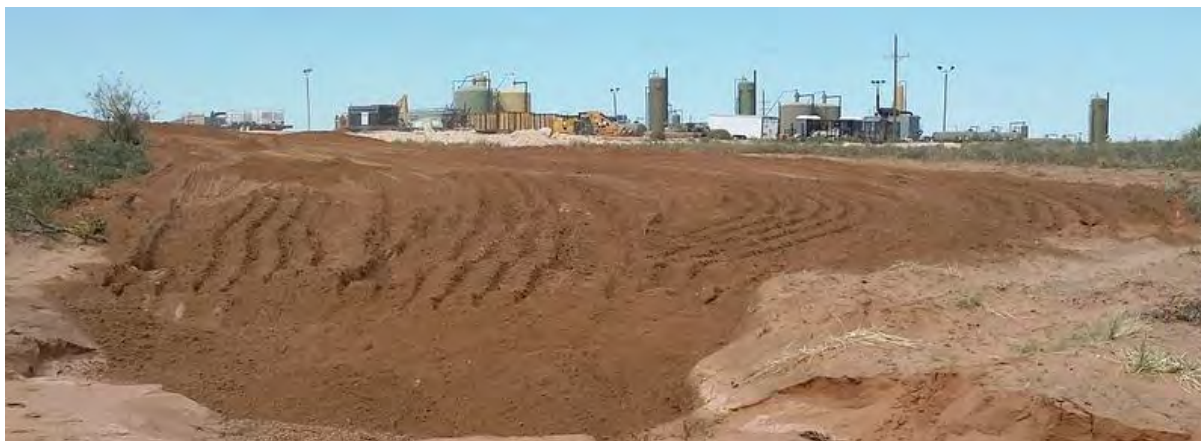
**Figure 3: Final reclamation and restoration. Photo is viewing northwest from S-0X. Date/Time: 2019-10-15 11:51:26. GPS: 32.4491920 N , -103.6033783 W.**

Figure 3, below, shows final restoration after seeding and surface contouring to blend with the surrounding topography.

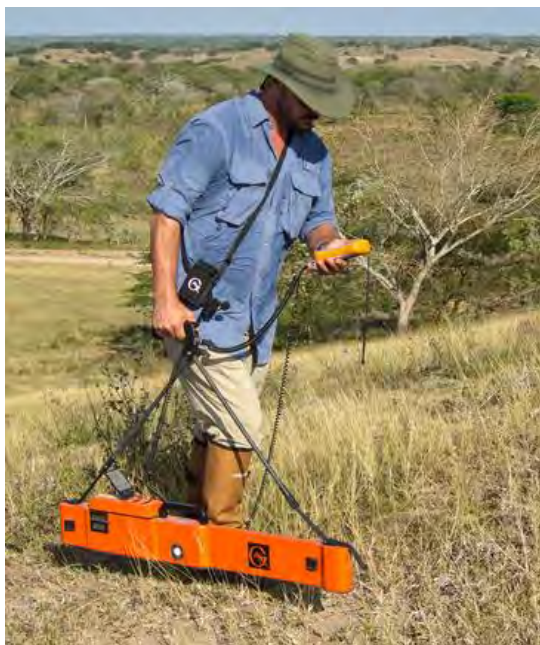
**Exhibit 1: Measuring EC with the EM38 in the vertical position.**

Electromagnetic surveys (EM Survey) are commonly used to measure electrical conductivity (EC, “soil salinity”) in soils. Employing a Geonics EM38 (Exhibit 1), field personnel can effectively delineate the horizontal extent of a produced water release by measuring EC and monitoring for EC changes between background and higher EC readings. Increasing EC measurements suggest that the edge of the release extent is approaching.

The EM38 detects EC from the surface to a depth of approximately 4-feet. EC measurements can be obtained in the vertical or horizontal positions. In the vertical position, EC readings are weighted toward the lower depths of 3 to 4 feet. In the horizontal position, EC readings are weighted toward the upper 0 to 2 feet. If a higher EC reading is obtained in the horizontal position than the vertical position, produced water has likely impacted the upper surface more than at lower depths. If a higher EC reading is obtained in the vertical position than the horizontal position, produced water has likely impacted lower soils than the upper surface soils.

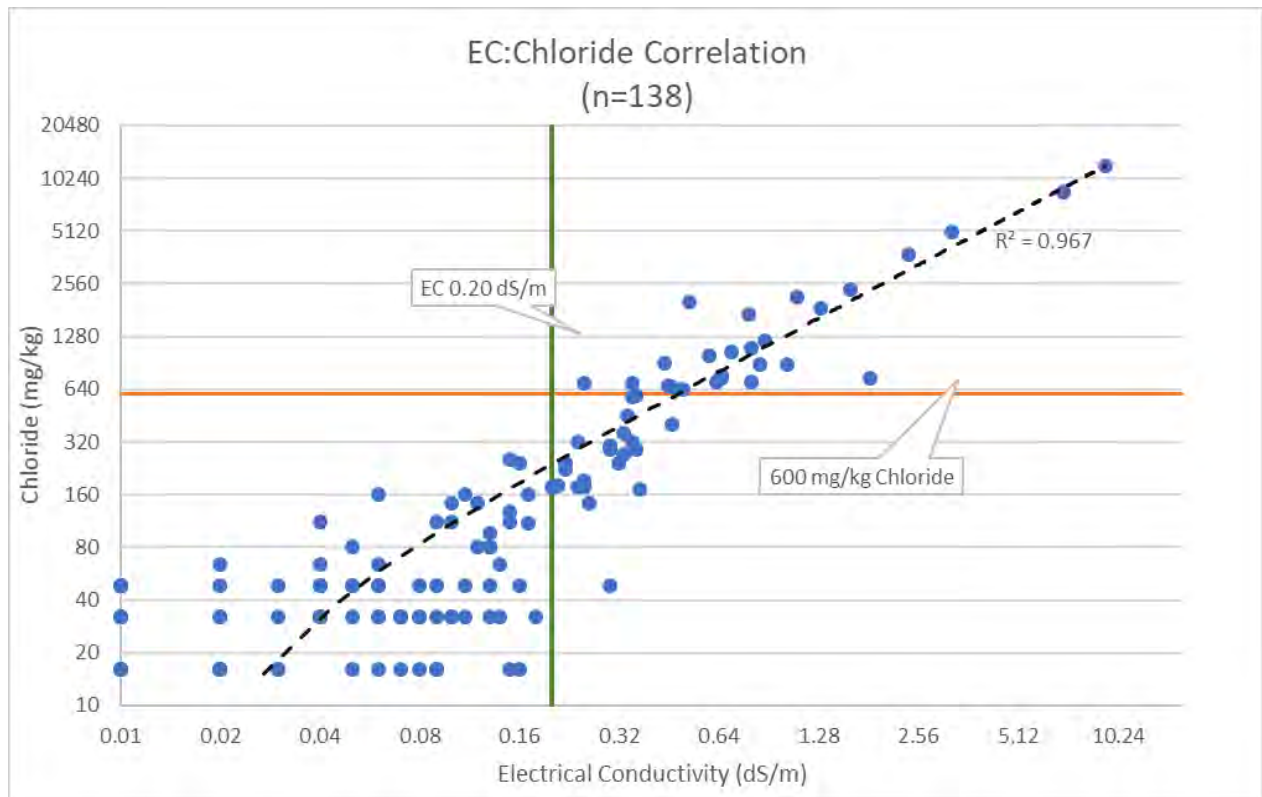
Analysis of data shows that an EC values greater than 0.20 dS/m is the delineation threshold where chloride in soil has a potential to be greater than 600 mg/kg. Furthermore, field personnel can survey a release and identify “hot spots” with the highest EC readings. These hot spots are likely areas where impacted to near surface soils (0 to 4 feet) from released produced water will be the greatest.
