# Site Characterization Report & Soil Closure Request

## COG Operating, LLC Glacier Fed Com #001H

Eddy County, New Mexico  
Unit Letter H, Section 16, Township 26 South, Range 25 East  
Latitude 32.04431 North, Longitude 104.39409 West  
NMOCD Reference No. 2RP-5568

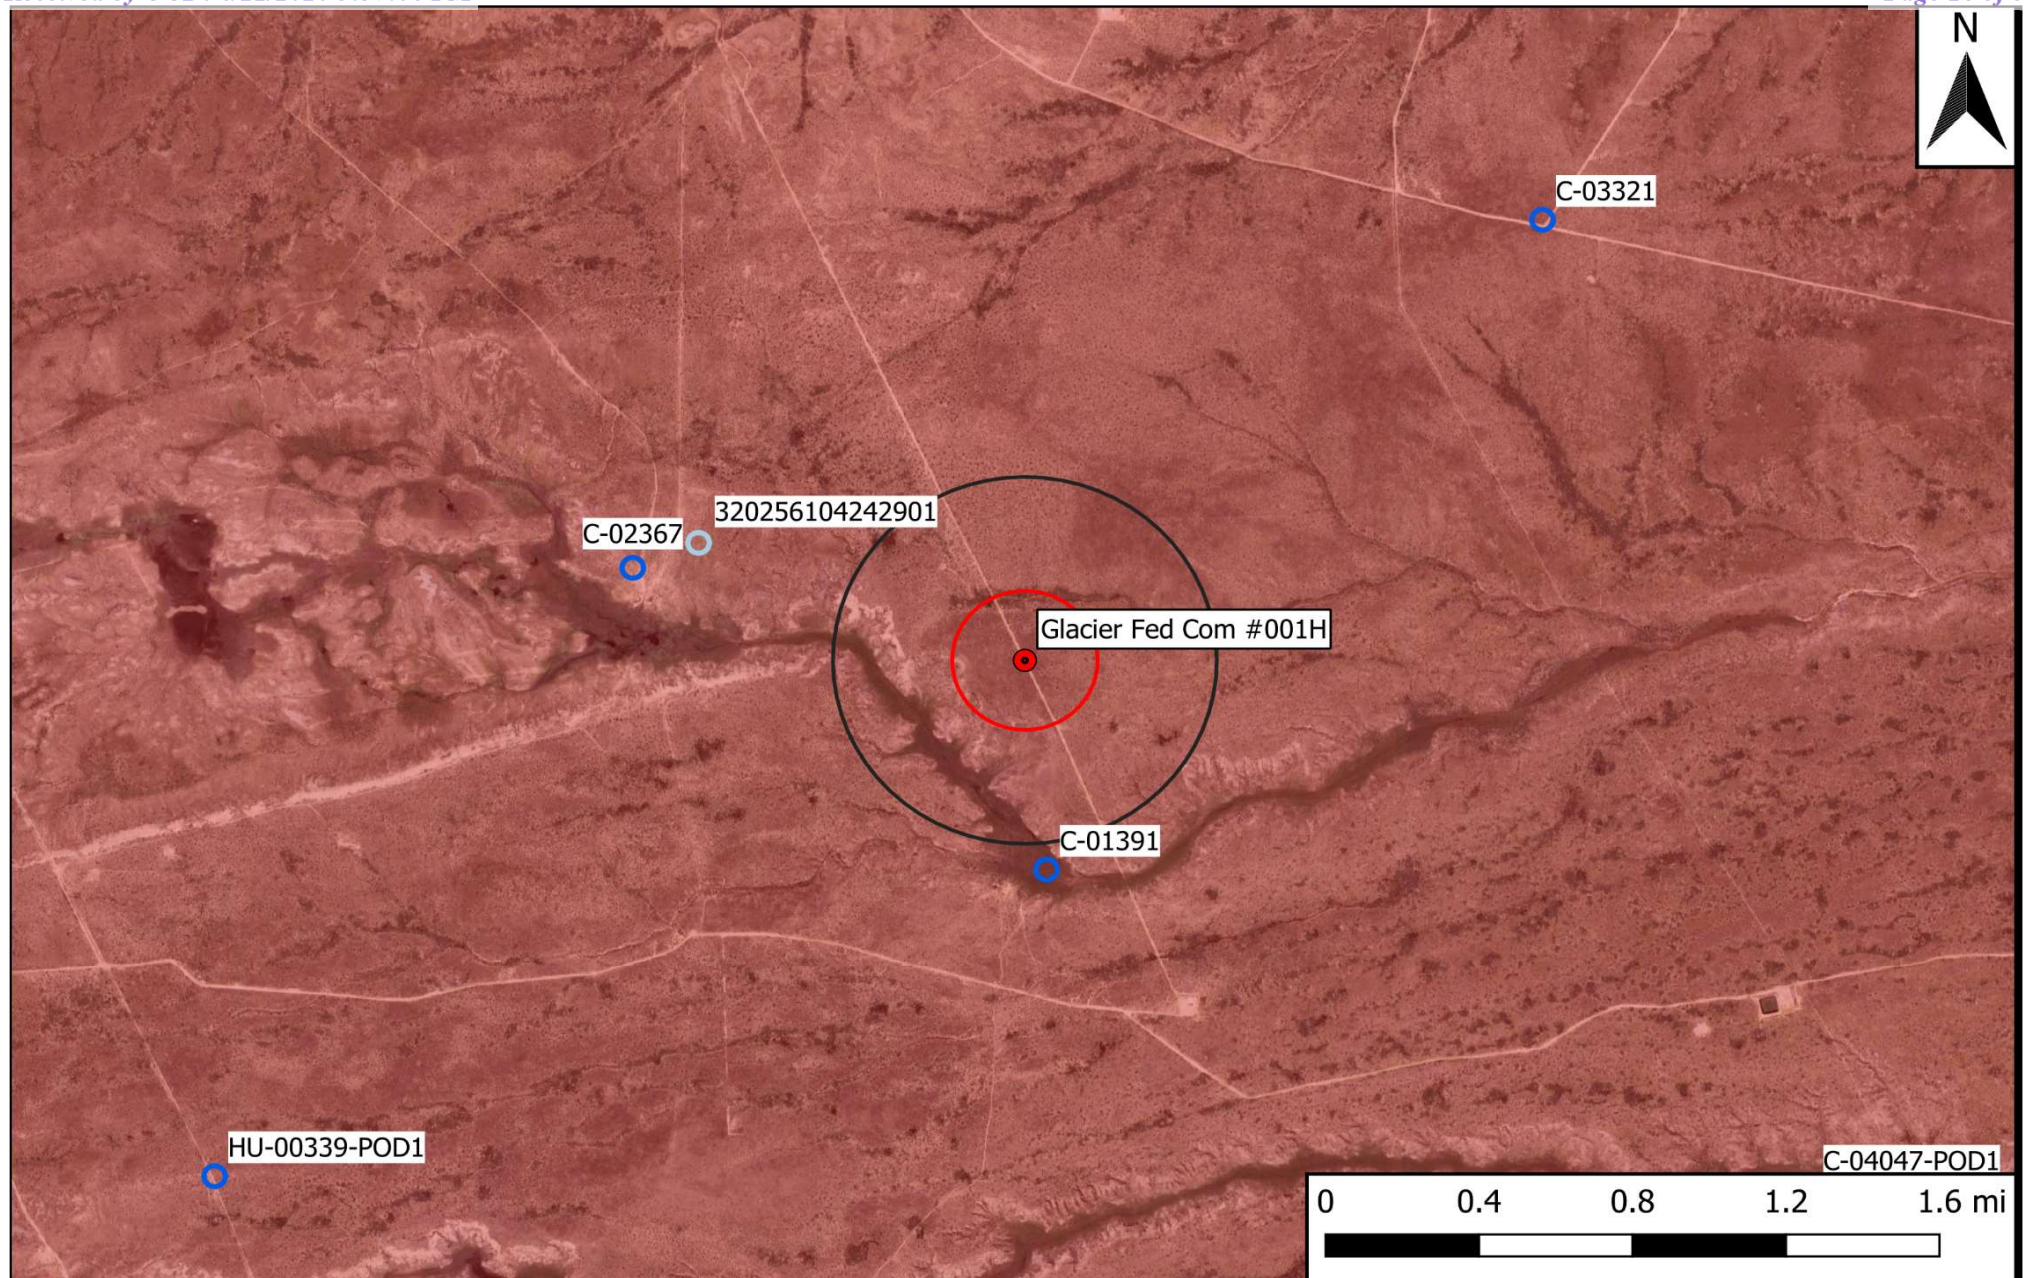
## **Figure 2**

NMOCD Siting Criteria data was gathered from available resources including Bureau of Land Management (BLM) shapefiles; topographic maps; NMOSE and USGS databases; and aerial imagery. The results are depicted on Figures 1 & 2.

### **Aerial Proximity Map**

**Figure 2**  
 Aerial Map  
 COG Operating, LLC  
 Glacier Fed Com #001H  
 GPS: 32.04431, -104.39409  
 Lea County

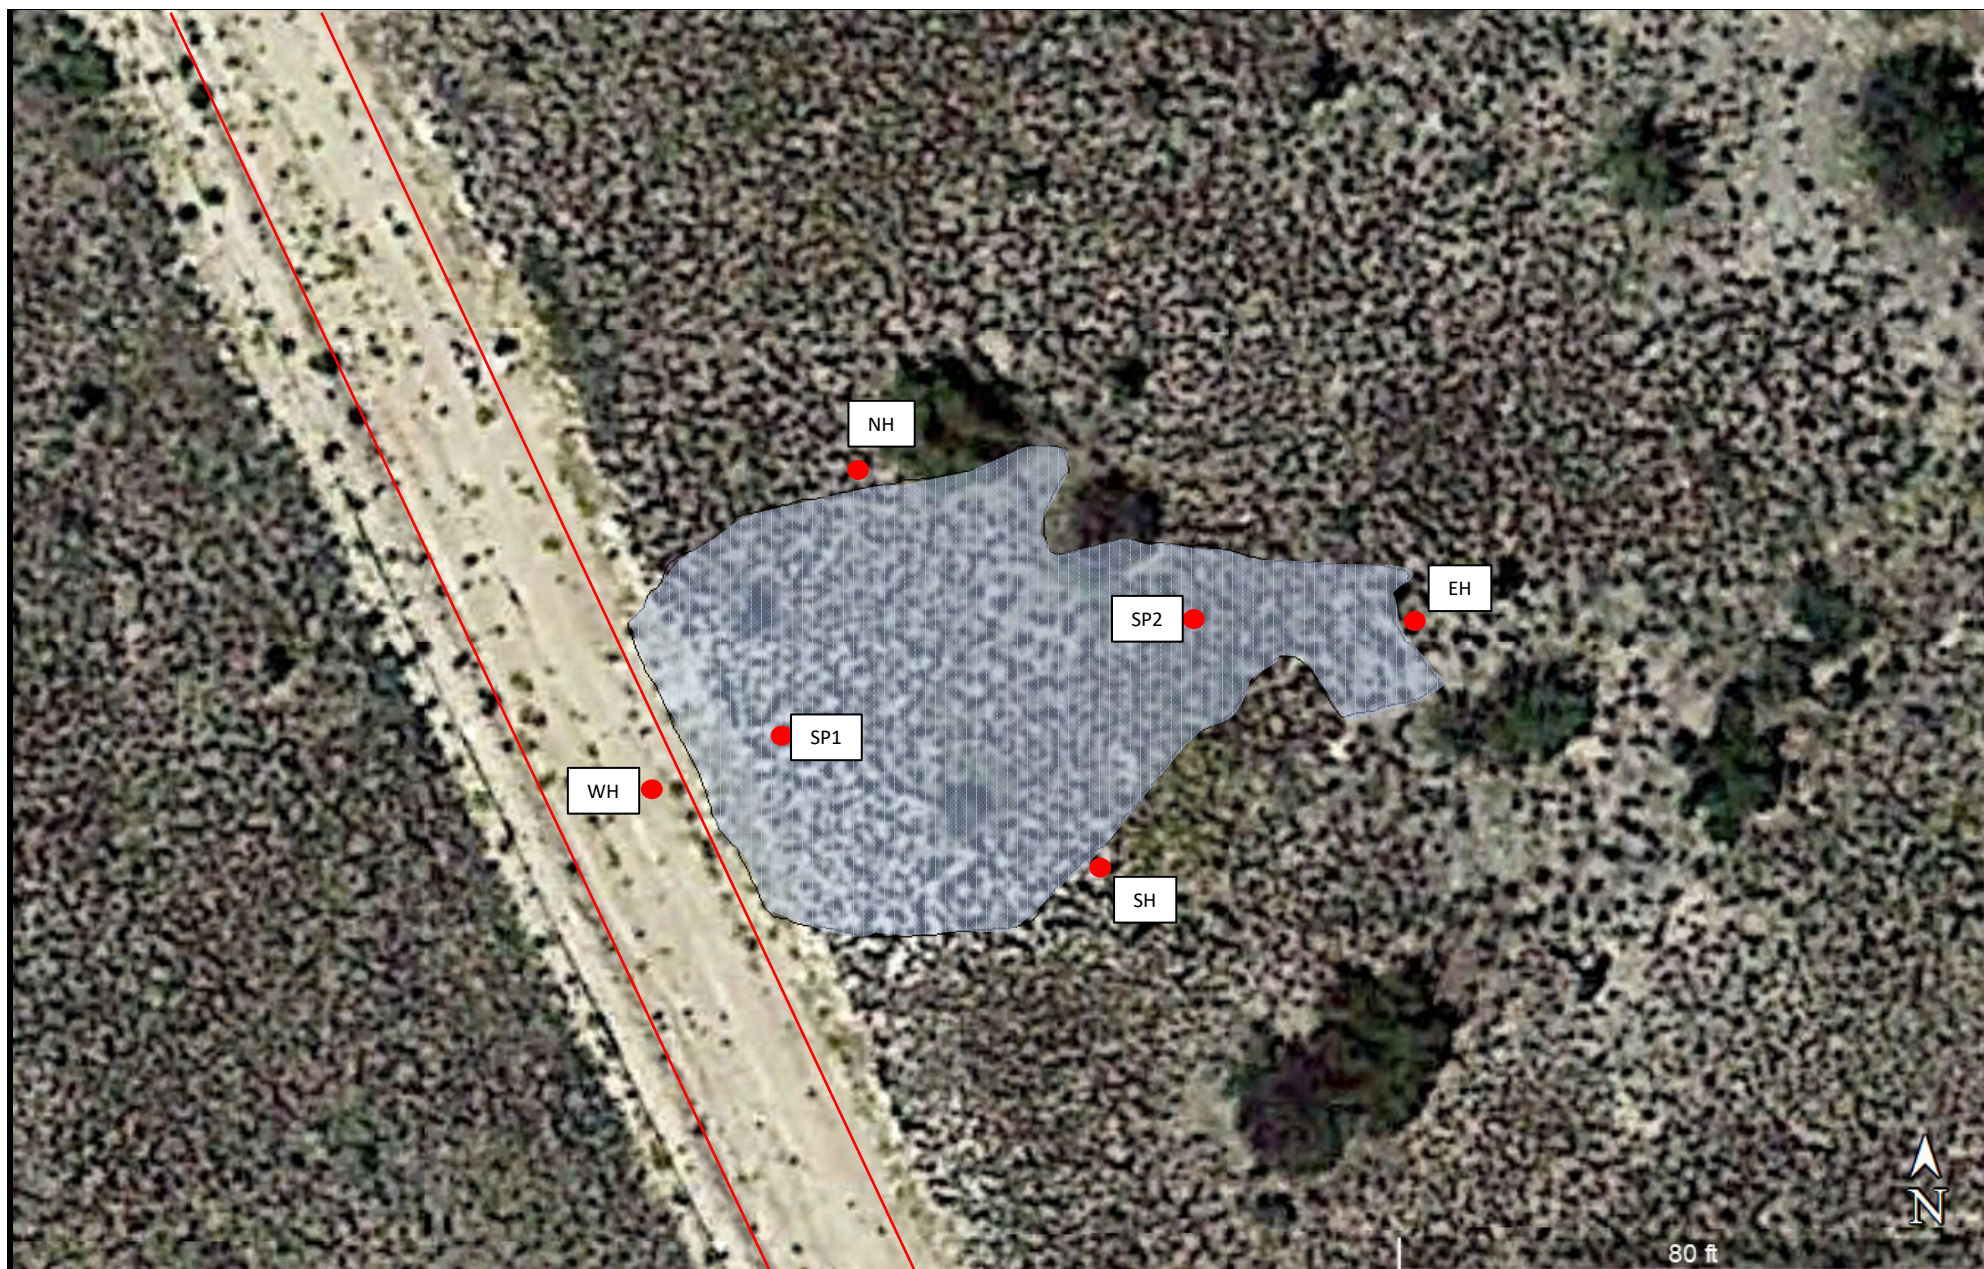
# **Figure 3**

On December 18, 2019, Etech conducted an initial site assessment. During the initial site assessment, a series of hand-augered soil bores ( were advanced within the release margins in an effort to characterize impacts from the release and determine the vertical extent, if any. In addition, hand-augered soil bores were advanced at the inferred edges of the affected area in an effort to determine the horizontal extent of soil impacts. During the advancement of the hand-augered soil bores, field soil samples were collected and field-screened for the presence of chloride concentrations utilizing a Hach Quantab ® chloride test kit. A "Site & Sample Location Map" is provided as Figure 3. Field data and soil profile logs, if applicable, are provided as Appendix B.

Based on field observations and field test data, **fourteen (14)** confirmation soil samples (NH@Surface, NH@1, EH@Surface, EH@1, SH@Surface, SH@1, WH@Surface, WH@1, SP1@Surface, SP1@1, SP1@2, SP2@Surface, SP2@1, and SP2@2) were submitted to the laboratory for analysis of BTEX, TPH and/or Chloride. Laboratory analytical results indicated soil was not affected above the NMOCD Closure Criteria and/or NMOCD Reclamation Standard. A "Soil Chemistry Table" is provided as Table 1. Laboratory Analytical Reports are provided in Appendix C.

Based on laboratory analytical data, soil within the affected area has not been impacted above NMOCD Closure Criteria and/or NMOCD Reclamation Standard. Based on those results soil has not been excavated from the affected area.

## **Site and Sample Location Map**

Site and Sample Location Map  
COG Operating, LLC  
Glacier Fed Com #001H  
GPS: 32.04431, -104.39409  
Eddy County

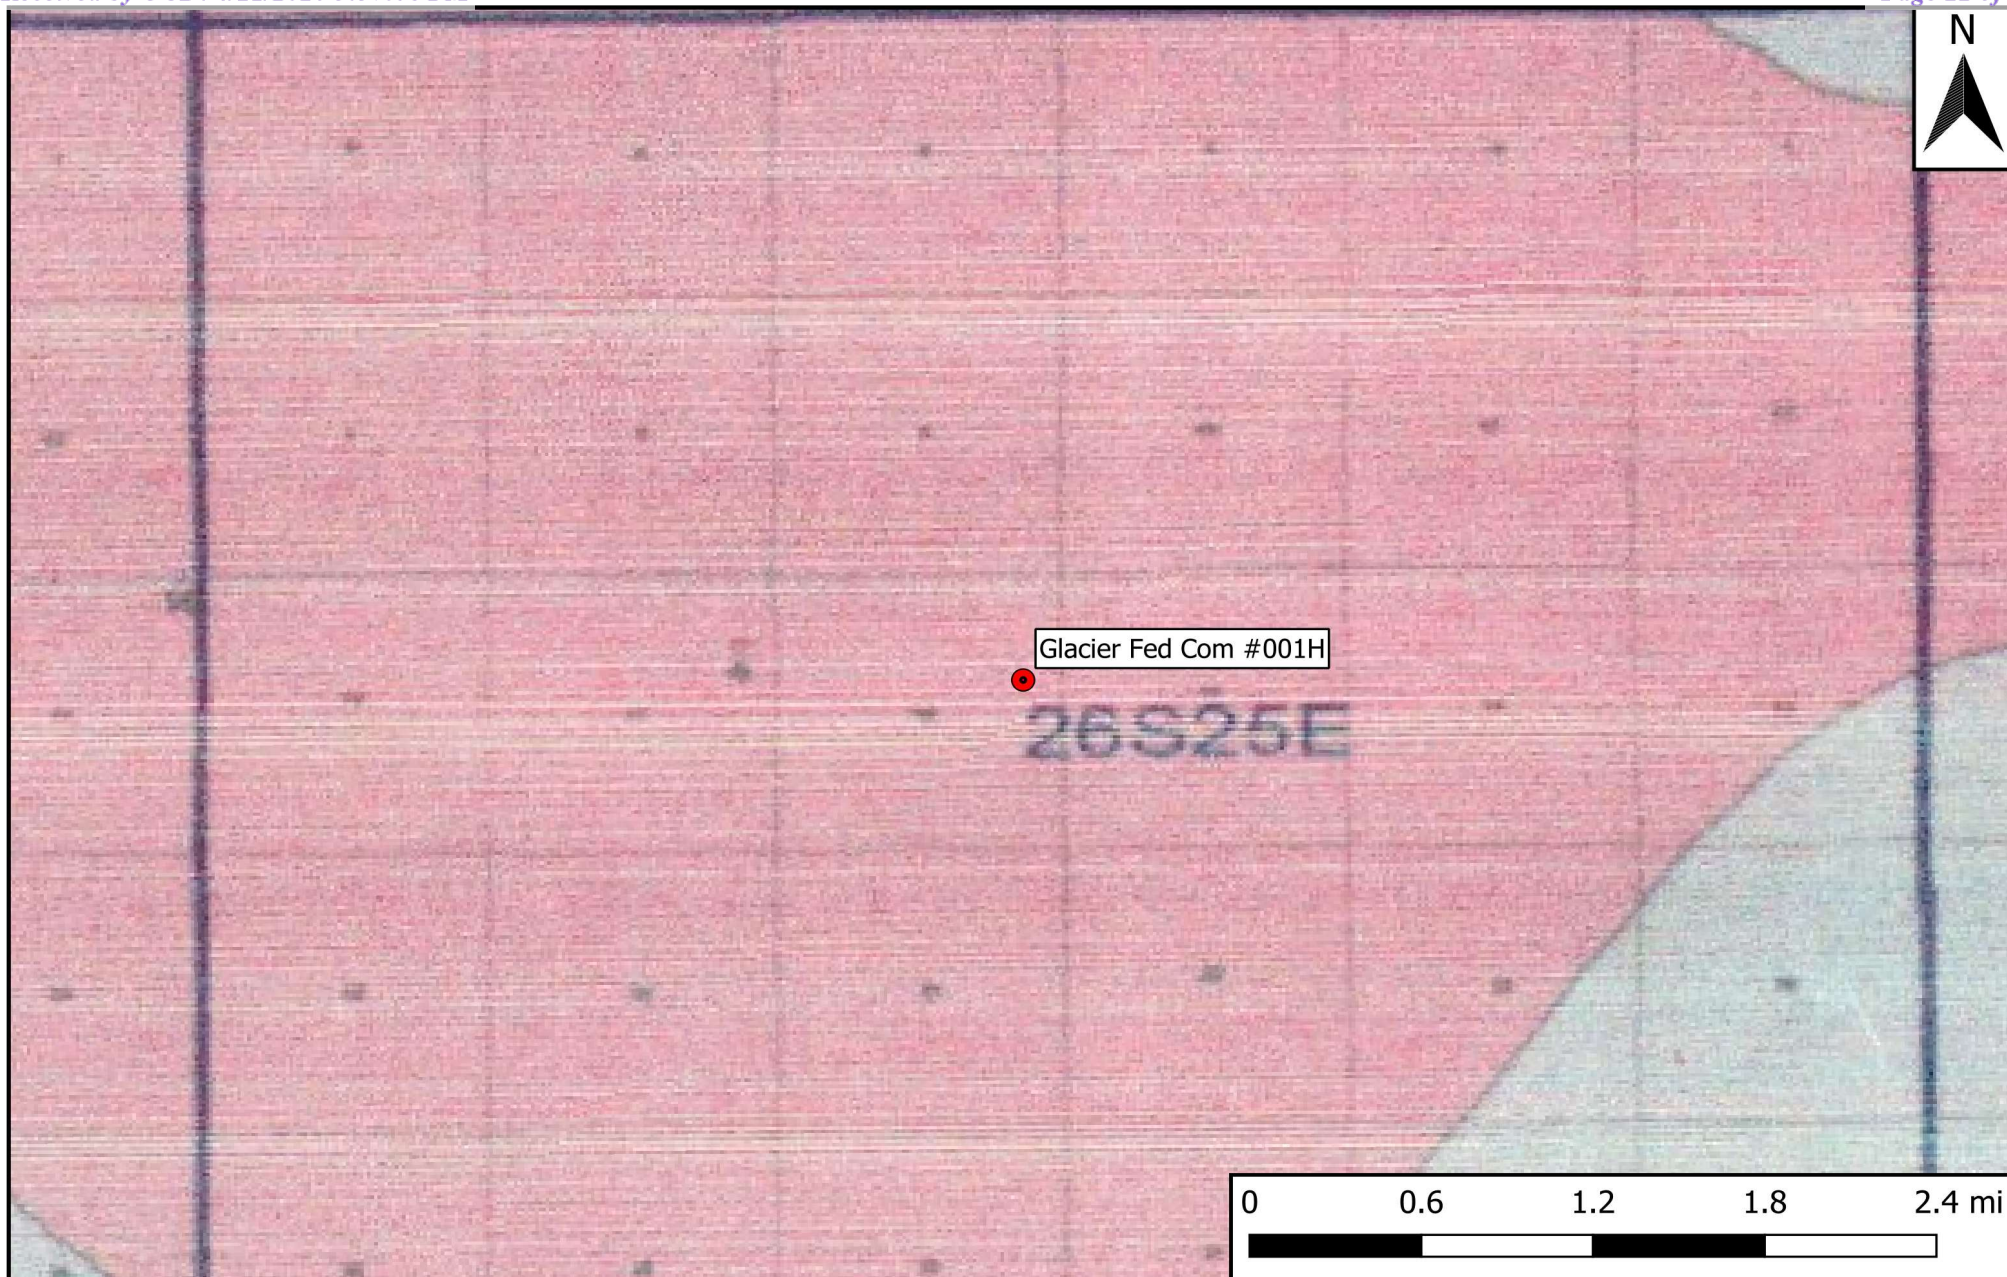
## Figure 4

Inferred Depth to Groundwater Trend Map  
COG Operating, LLC  
Glacier Fed Com #001H  
GPS: 32.04431, -104.39409  
Lea County

Average Depth to Water: **31 feet**
