M&M Excavating, Inc. (MMX) has prepared this Closure Report for Devon Energy Production Company that describes the delineation and remediation of two releases of liquid at the Cotton Draw 10 Federal Com #002H site (2RP-4604 & 2RP-5481). The site is in Unit A, Section 10, Township 25S, Range 31E, Latitude 32.15150, Longitude -103.75878, Eddy County, New Mexico, on Federal land. Figure 1 provides the vicinity and site location on an USGS 7.5-minute quadrangle map.

Regional Vicinity & Wellhead Protection Map  
 Cotton Draw 10 Federal Com #002H - Devon Energy  
 Sec 10 T25S R31E Eddy County, New Mexico

Site & Sample Locations  
Cotton Draw Unit 10 Federal Com 2H- Devon Energy  
Eddy County, New Mexico

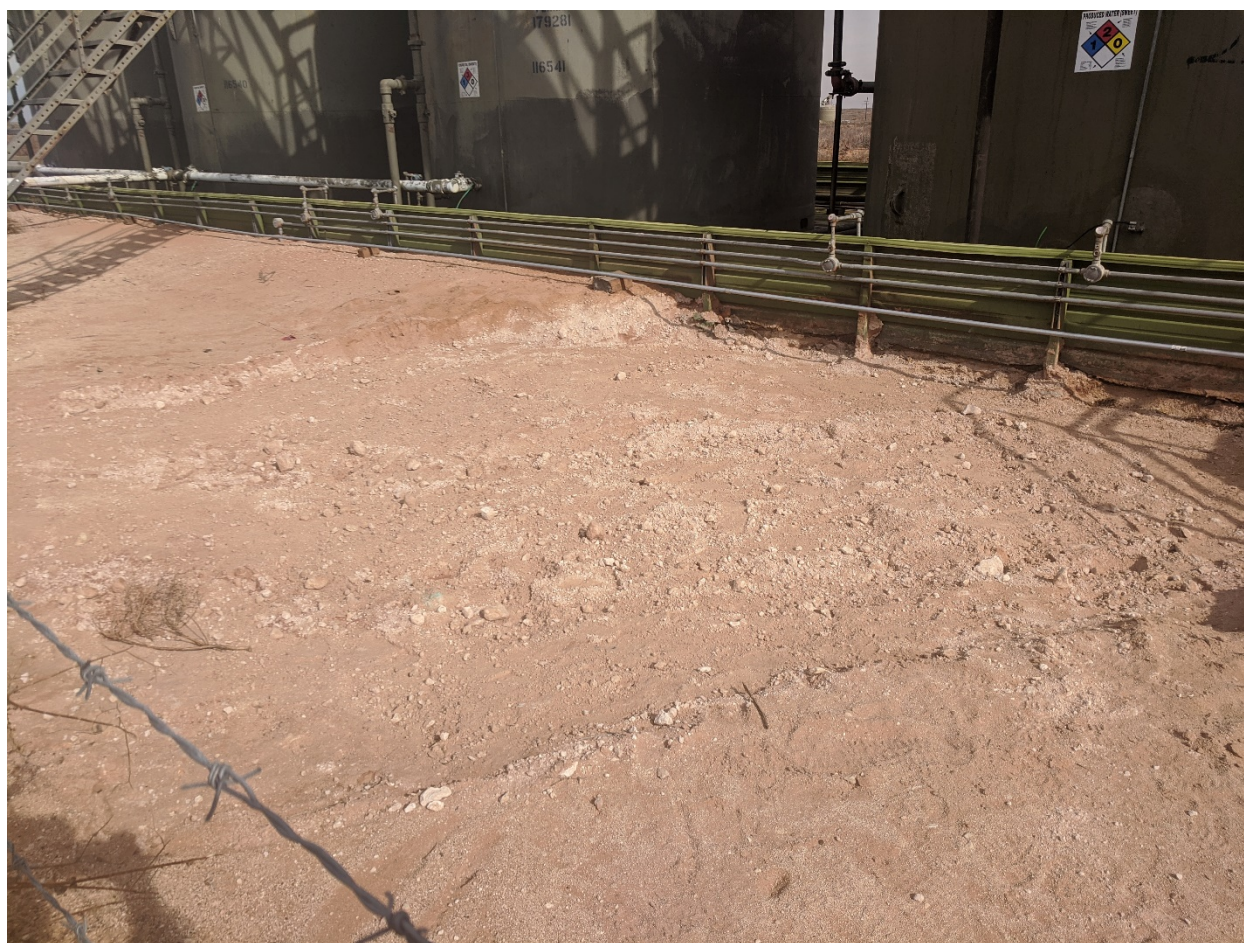
Photo of excavation facing northeast

Contaminated soils were removed and replaced with clean backfill material to return the surface to previous contours. The contaminated soil was transported and disposed of at an NMOCD permitted disposal facility. Georeferenced photos are included in Appendix D.

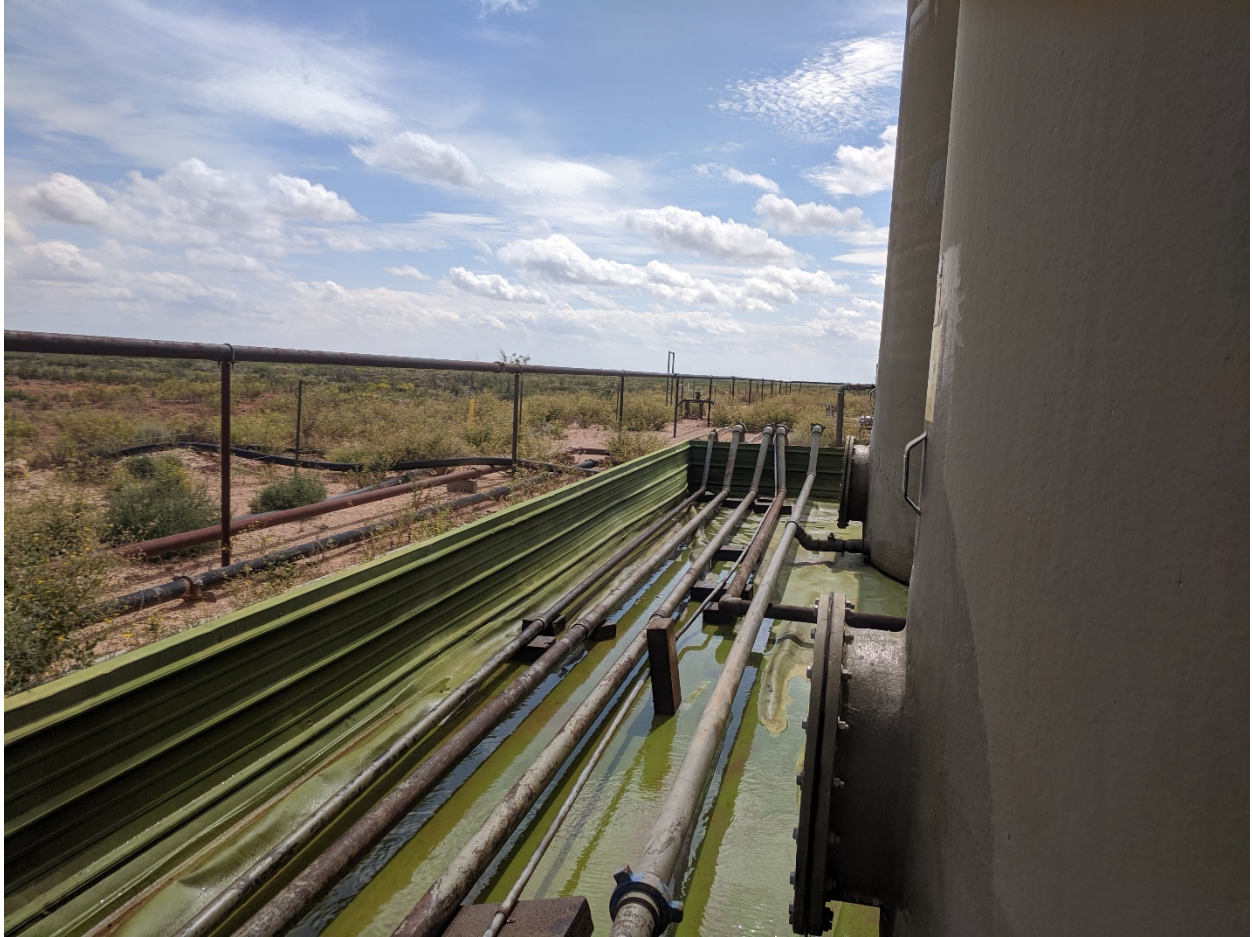
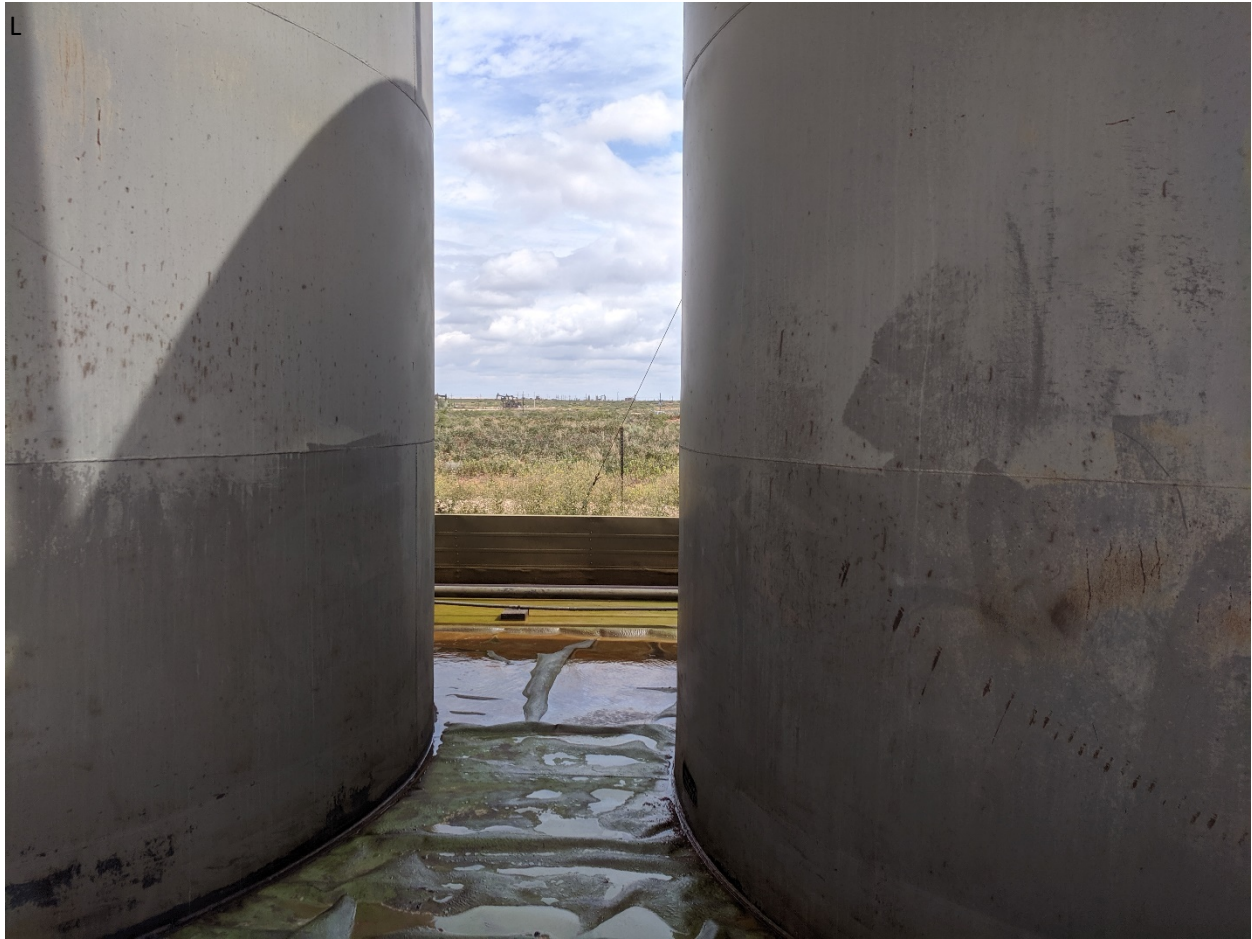
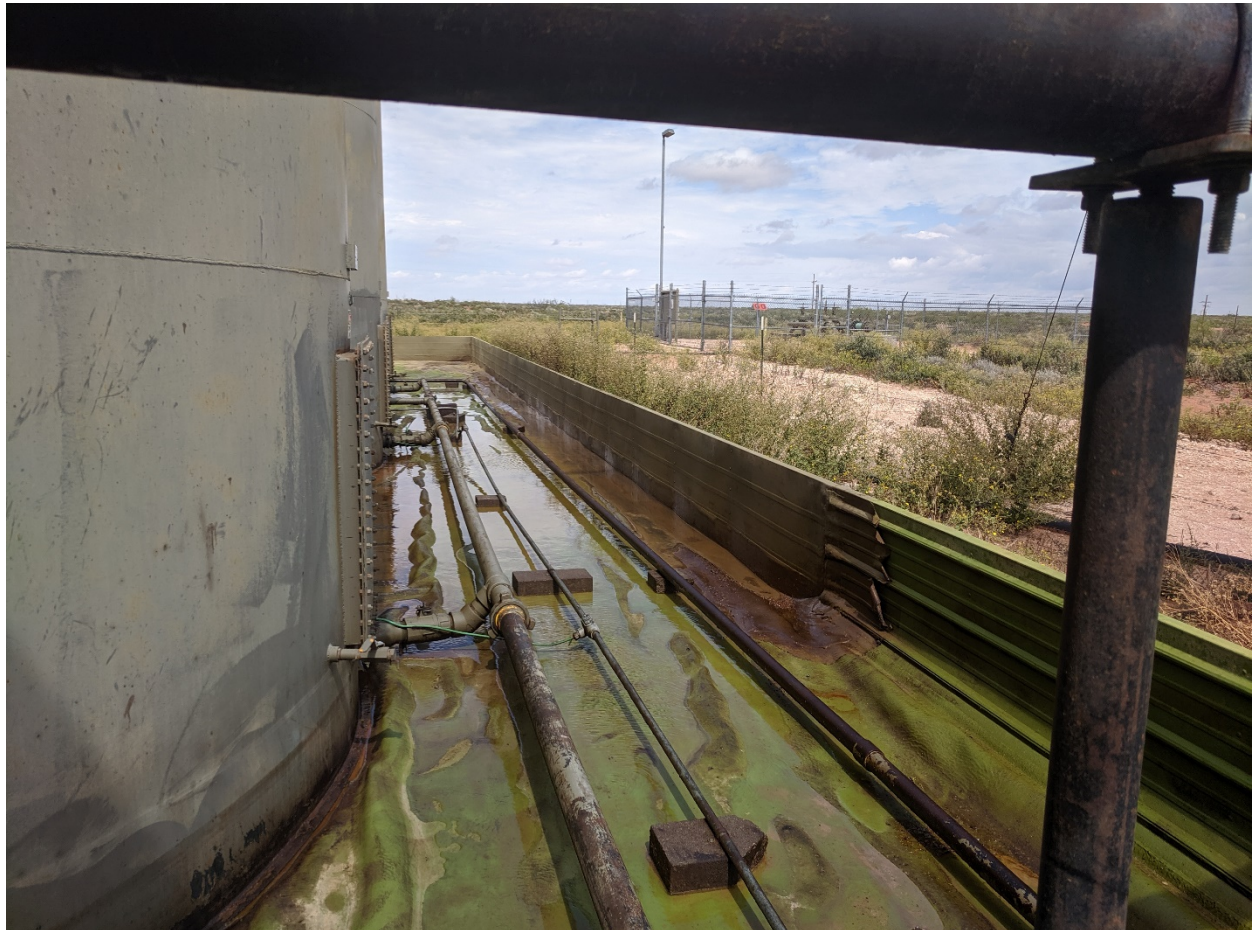
9/30/2019 Liner Inspection Photo Log

On September 30, 2019, MMX personnel arrived on site in response to the releases associated with Cotton Draw 10 Federal Com #002H. MMX collected initial soil samples around the release site and conducted a liner integrity inspection within the containment. No failures were observed in the liner. Photos of the liner inspection are included in Appendix D.
