Christmas #28 Battery

Closure Report

1RP-5132 Release Date: 07/09/2018 U/L H, Section 28, Township 22S, Range 37E

Subject: Closure Request for Grizzly Energy, LLC - Christma: 28 Battery

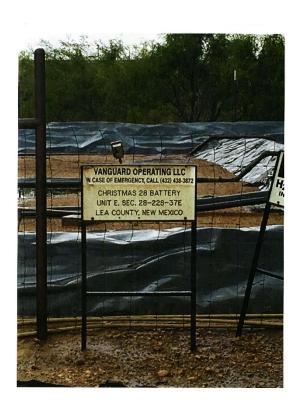
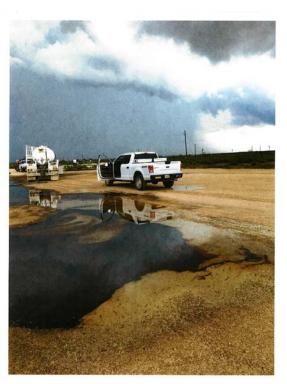
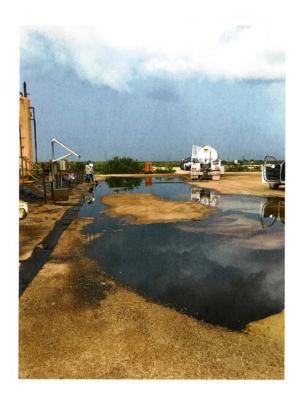
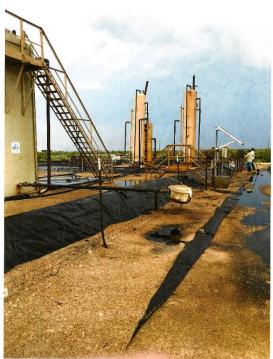
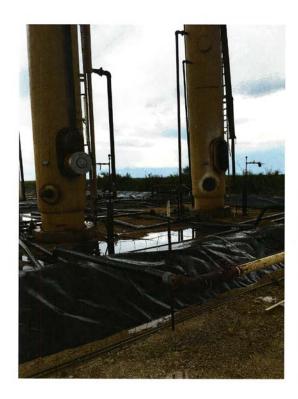
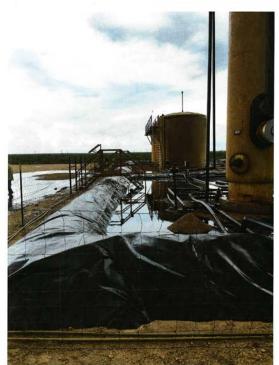
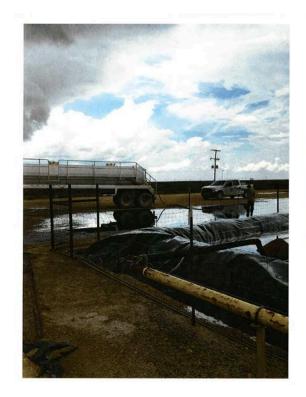
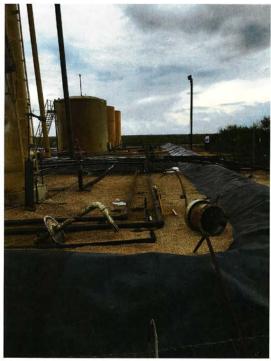
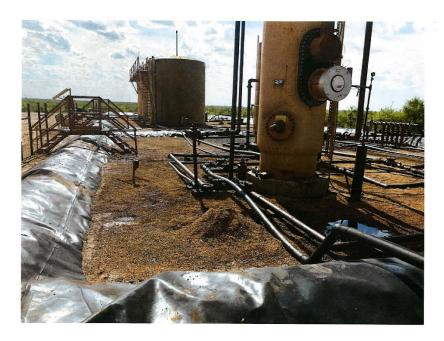
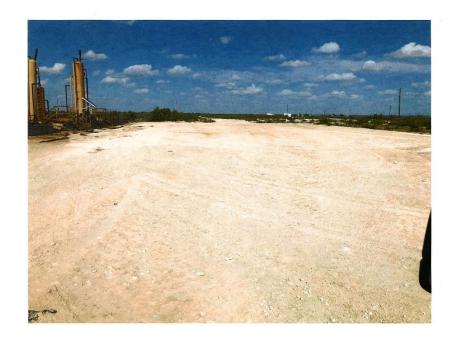
GRIZZLY CHRISTMAS 28 BATTERY BEFORE PHOTOS – RELEASE DATE 07/09/2018

This site is located in Lea County, New Mexico. The release was located on July 9th, 2018. It was discovered by a NMOCD Inspector while checking surface casing pressures on wells. NMOCD notified Grizzly (Vanguard) of their findings. The automatic valve on the gas purchaser line closed causing the Heater Treater to pressure up and pop off through the relief valve. Oil sprayed an area inside of the lined containment and in front of the tank battery just outside of the containment. Approximately 11 bbls of oi was released and 10 bbls of standing fluid was recovered. The released fluid was also mixed with rain water. The soil outside of the containment was blended in place with new caliche to soak up the remaining fluid after the vacuum truck left the location. The area of impact was 3,242.025 sq. ft. The corresponding C-141 for the release is attached.

Due to the low to none detected levels of the vertical and horizontal area no further action was needed. Crews hand dug the pea gravel from inside the facility. With the vertical sample confirmations from Envirotech Laboratory, it was determined that 6" of contaminated soil would be dug out, stockpiled on plastic and hauled to a disposal site from the lined containment. The spray area was back-dragged and contoured because the sample concentrations were under the site closure requirements, therefore no composite samples were taken. On February 14th, 2020, 20 yards of contaminated soil from inside the containment, was hauled to Lea Landfill Disposal Site. Liner inspection did not show any punctures, nicks or any compromising issues that would have compromised the integrity of the liner. Liner was then backfilled with pea gravel.
