## Grizzel B Central Tank Battery

# Closure Report

API No. 30-025-36228

1RP-5317

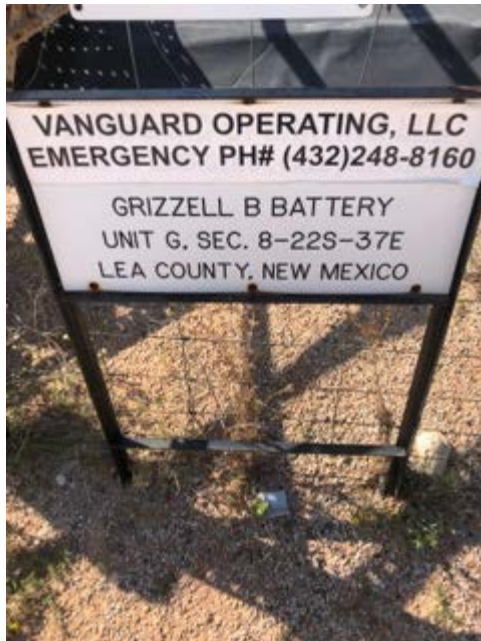
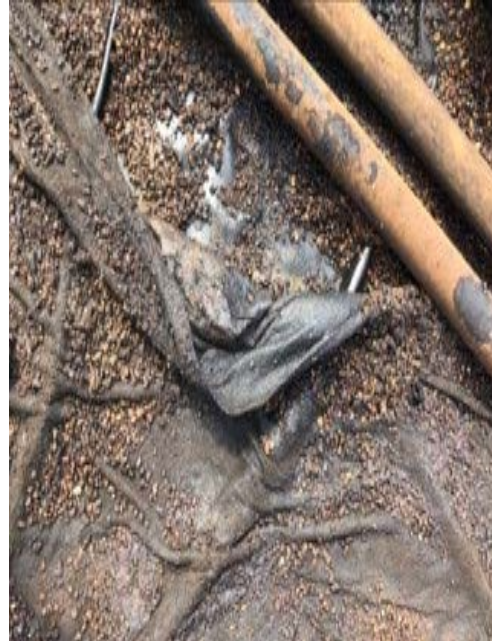
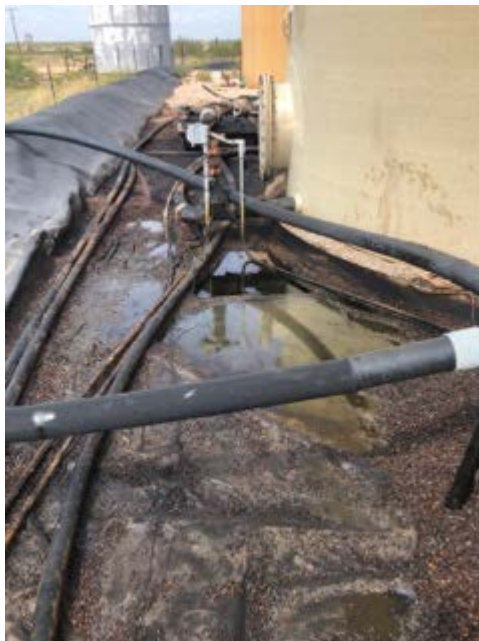
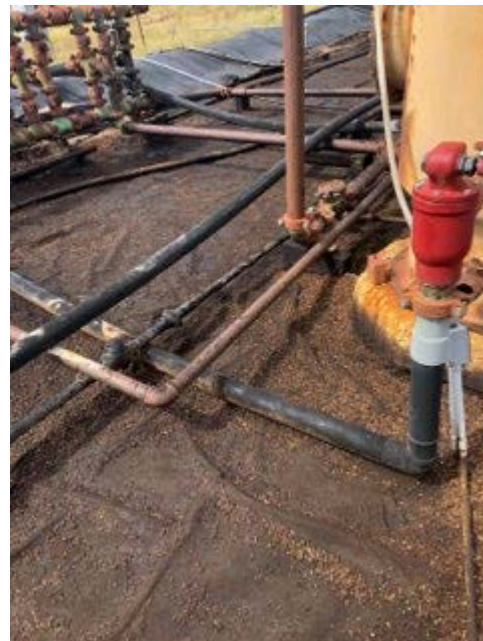
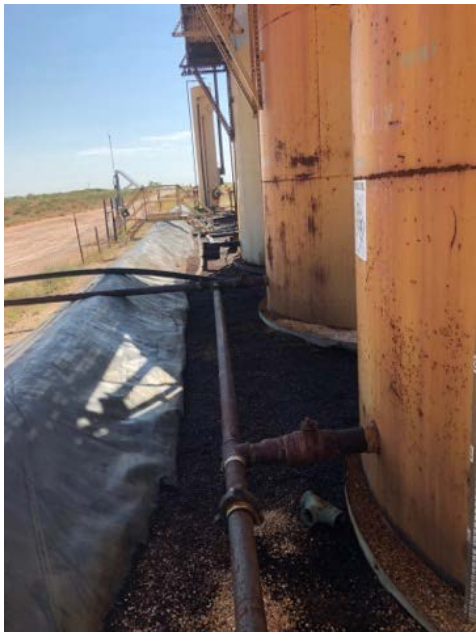
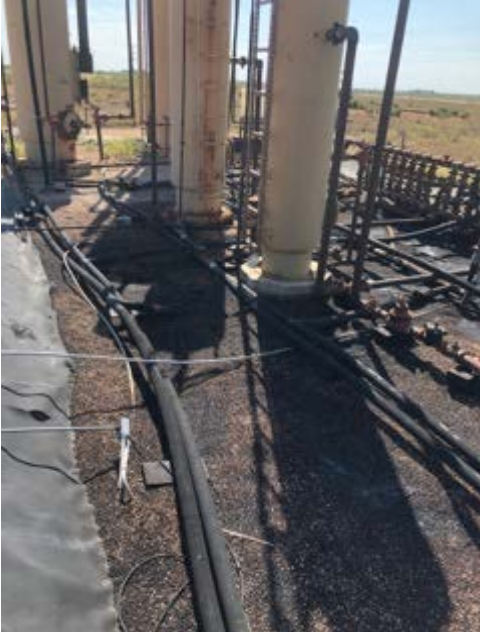
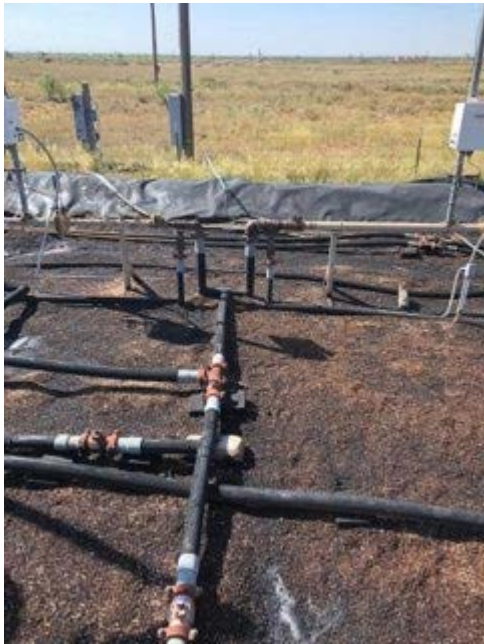
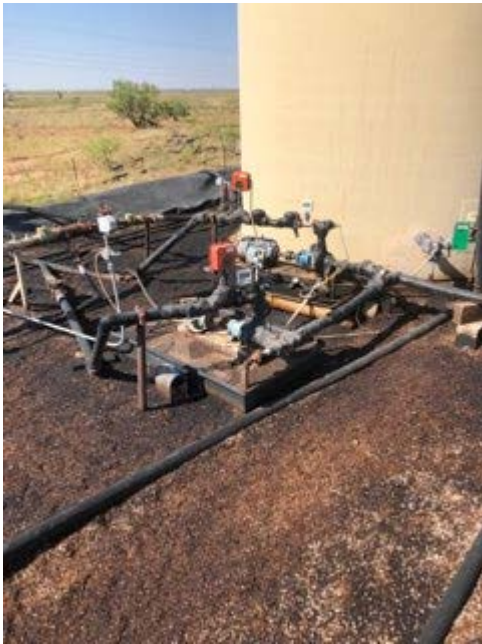
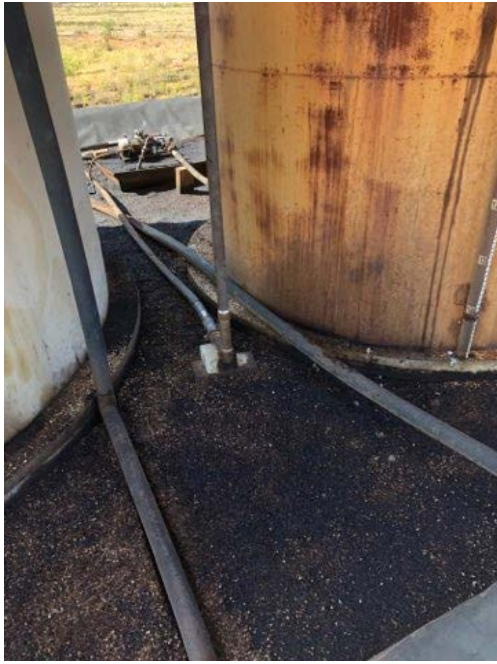
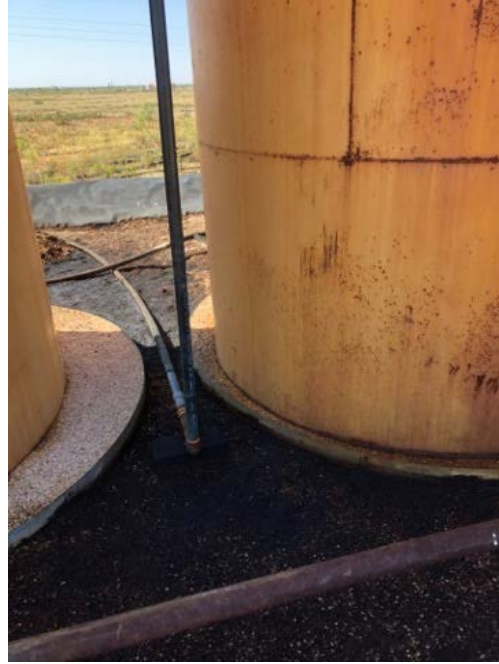
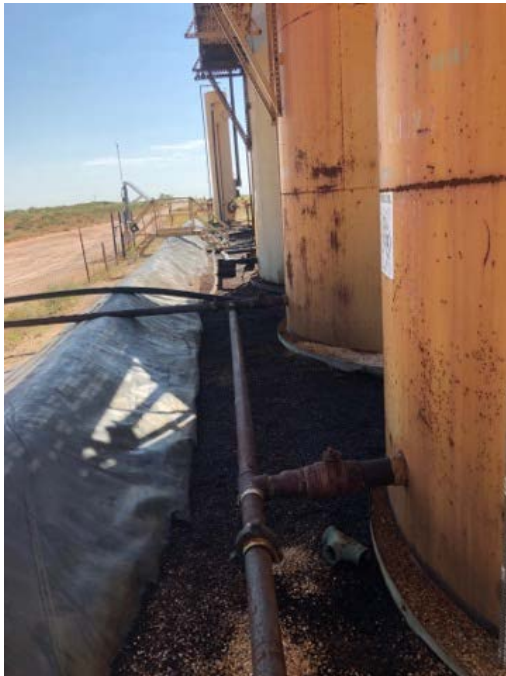
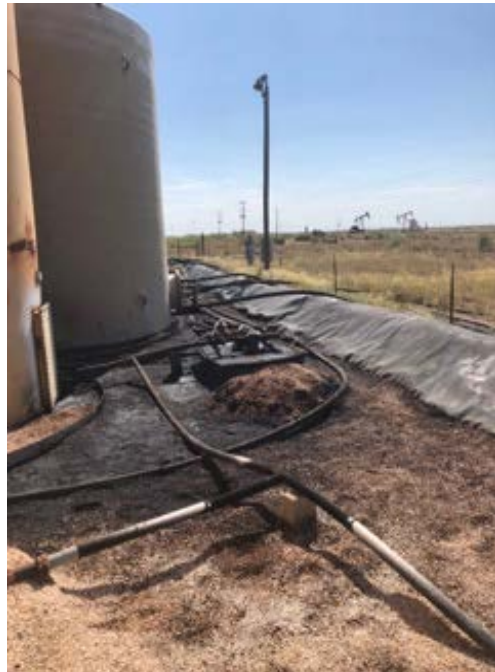
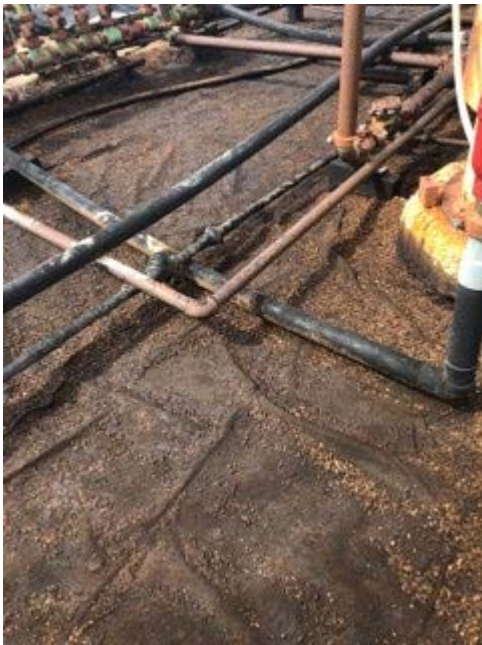
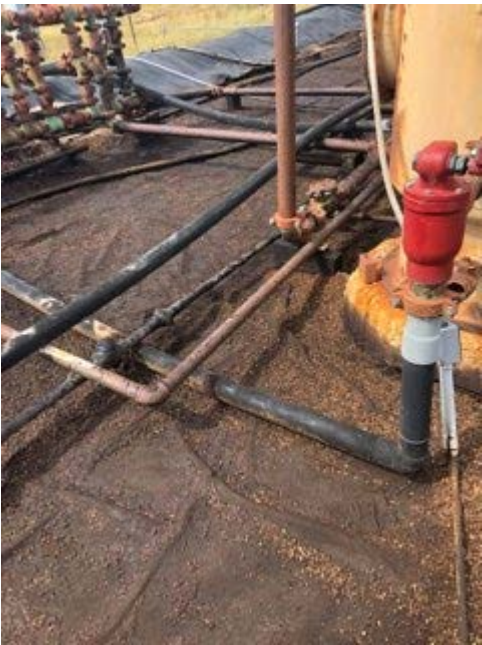
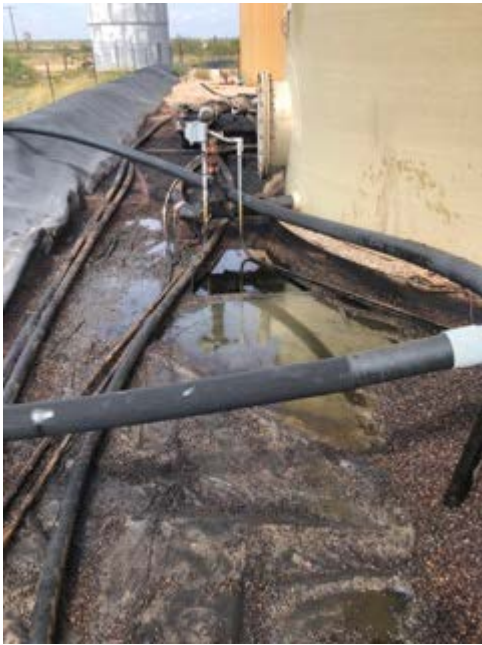
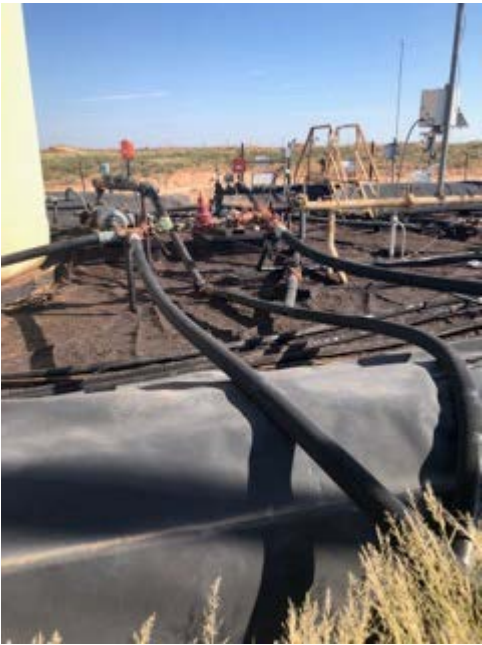
**GRIZZEL B BATTERY  
BEFORE & DURING PHOTOS – RELEASE DATE 12/14/2018**

This site is located in Lea County, New Mexico. The release was located on December 14<sup>th</sup>, 2018. The release was due to high winds that broke the power line to the battery causing the transfer pumps to fail. The tanks filled and overran into a lined containment. A vacuum truck removed the standing fluid and the line was repaired. A 35' x 50' area inside the containment was impacted. The corresponding C-141 for the release is attached.

High winds broke the power line to the battery causing the transfer pumps to fail. The tanks filled and overran into a lined containment. A vacuum truck removed the standing fluid and the line was repaired. A 35'X 50' area inside of the containment was impacted.

This was a lined earthen berm with a surface area of 4,384.86 sq. ft. A crew was sent to the site on 09/04/2019 to begin hand excavation of the impacted soil on top of the liner. Soil was stockpiled on plastic. On 09/09/2019 18 yds of contaminated material were loaded and hauled to Sundance Disposal. The liner was power washed, allowed to dry, then inspected revealing no obvious signs of perforation noted. 36 yds of 3/8" gravel was hauled in to backfill the location.

White Buffalo Environmental will remove the 2 inches of gravel/soil on top of the liner to inspect and power wash.
