February 13, 2020

Vertex Project #: 19E-00575-017

Spill Closure Report: Fighting Okra 18 CTB 3
Unit D, Section 18, Township 26 South, Range 34 East
County: Lea
Tracking Number: TBD

Prepared For: Devon Energy Production Company
6488 Seven Rivers Highway
Artesia, New Mexico 88210

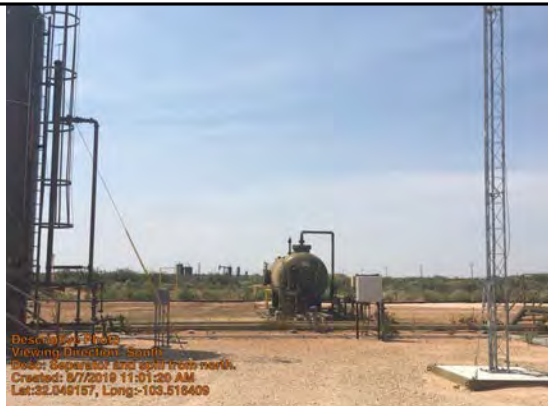
Viewing Direction: South

Separator and spill from north.

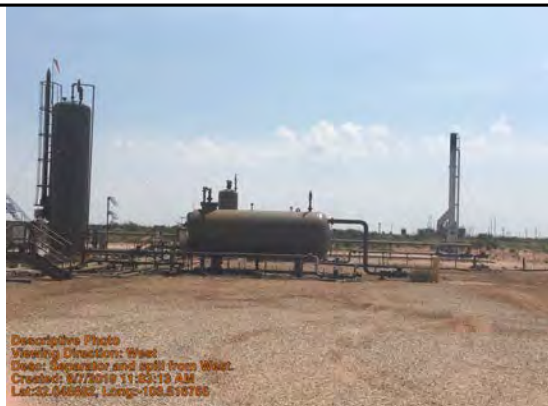
Viewing Direction: West

Separator and spill from West.

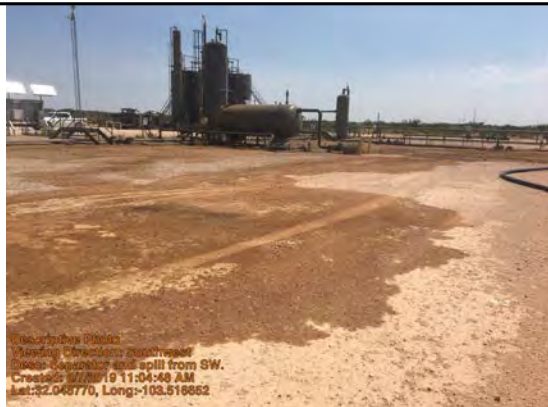
Viewing Direction: Southwest

Separator and spill from SW.

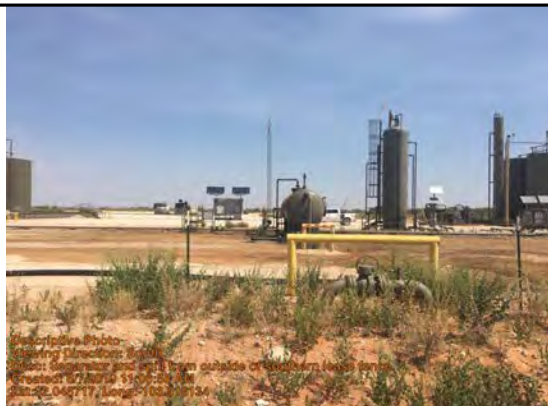
Viewing Direction: South

Separator and spill from outside of southern lease fence.

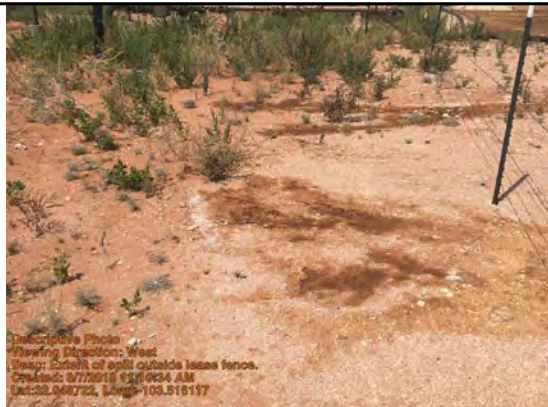
Viewing Direction: West

Extent of spill outside lease fence.

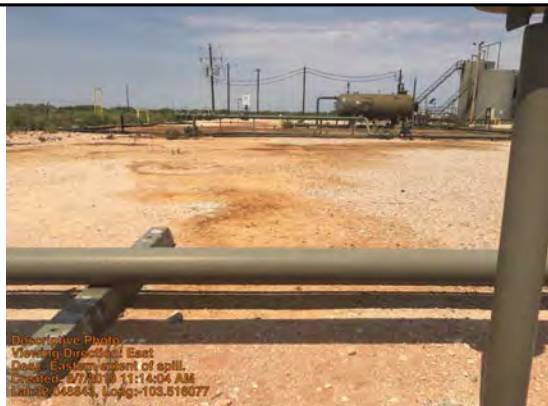
Viewing Direction: East

Eastern extent of spill.

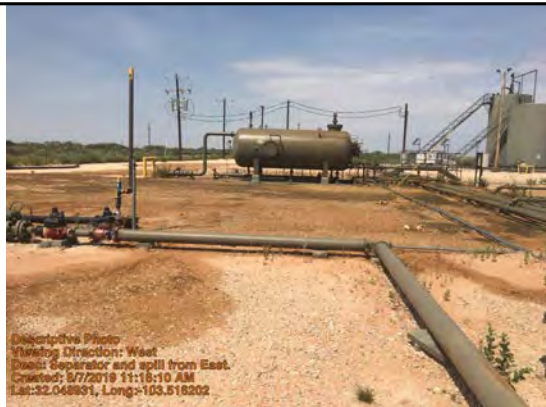
Viewing Direction: West

Separator and spill from East.

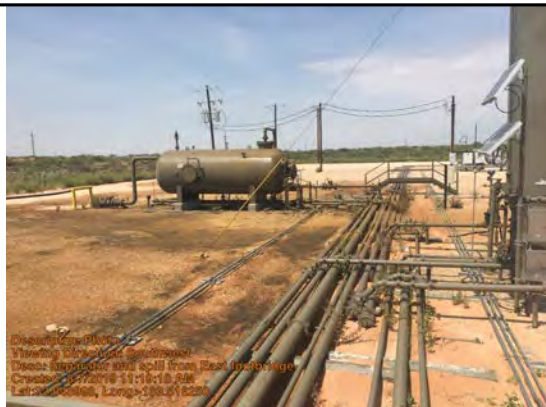
Viewing Direction: Southwest

Separator and spill from East footbridge.

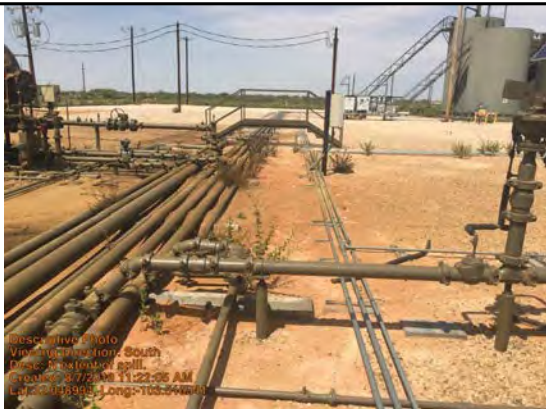
Viewing Direction: South

N extent of spill.

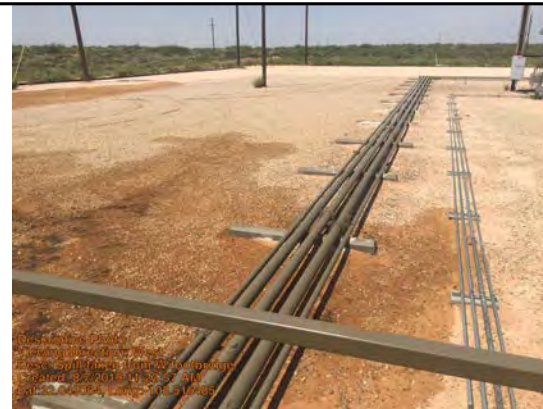
Viewing Direction: West

Spill taken from W footbridge.

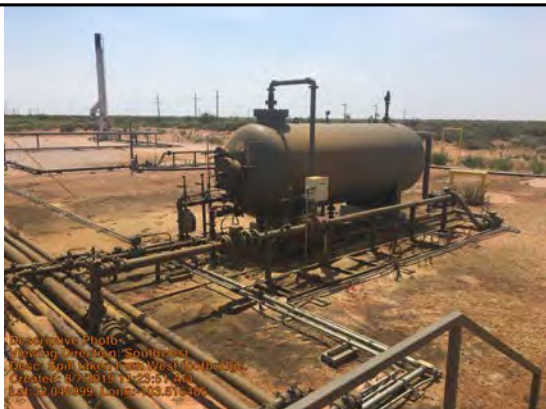
Viewing Direction: Southwest

Spill taken from West footbridge.

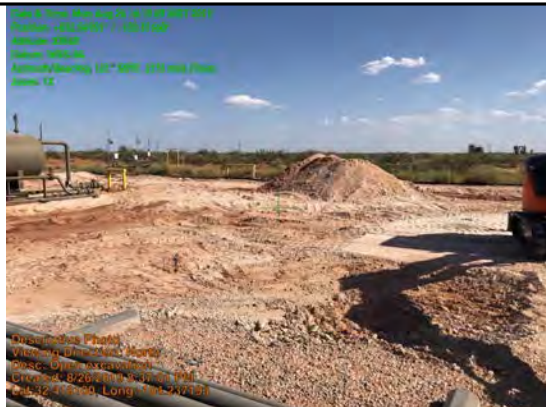
Viewing Direction: North

Open excavation

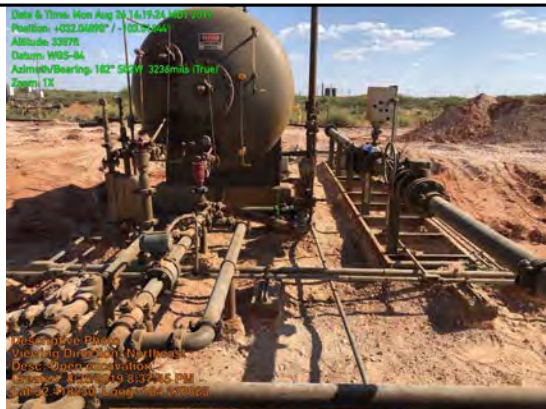
Viewing Direction: Northeast

Open excavation

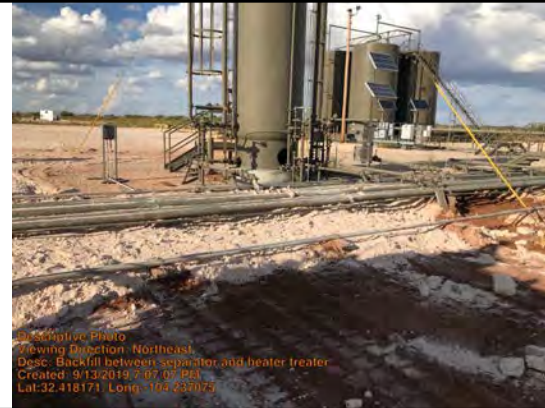
Viewing Direction: Northeast

Backfill between separator and heater treater

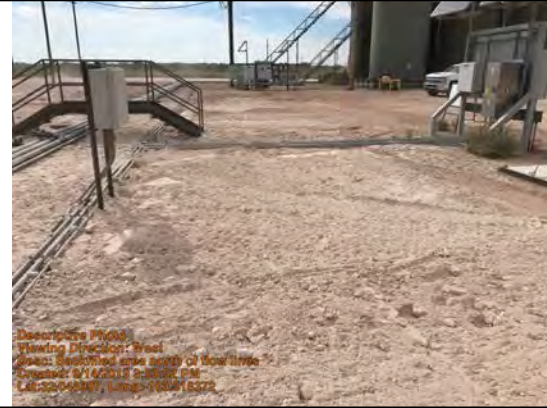
Viewing Direction: West

Backfilled area north of flow lines
