Release Notification

Site Name	BEU 156 (BEGS) CS	Site Type	Well Location
Date Release Discovered	12/04/2019	API# (if applicable)	30-015-35269 (Big Eddy Unit #156)

**RE: Closure Request
BEU 156 (BEGS) CS
Incident Number: NRM2002948523
Eddy County, New Mexico**

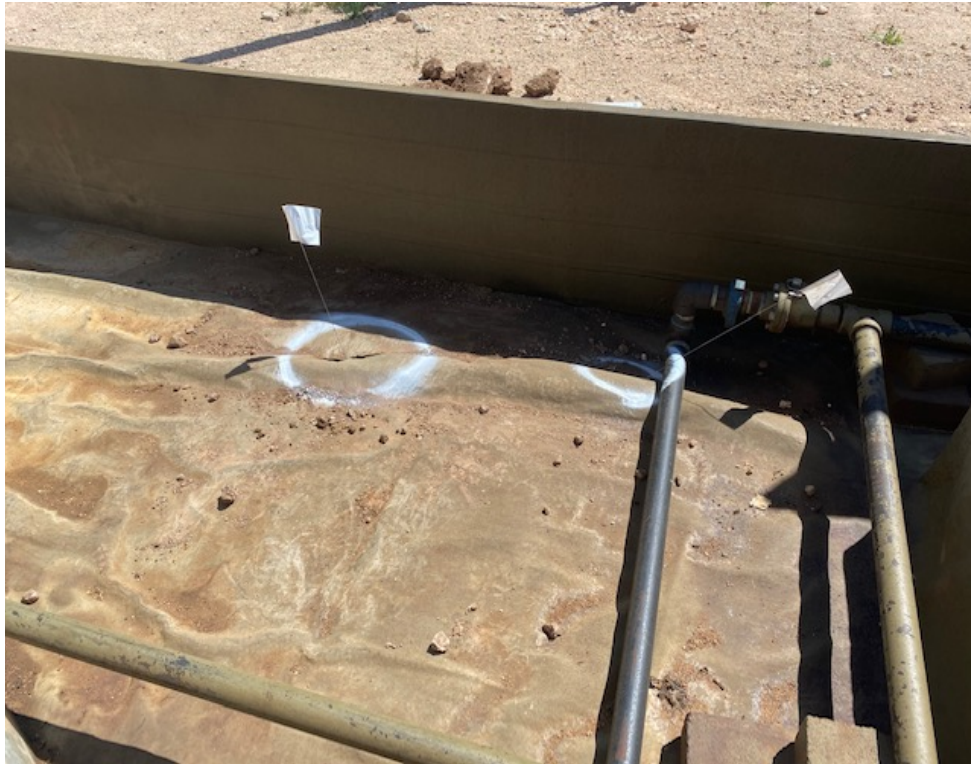
Photograph 1: View of BH01 location along with secondary tear in liner.

Following the failed liner integrity inspection, LTE personnel advanced one borehole in the location of the hole in the compromised liner. Delineation soil sample BH01 was collected from within the lined tank battery containment at a depth of approximately 0.75 feet bgs to assess for the presence or absence of soil impacts as a result of the December 4, 2019 produced water and condensate release. Laboratory analytical results indicated benzene, BTEX, TPH-GRO, TPH-DRO, TPH, and chloride concentrations were compliant with the Closure Criteria in soil sample BH01. The liner was subsequently repaired. As such, XTO respectfully requests NFA for Incident Number NRM2002948523.

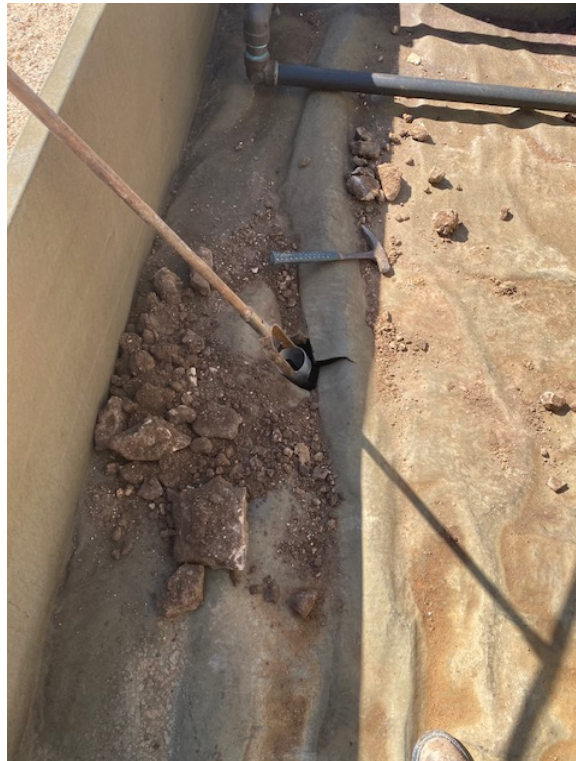
Photograph 2: BH01 location backfilled and the liner was repaired.
