CLOSURE REPORT

MILLMAN SB STATE #2

API NO: 30-015-24756

2RP – 4983

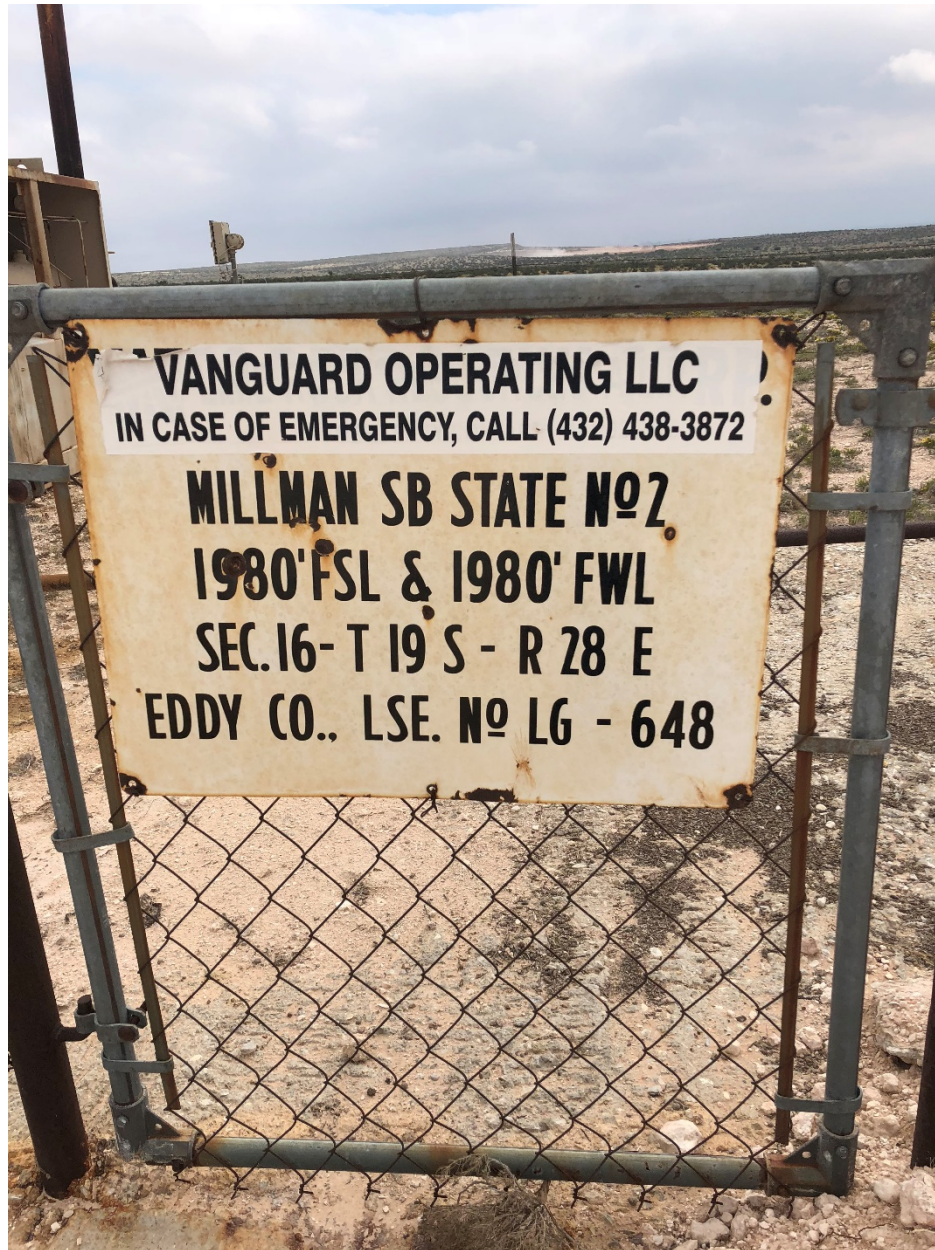
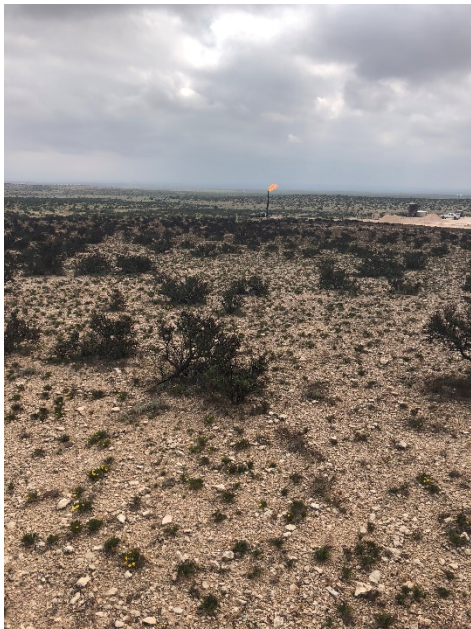
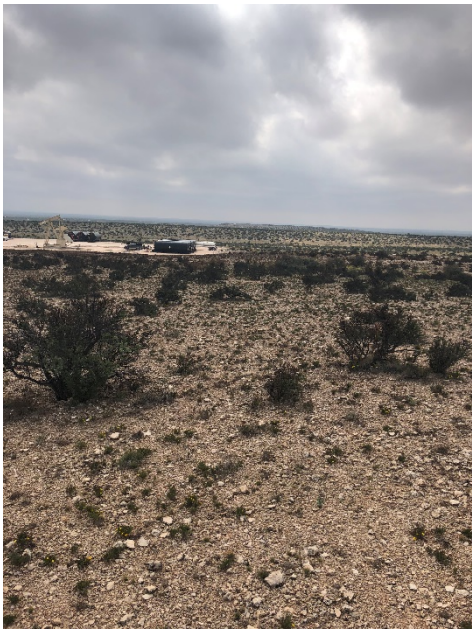
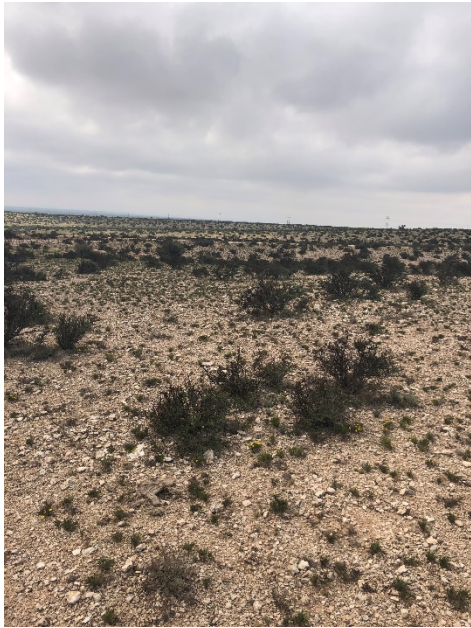
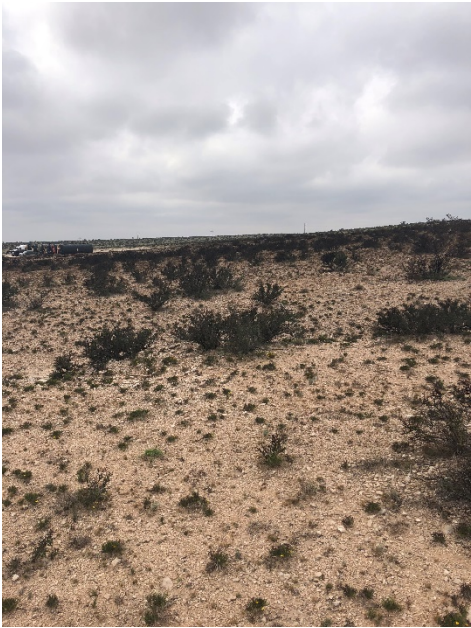
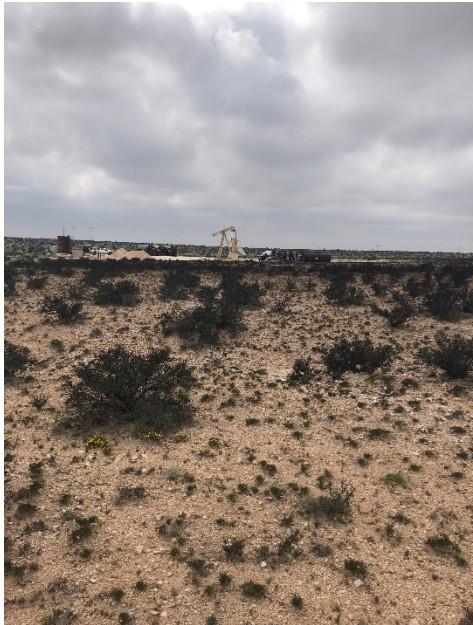
BEFORE PHOTOS

The site is located in Eddy County, New Mexico. The incident occurred due to an offset frac on a nearby well, that caused the separator to overpressure and release through the relief valve. A large area was sprayed by oil that covered approximately 304,920 Sq. Ft. of pasture and pad area. The release occurred on or before September 11th of 2018.
