Devon Energy Production Co LP Falcon 32 State 1 Battery

Closure

**Unit Letter F, Section 32, T23S, R32E
Lea County, New Mexico**

1RP-4947

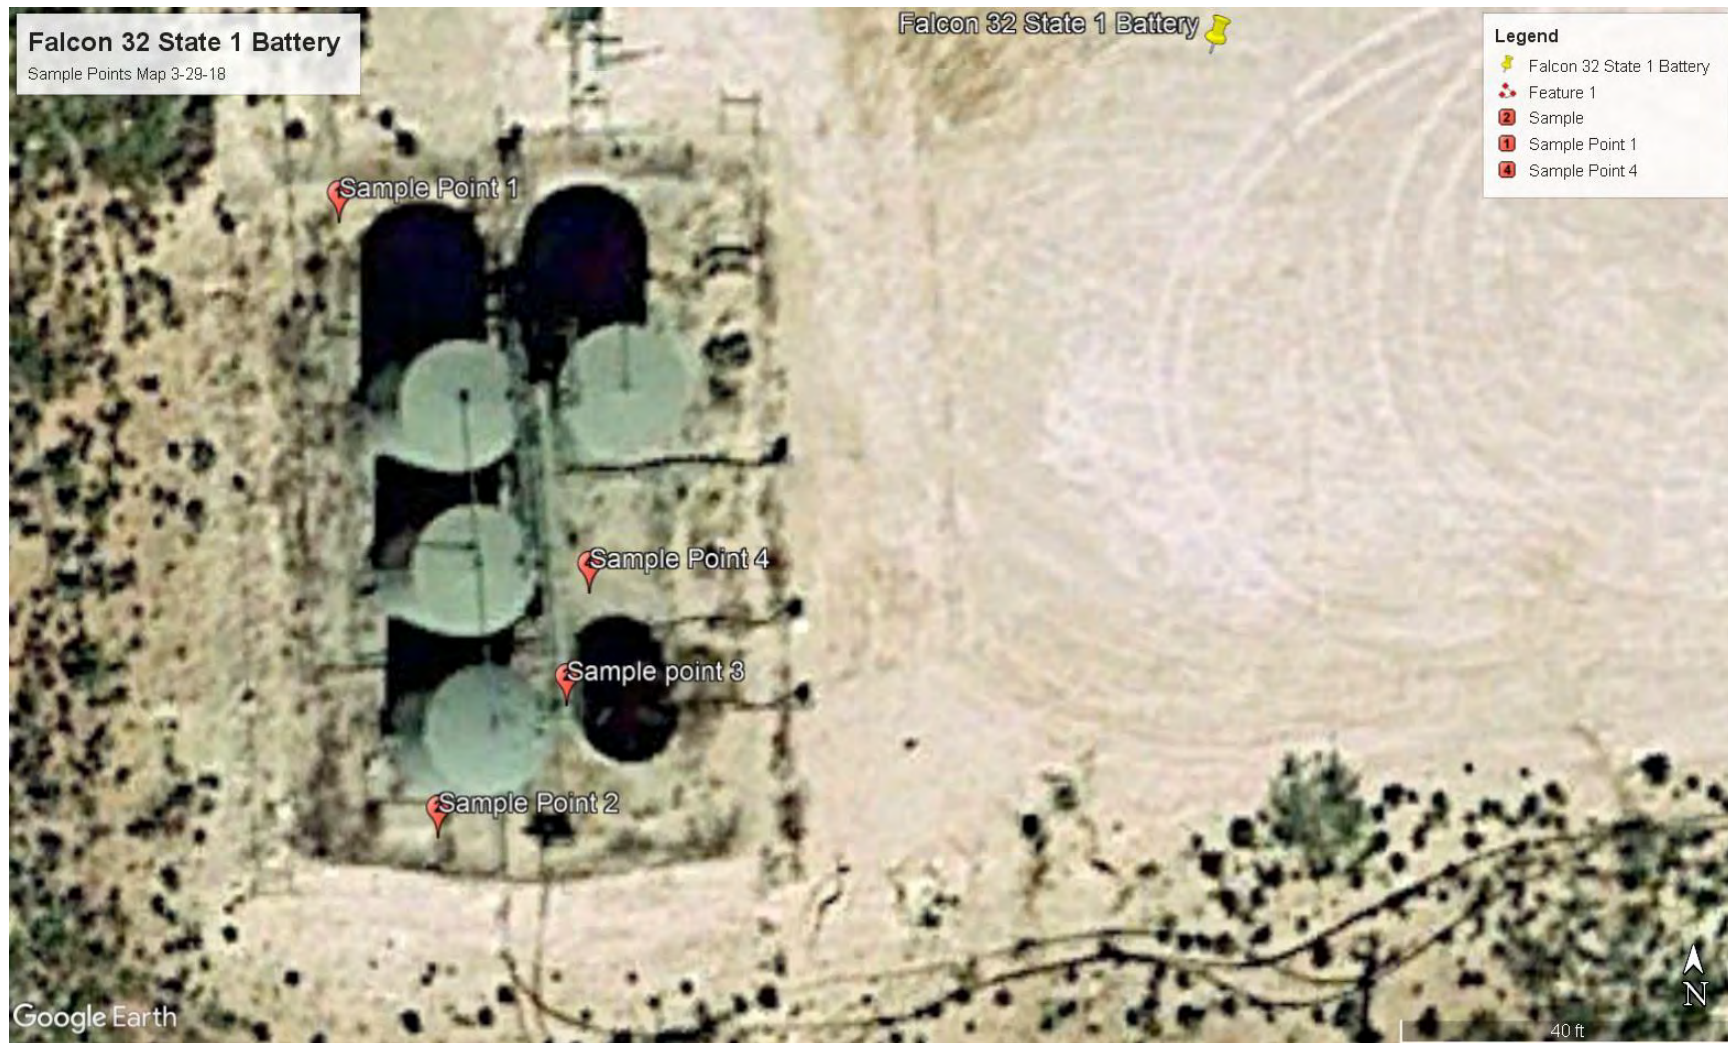
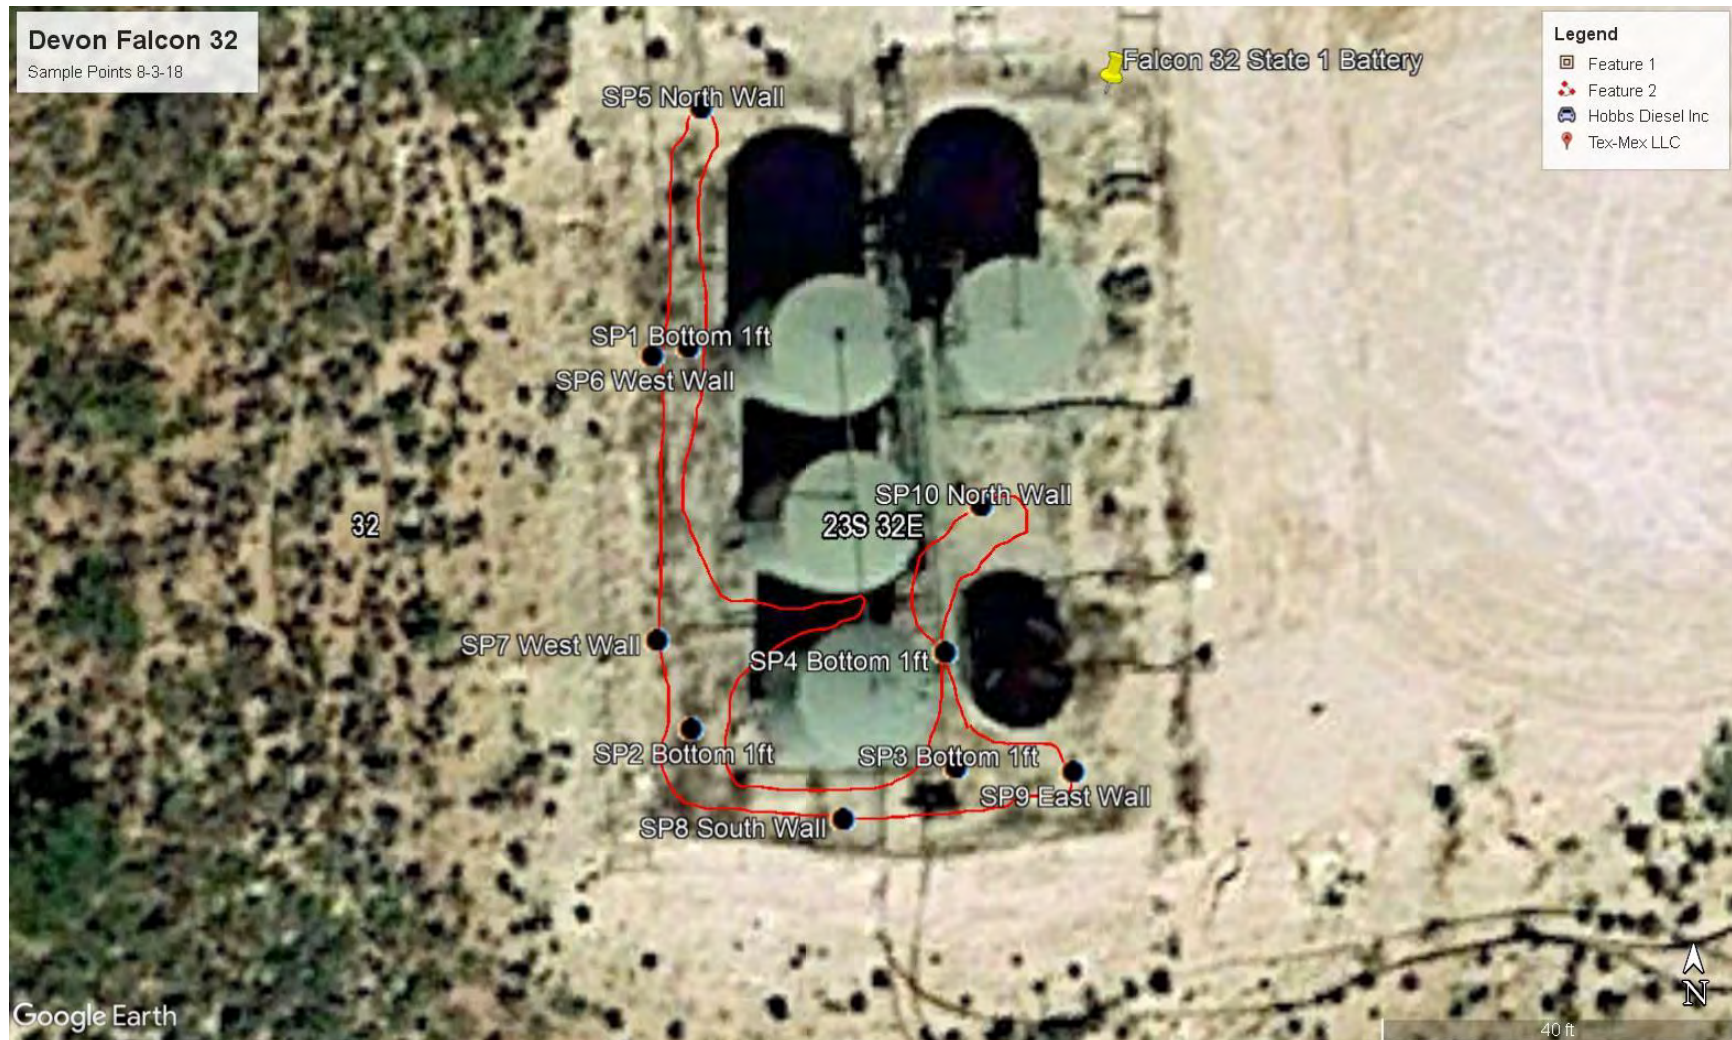
Figure 2

Site Plan
