**SUBJECT: REMEDIATION CLOSURE REPORT FOR THE ICE DANCER 30 FEDERAL COM #002H RELEASE (2RP-4691 & 2RP-4752), EDDY COUNTY, NEW MEXICO**

Devon Ice Dancer 30 Federal Com 2H Remediation Closure Report (2RP-4691 & 2RP-4752) Page 3 of 4  
November 9, 2018

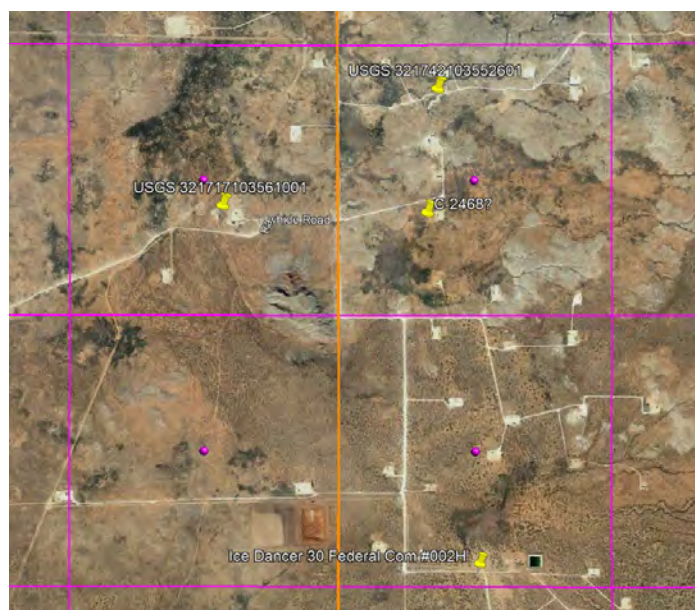
Figure a: Site vs nearby wells

The same PLSS sections were searched for USGS/OSE observation wells. Two observation wells were located USGS well 321717103561001 located in the NW/4NE/4SW/4NW/4SE/4 of Section 24, Township 23 South, Range 24 East, and USGS well 321742103552601 located in the NW/4NE/4SE/4SW/4NE/4NW/4 of Section 19, Township 23 South, Range 30 East. Both wells are reported as livestock wells, and it is common for ranches to drill to the first available water bearing zone.

Both these wells indicate they are completed in the Permian Rustler formation with water levels reporting in the 50-70-foot range but at lower land surface elevations than the Site.

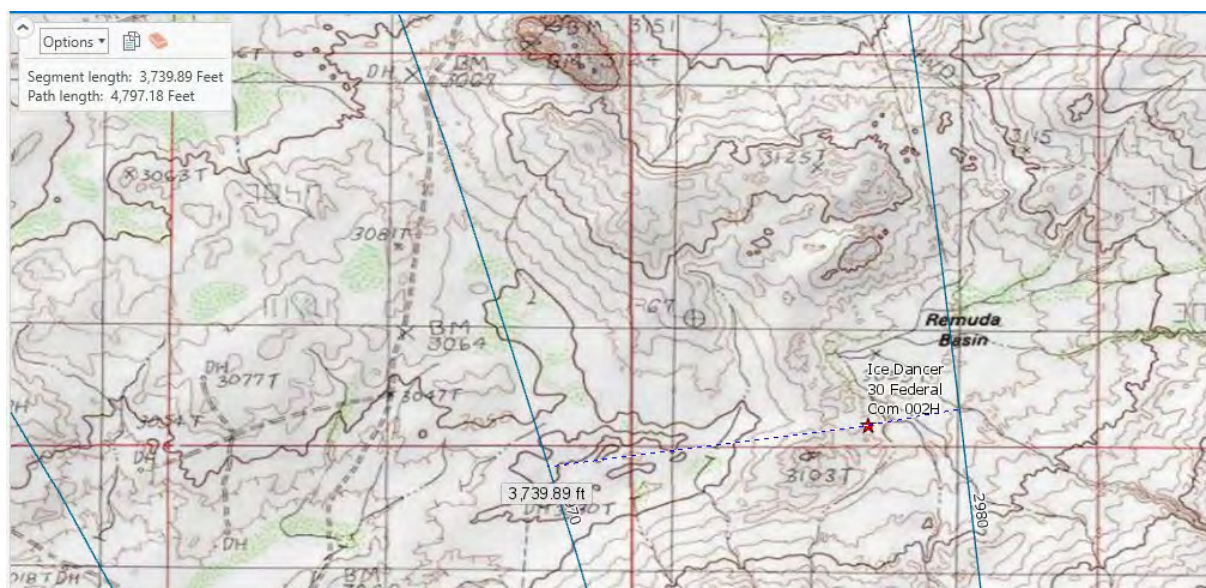
Figure b: Site vs 1998 Water Level Elevation Contours

Using the USGS latitude/longitude and vertical data (NAVD1988), the water level elevation from the 1998 entry was gridded (kriging) using Surfer 14. Contours for that water level elevation period was generated and projected into ArcGIS. Figure b show the site versus the water level elevation contours in 1998.

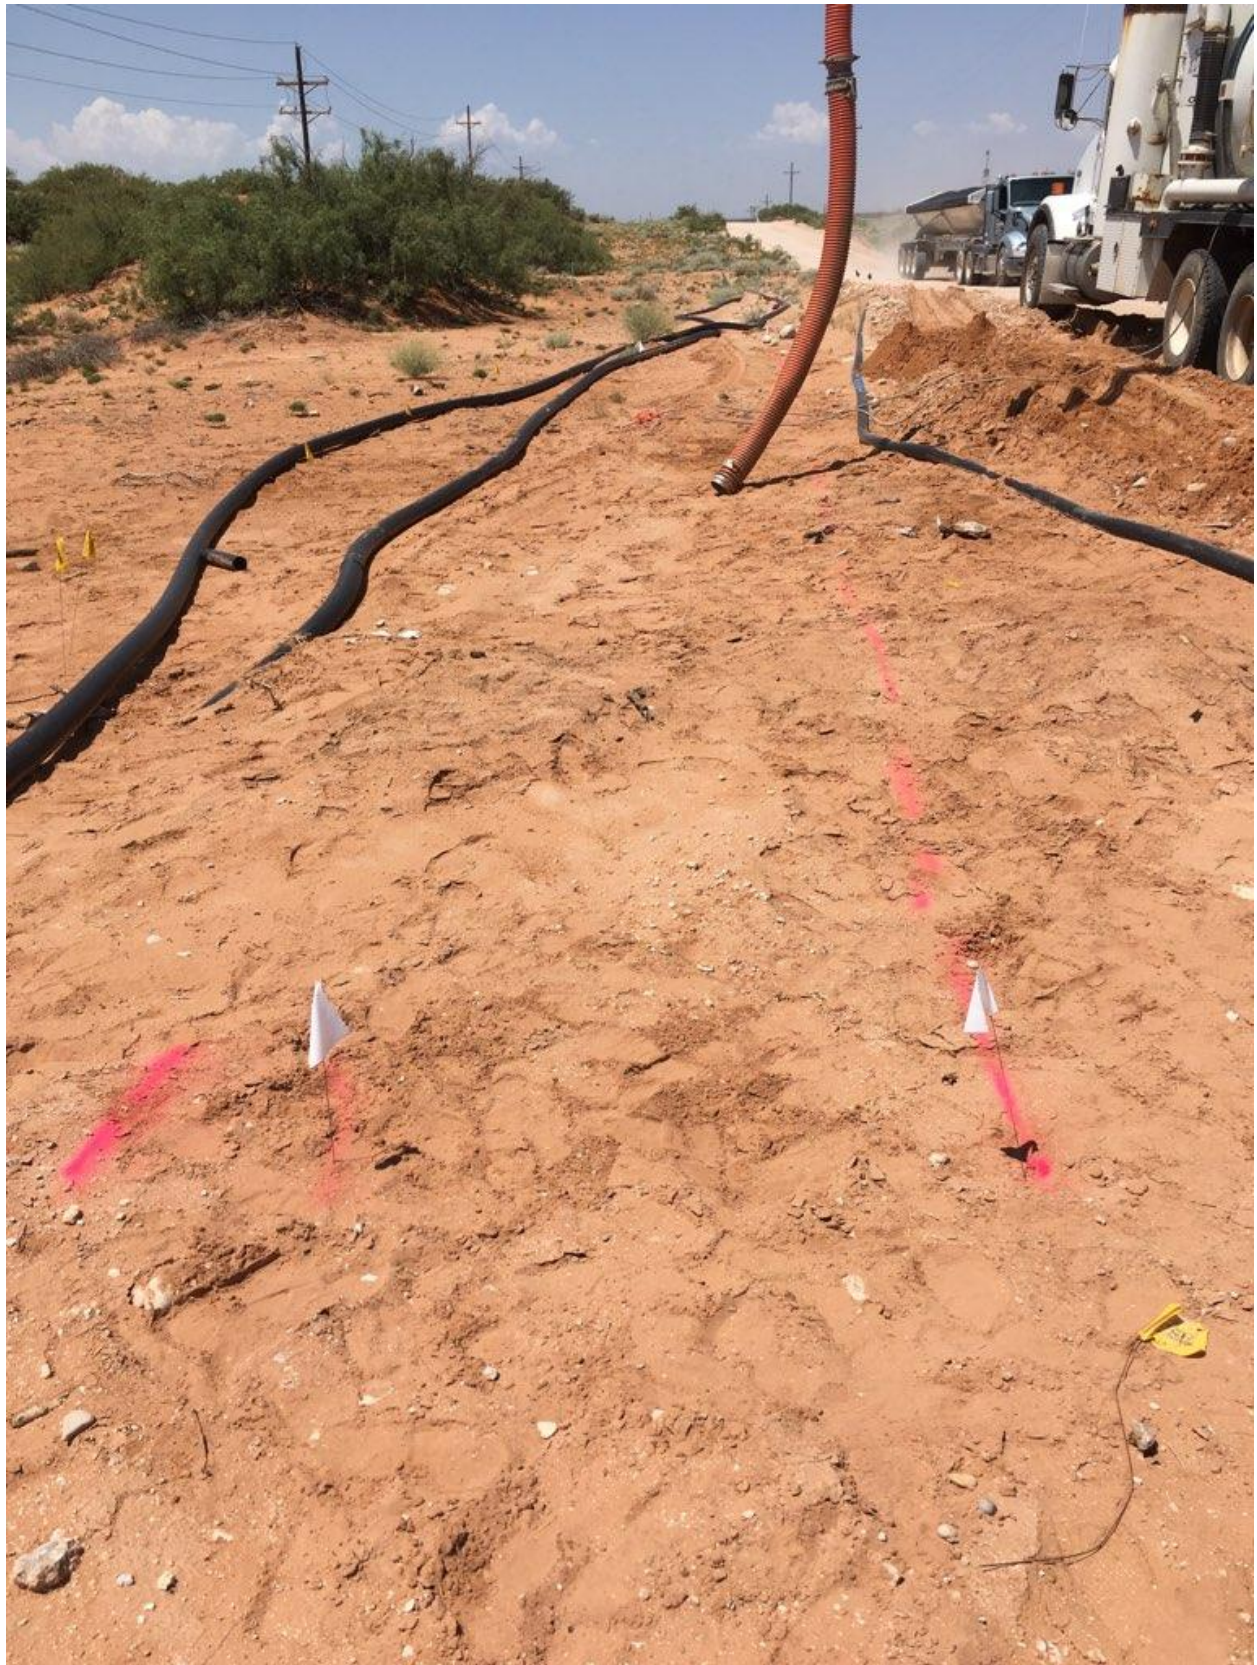
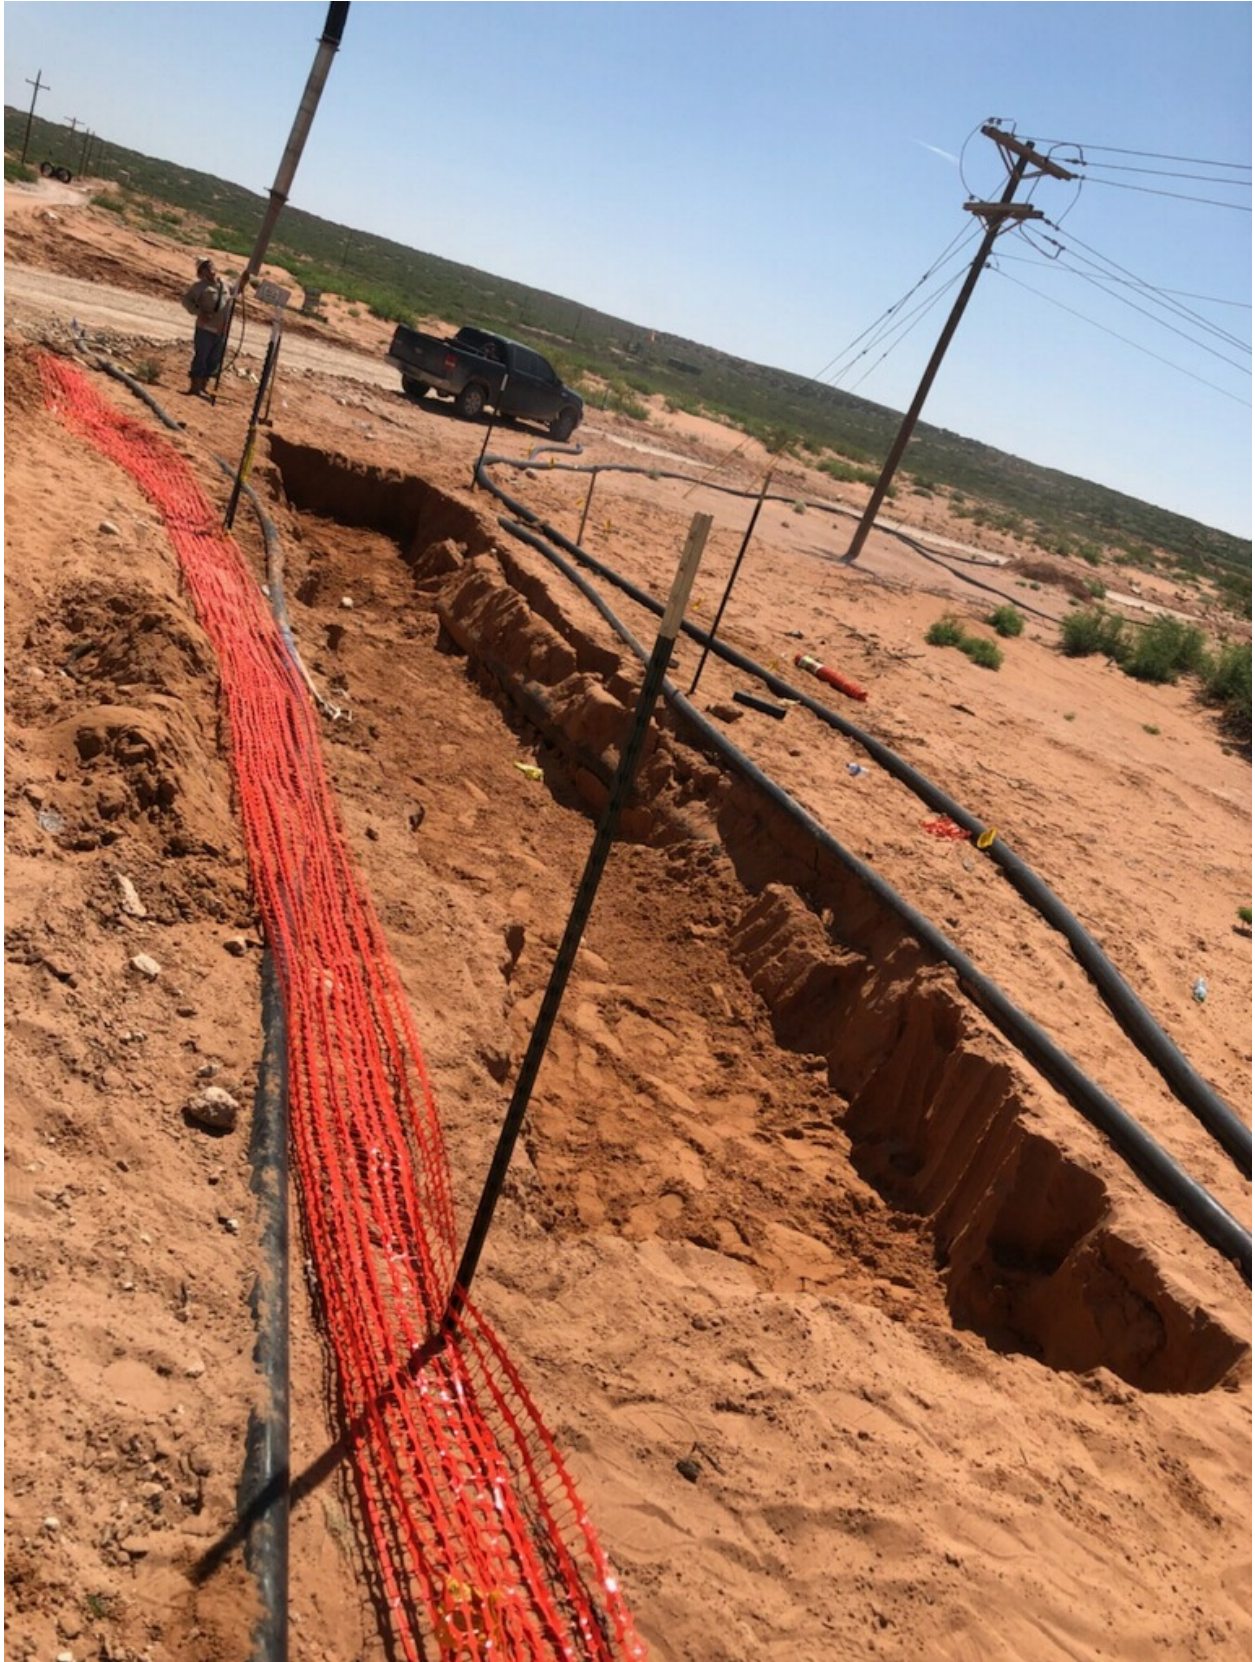
# APPENDIX C PHOTO LOG

Due to safety reasons and the presence of underground gas and SWD lines, excavation was completed with a hydrovac to the maximum extent safely possible, approximately 4 feet bgs. Discrete samples were collected from the bottom of the hydro excavation at 2 and 4 feet. The impacted area was excavated to an area approximately 75 feet by 9 feet bgs. Confirmation samples were comprised of sidewalls (West SW, Northwest SW, Southwest SW, Northeast SW, Southeast SW, East SW). Figure 3 demonstrates the extent of the excavation and sample locations and a photo of the open excavation can be found in Appendix C.

Contaminated soils were removed and replaced with clean backfill material to return the surface to previous contours. The contaminated soil was transported for proper disposal at an NMOCD permitted disposal facility. Sample locations are depicted on Figure 2. All laboratory results are summarized in Table 3. Laboratory reports are included in Appendix D.
