May 1, 2020

Vertex Project #: 19E-00614-014

**Spill Closure Report:** Taylor Deep 12 Federal #009  
Unit H, Section 12, Township 18 South, Range 31 East  
County: Lea  
API: 30-015-39764  
Tracking Number: NRM1935242300

**Prepared For:** Marathon Oil Permian, LLC  
4111 S. Tidwell Road  
Carlsbad, New Mexico 88220

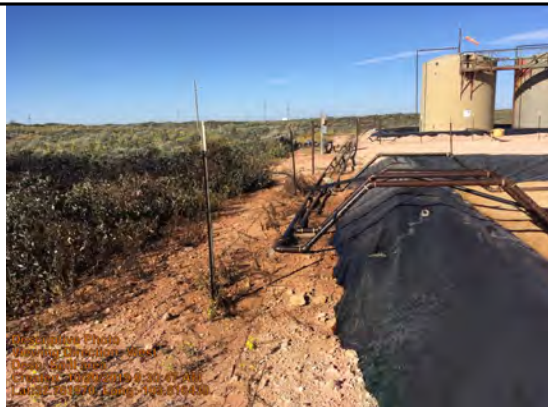
Descriptive Photo  
Viewing Direction: West  
Desc: Spill area  
Created: 10/20/2019 9:36:51 AM  
Lat: 32.262009, Long: -103.816570

Spill area

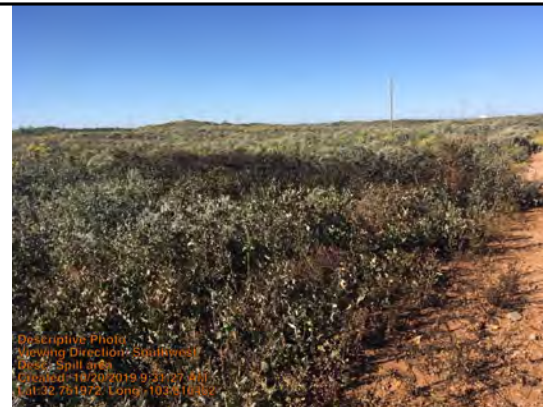
Descriptive Photo  
Viewing Direction: Southwest  
Desc: Spill area  
Created: 10/20/2019 9:36:51 AM  
Lat: 32.262009, Long: -103.816570

Spill area

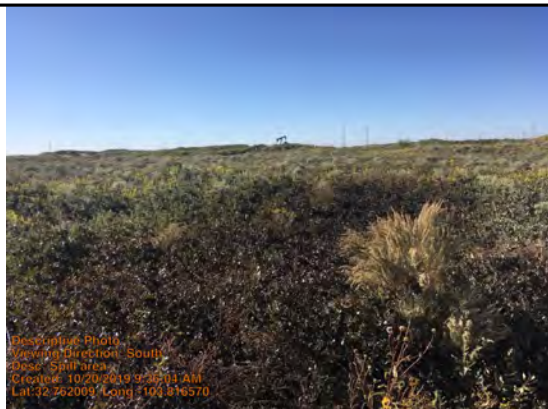
Descriptive Photo  
Viewing Direction: South  
Desc: Spill area  
Created: 10/20/2019 9:36:51 AM  
Lat: 32.262009, Long: -103.816570

Spill area

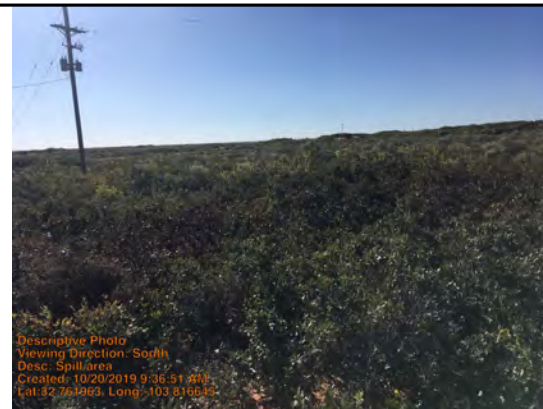
Descriptive Photo  
Viewing Direction: South  
Desc: Spill area  
Created: 10/20/2019 9:36:51 AM  
Lat: 32.262009, Long: -103.816570

Spill area

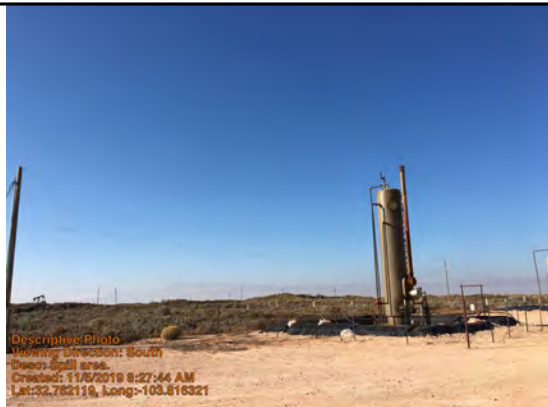
Viewing Direction: South

Spill area.

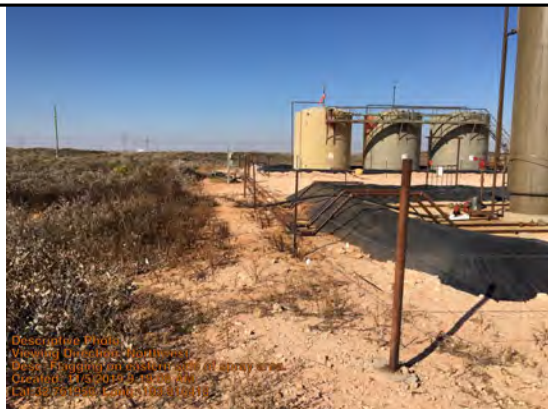
Viewing Direction: Northwest

Flagging on eastern side of spray area.

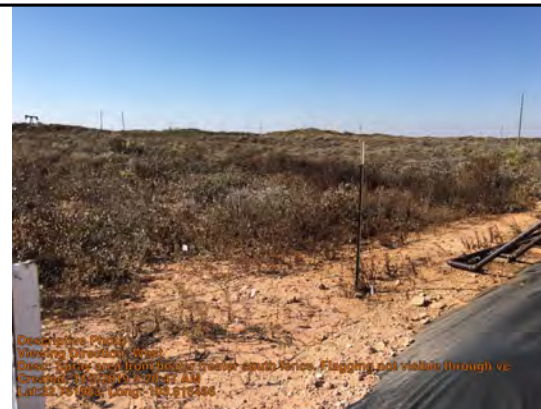
Viewing Direction: West

Spray area from heater treater south fence. All flagging not visible through vegetation.

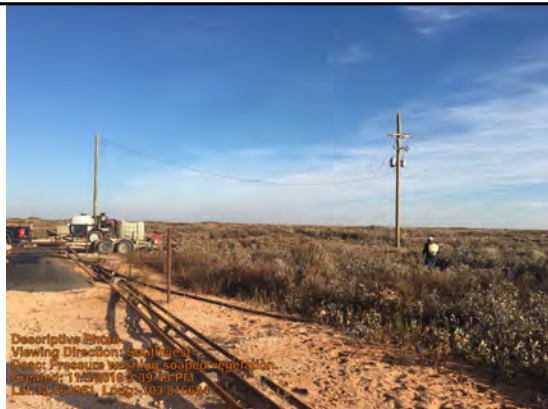
**Viewing Direction: Southeast**

Watering down vegetation after Dawn application.

Following approval from BLM regarding in-situ remediation using a vegetation wash and Microblaze, Vertex was onsite on November 5, 2019, to oversee remediation efforts involving the application of Dawn liquid soap to vegetation affected by the overspray and subsequent high pressure washing to remove hydrocarbons from the plant foliage. After this washing process was completed, Microblaze was applied evenly across the soil surface of the identified area of impact and the site was left for 30 days to allow for the topical treatment to stimulate soil microbial activity and reduce the presence of carbons in the soil.

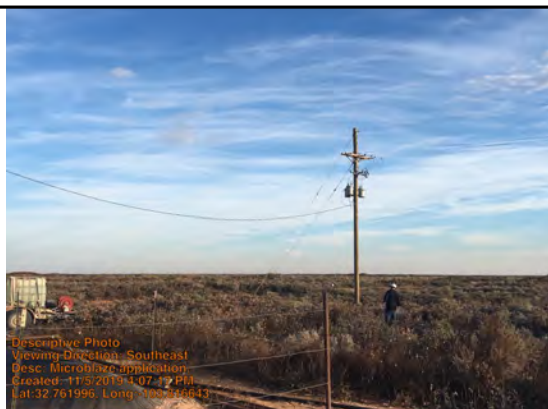
**Viewing Direction: Southeast**

Microblaze application.

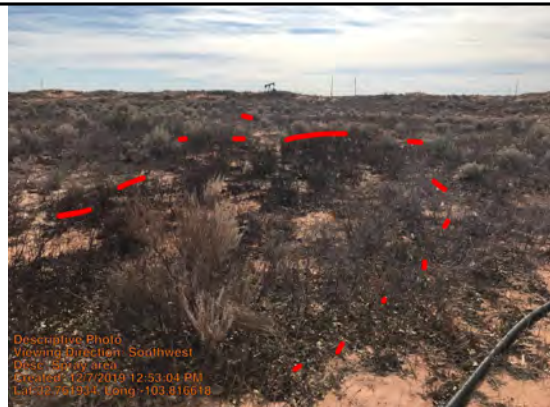
Descriptive Photo  
Viewing Direction: Southwest  
Dist: Spray area  
Created: 12/7/2019 12:53:04 PM  
Lat: 32.701927 Long: -103.015224

Spray area

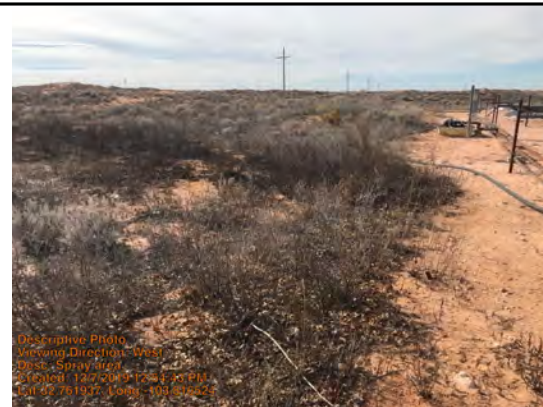
Descriptive Photo  
Viewing Direction: West  
Dist: Spray area  
Created: 12/7/2019 12:54:23 PM  
Lat: 32.701927 Long: -103.015224

Spray area

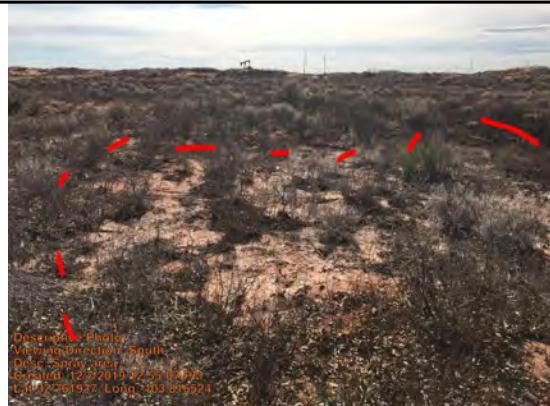
Descriptive Photo  
Viewing Direction: South  
Dist: Spray area  
Created: 12/7/2019 12:53:13 PM  
Lat: 32.701927 Long: -103.015224

Spray area

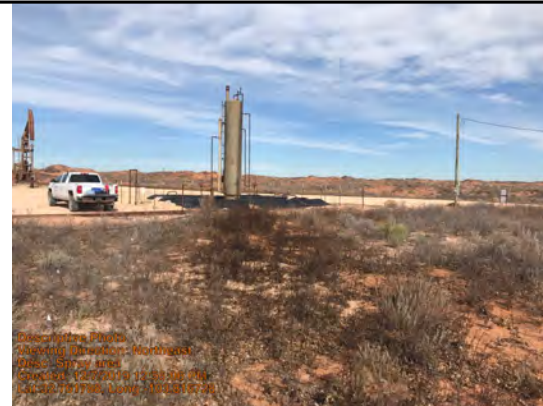
Descriptive Photo  
Viewing Direction: Northeast  
Dist: Spray area  
Created: 12/7/2019 12:53:26 PM  
Lat: 32.701927 Long: -103.015224

Spray area
