Site Assessment Report and Proposed Remediation Workplan

Grizzly Energy, LLC

Tigner State #3

Eddy County, New Mexico

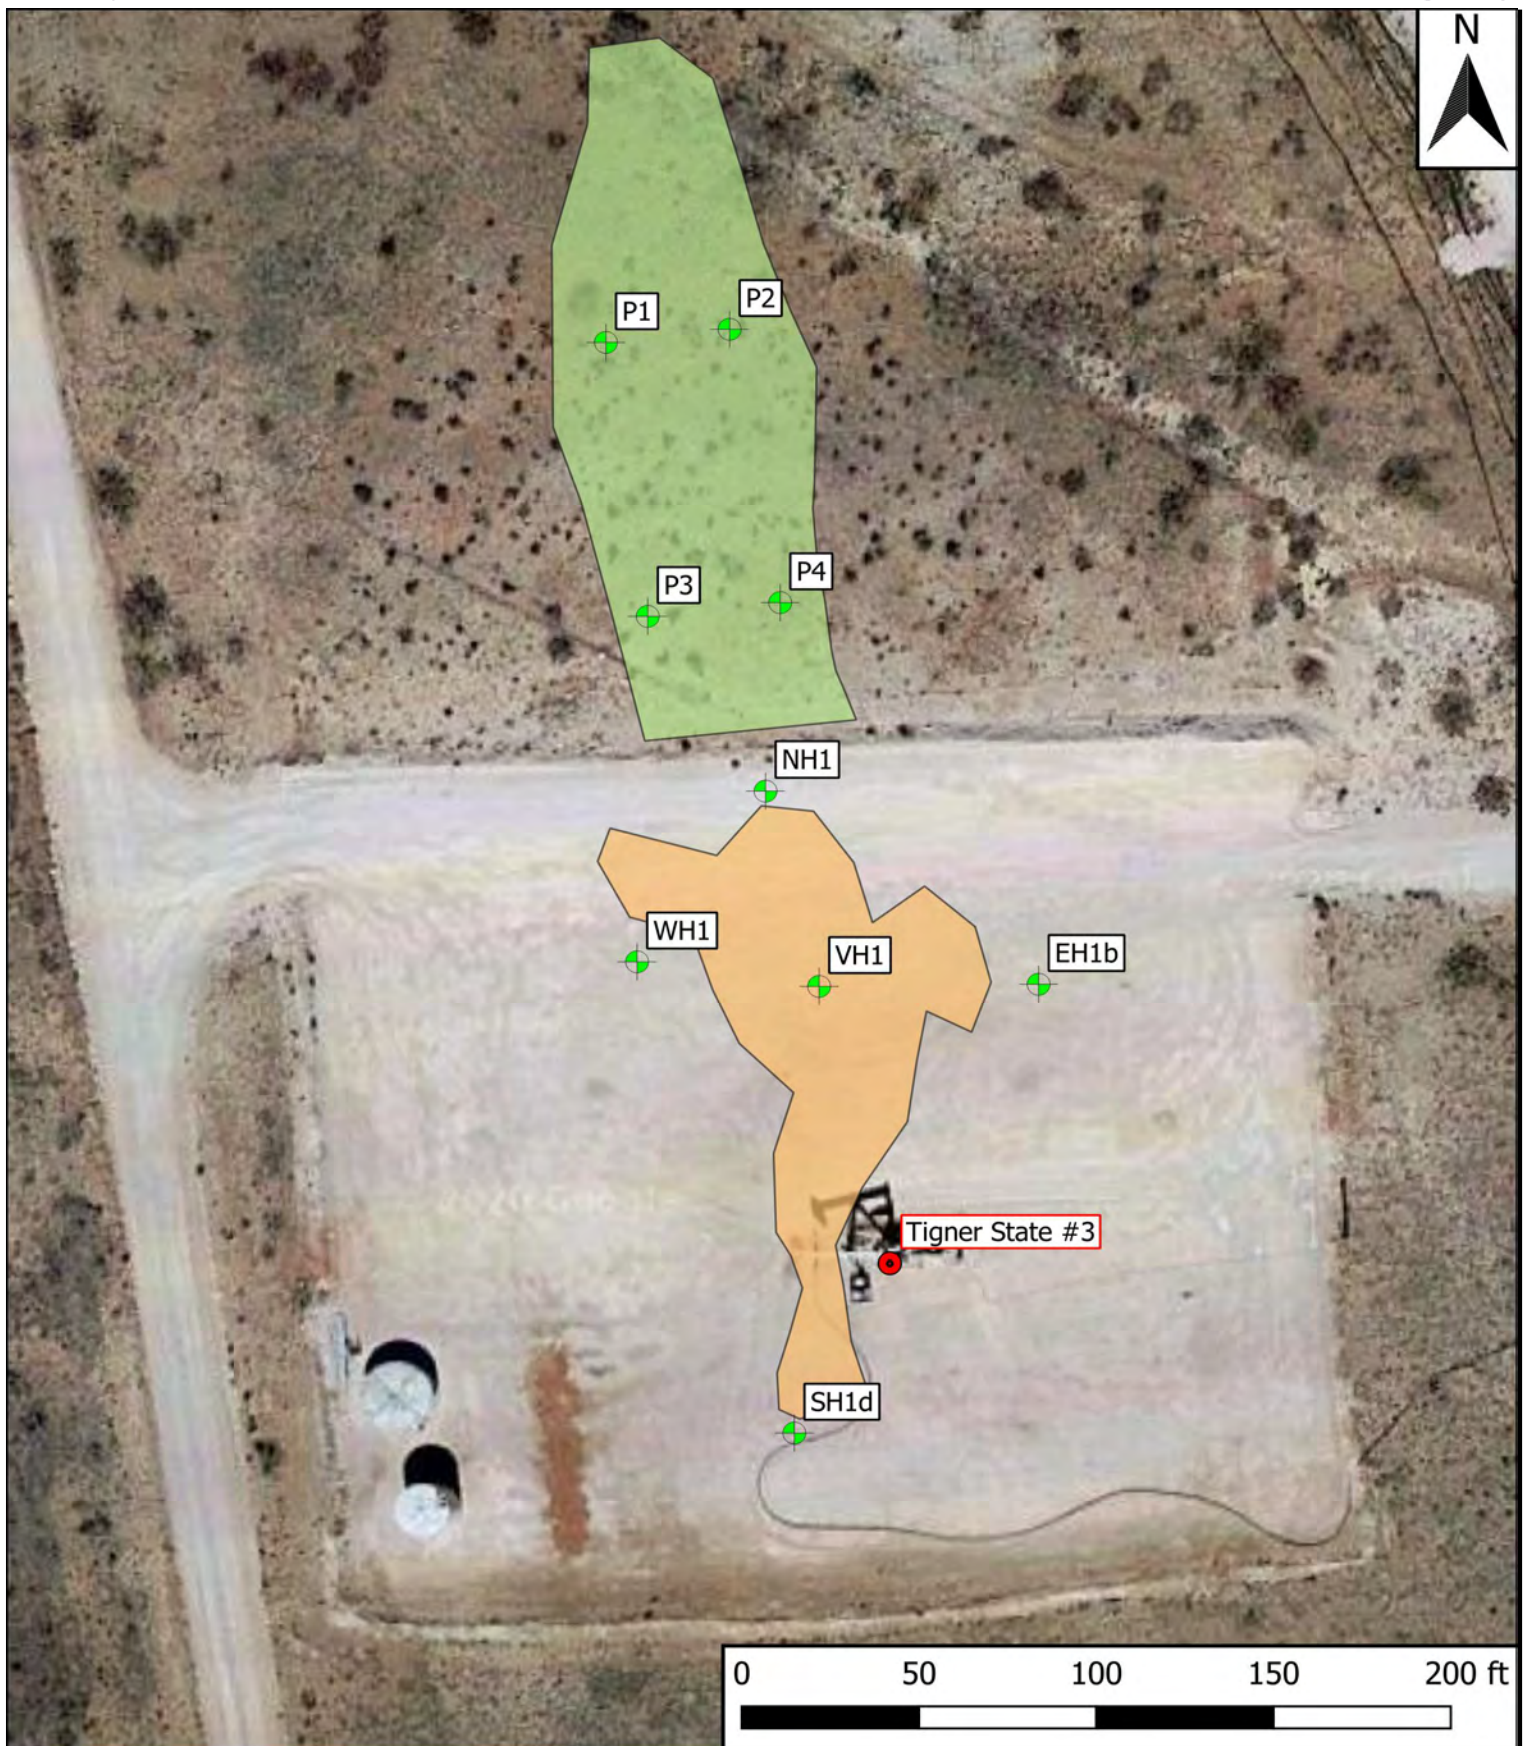
Figure 3

Site and Sample Location Map

- Site Location
- Spill - 7,361 sq ft
- Overspray - 11,977 sq ft

Upon completion of excavation activities, representative five-point composite excavation confirmation soil samples will be collected from the excavation sidewalls in each cardinal direction, representing no more than 50 linear ft. A minimum of eighteen (18) representative five-point composite excavation confirmation soil sample will be collected from the base of the excavated area representing every 400 square feet. Additional, discrete grab samples will be collected from wet or visibly stained areas inferred to have been affected by the release, as necessary.

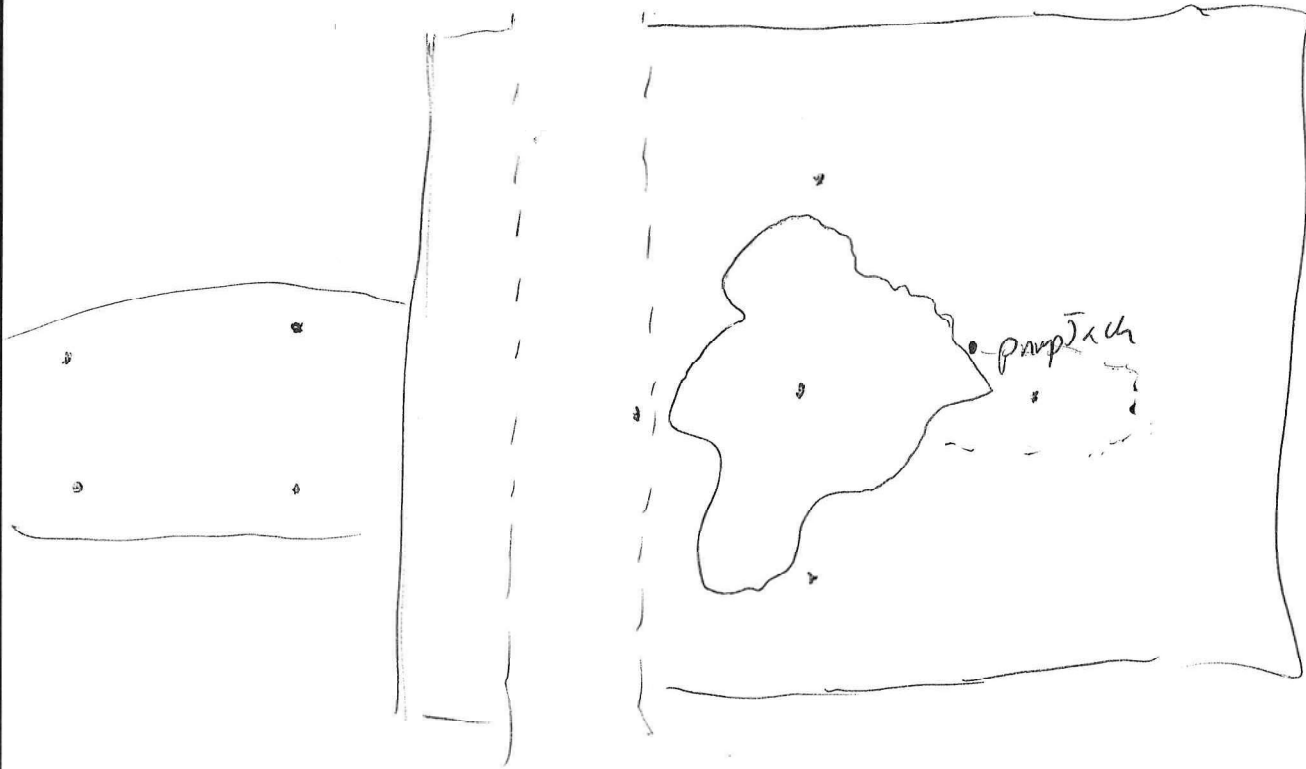
Site Diagram

Positive upper class.
 Spill extends south of pumpish based what GPS map shows

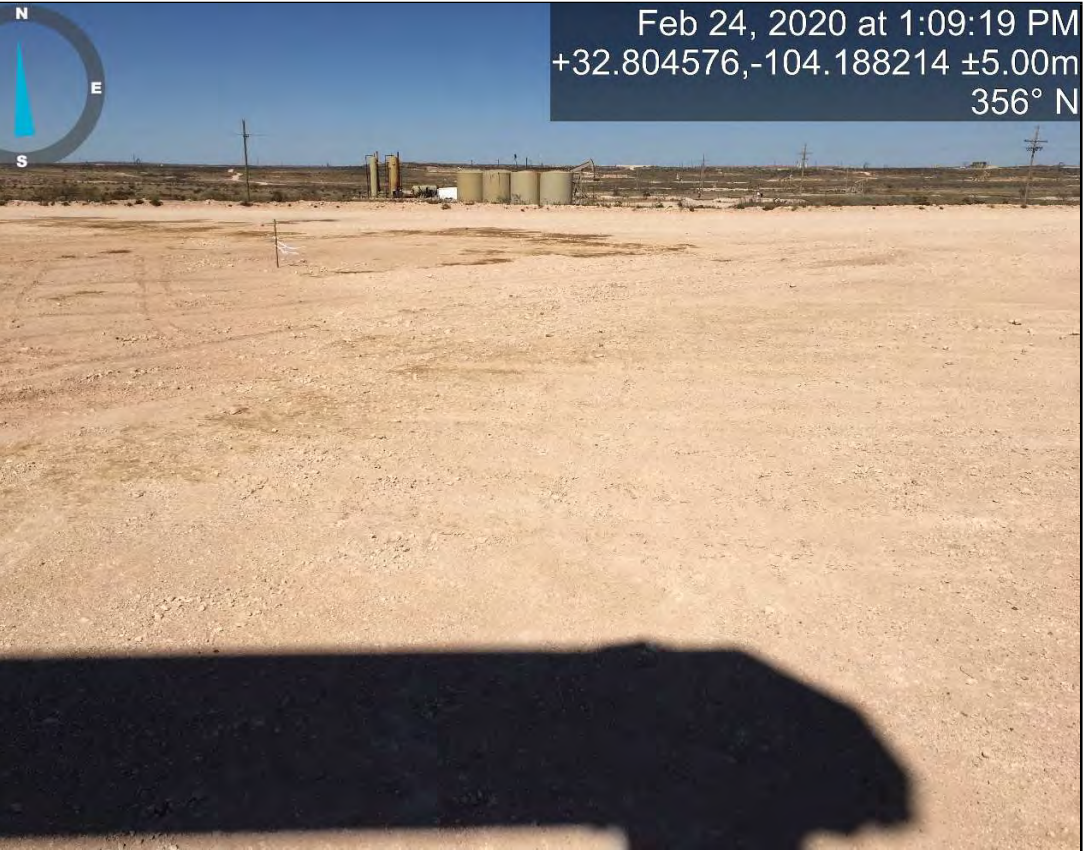
Photo Number: 1

<div>Feb 24, 2020 at 1:09:19 PM +32.804576,-104.188214 ±5.00m 356° N</div>
Photo Direction: North	
Photo Description: Spill area as seen from pumpjack.

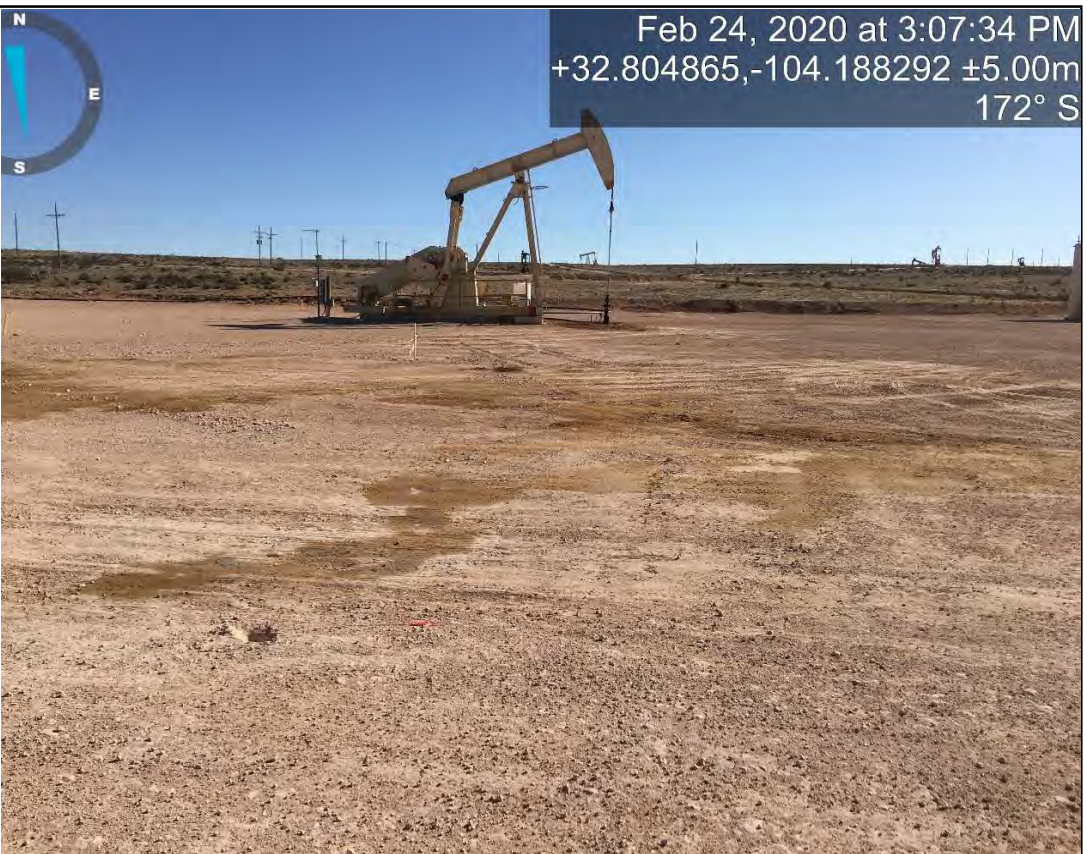
Photo Number: 2

<div>Feb 24, 2020 at 3:07:34 PM +32.804865,-104.188292 ±5.00m 172° S</div>
Photo Direction: South	
Photo Description: Northern spill area looking at pumpjack.
