Vertex Project #: 20E-00141-023

| Spill Closure Report: | Big Cat 16 9 State Federal Com #001H | |
| Propared For: | Devon Energy Production Company | |

2020 Spill Assessment and Closure April 2020

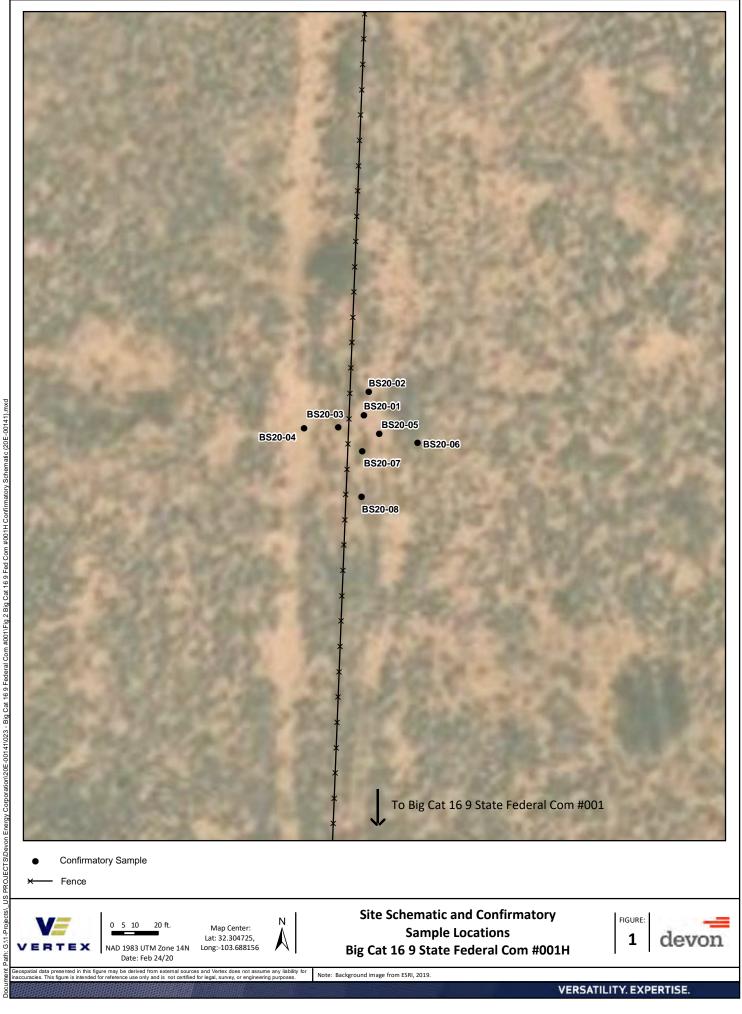
ATTACHMENT 2

A GeoExplorer 7000 Series Trimble global positioning system (GPS) unit was used to map the approximate center of each of the five-point composite samples. The confirmatory sample locations are presented on Figure 1 (Attachment 2).

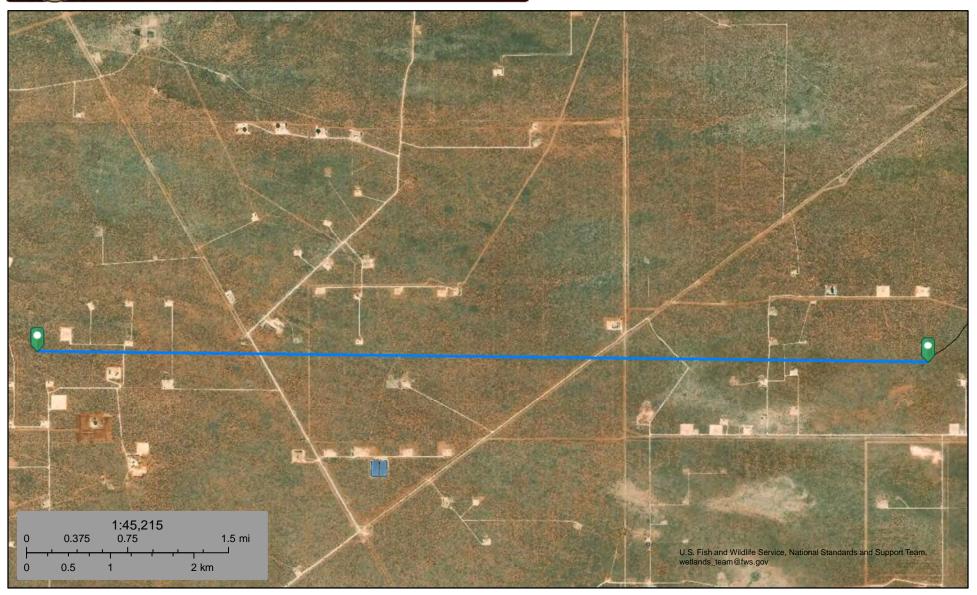
Big Cat: Watercourse 29,572 ft

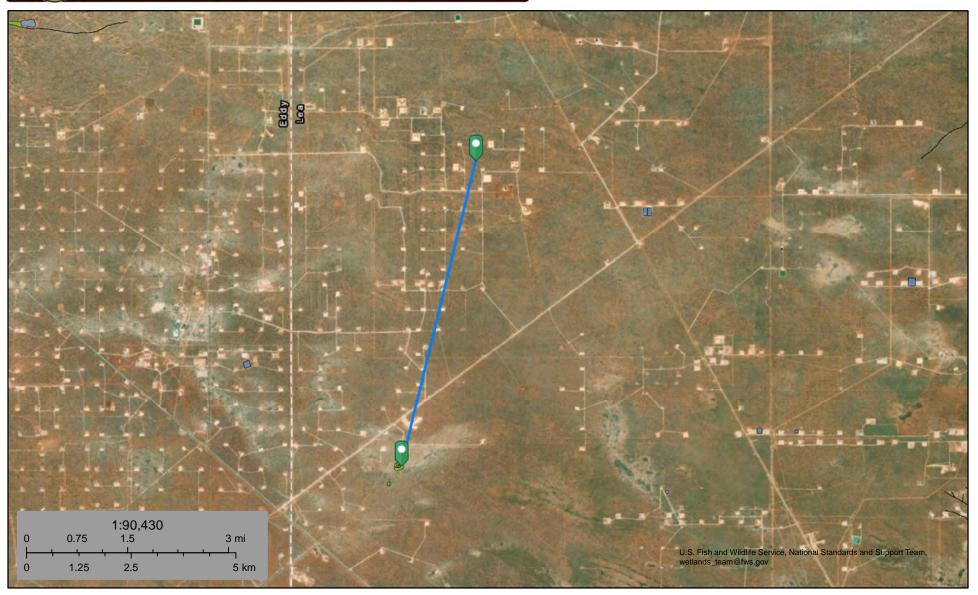
Big Cat: Wetland 20,817 ft
