SUBJECT: Remediation Closure Report for the Boomslang 14 CTB 1 Release (1RP-4949), Lea County, New Mexico

Boomslang 14 CTB 1 Remediation Closure Report (1RP-4949)  
April 9, 2020

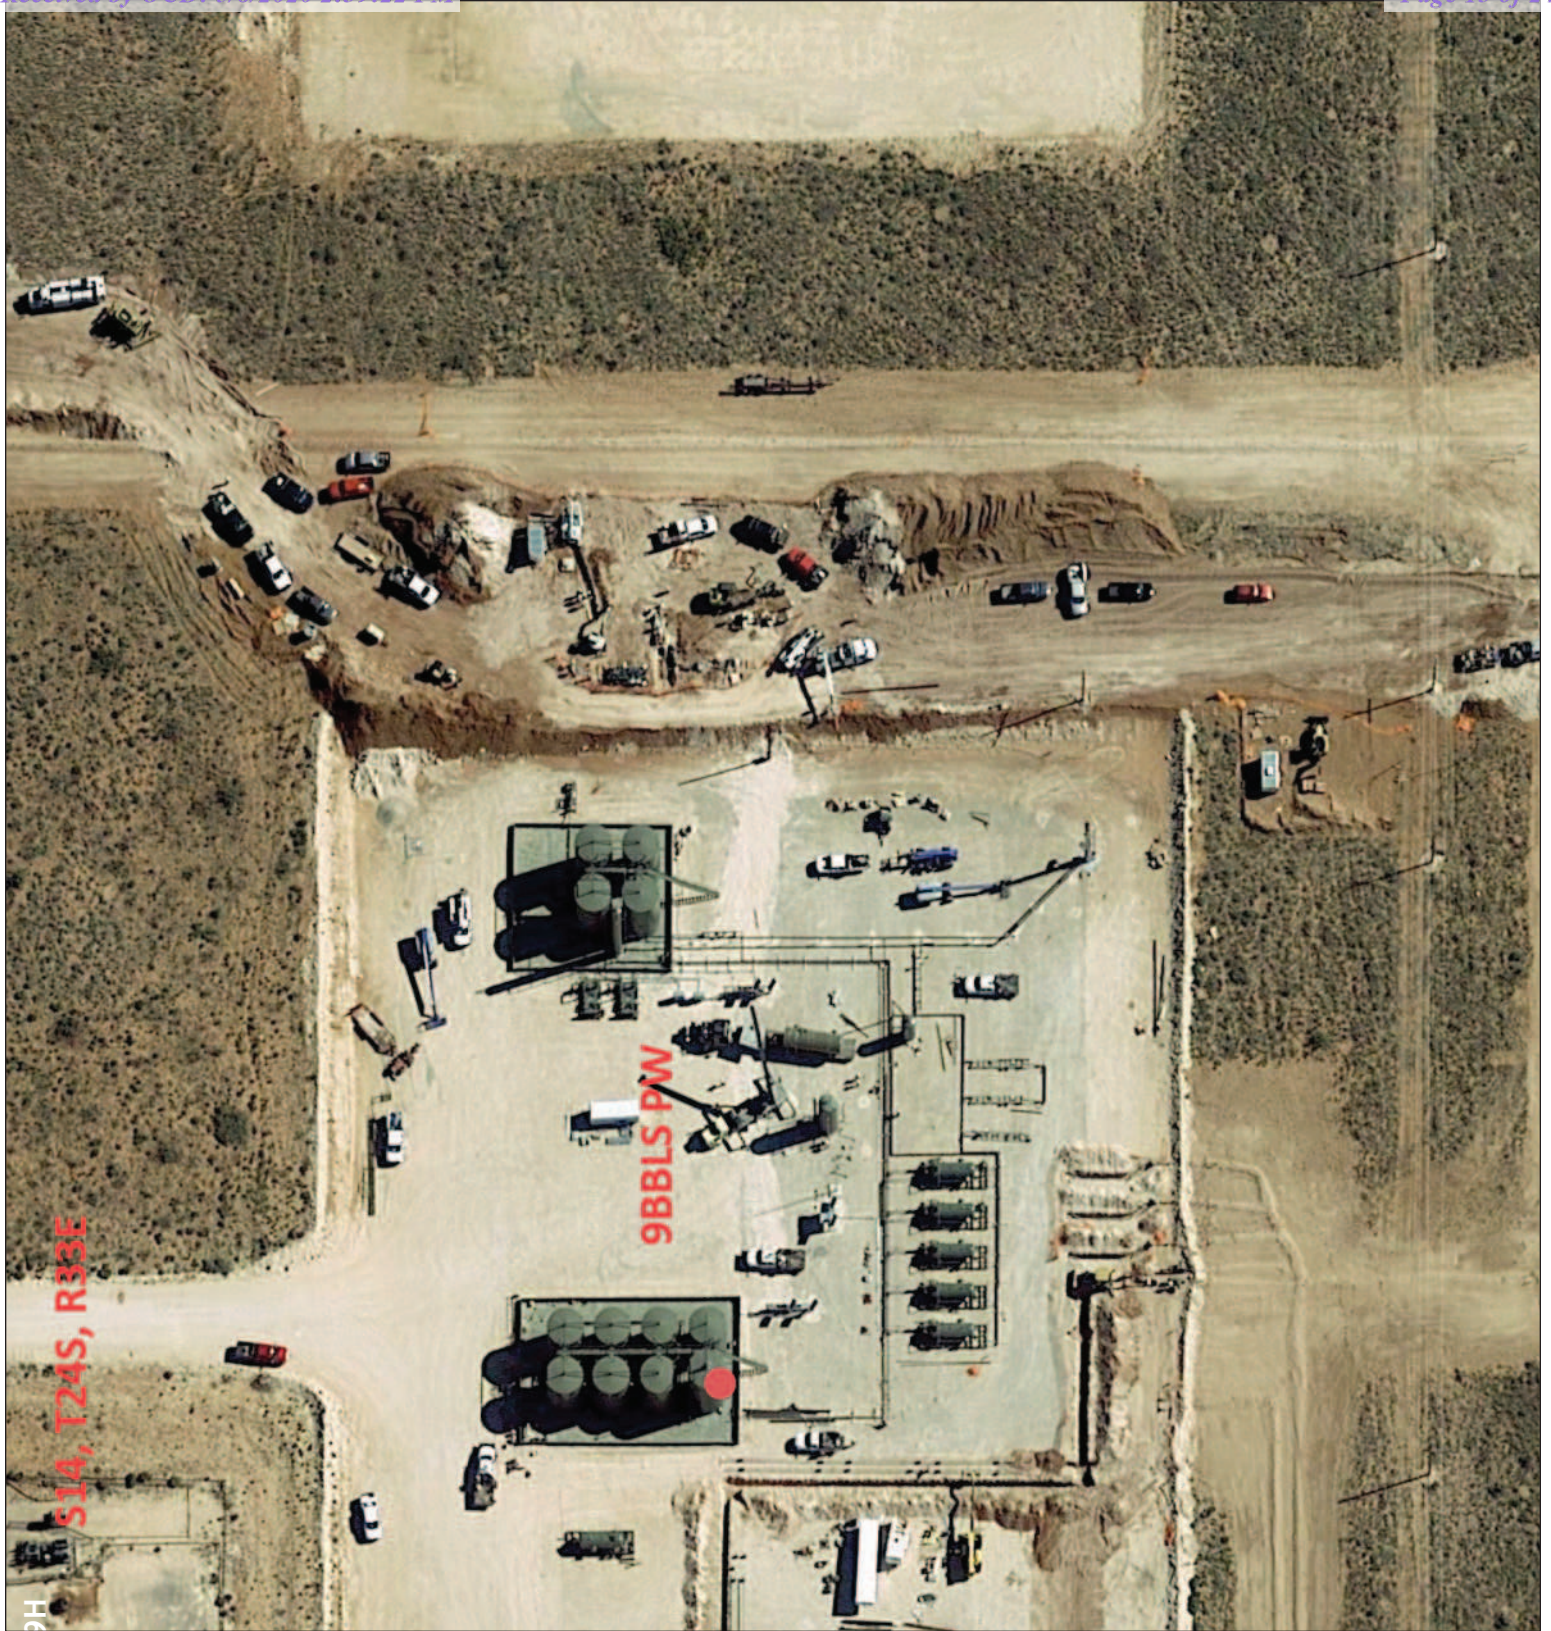
Boomslang 14-23 Federal 9H  
9BBLS PW\_1.17.2018

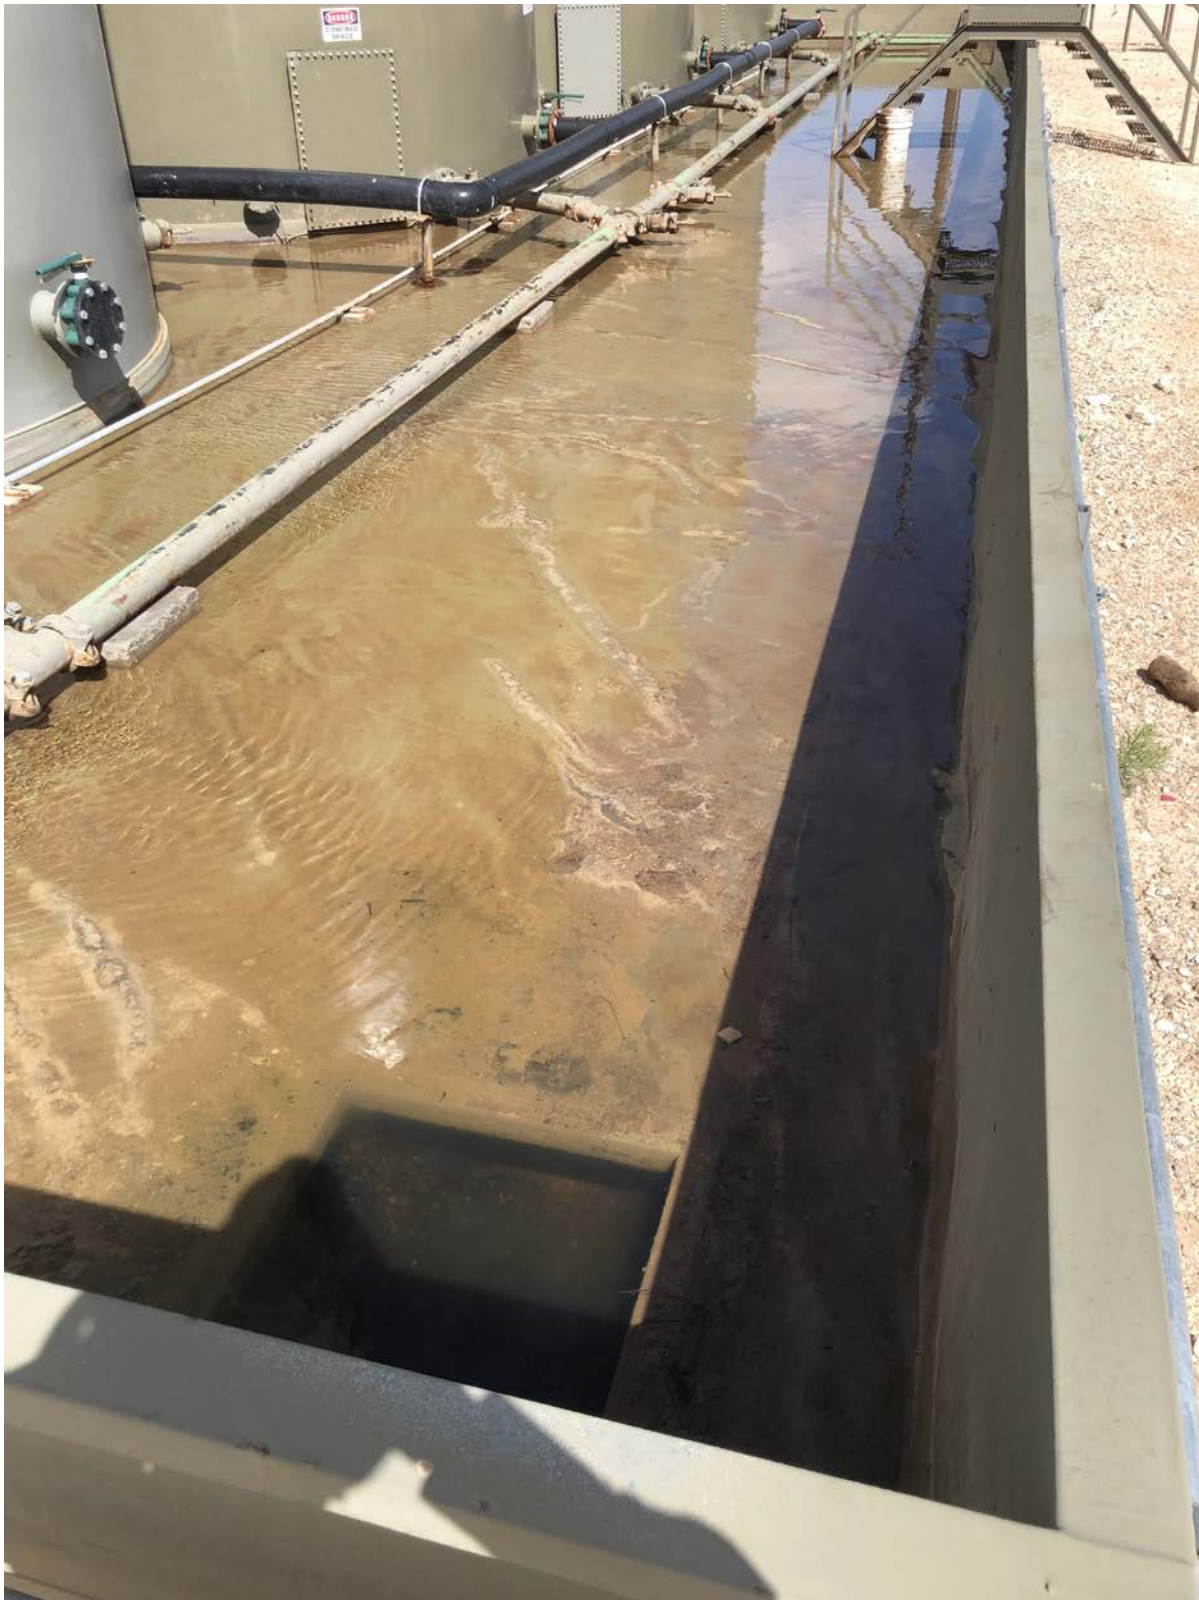
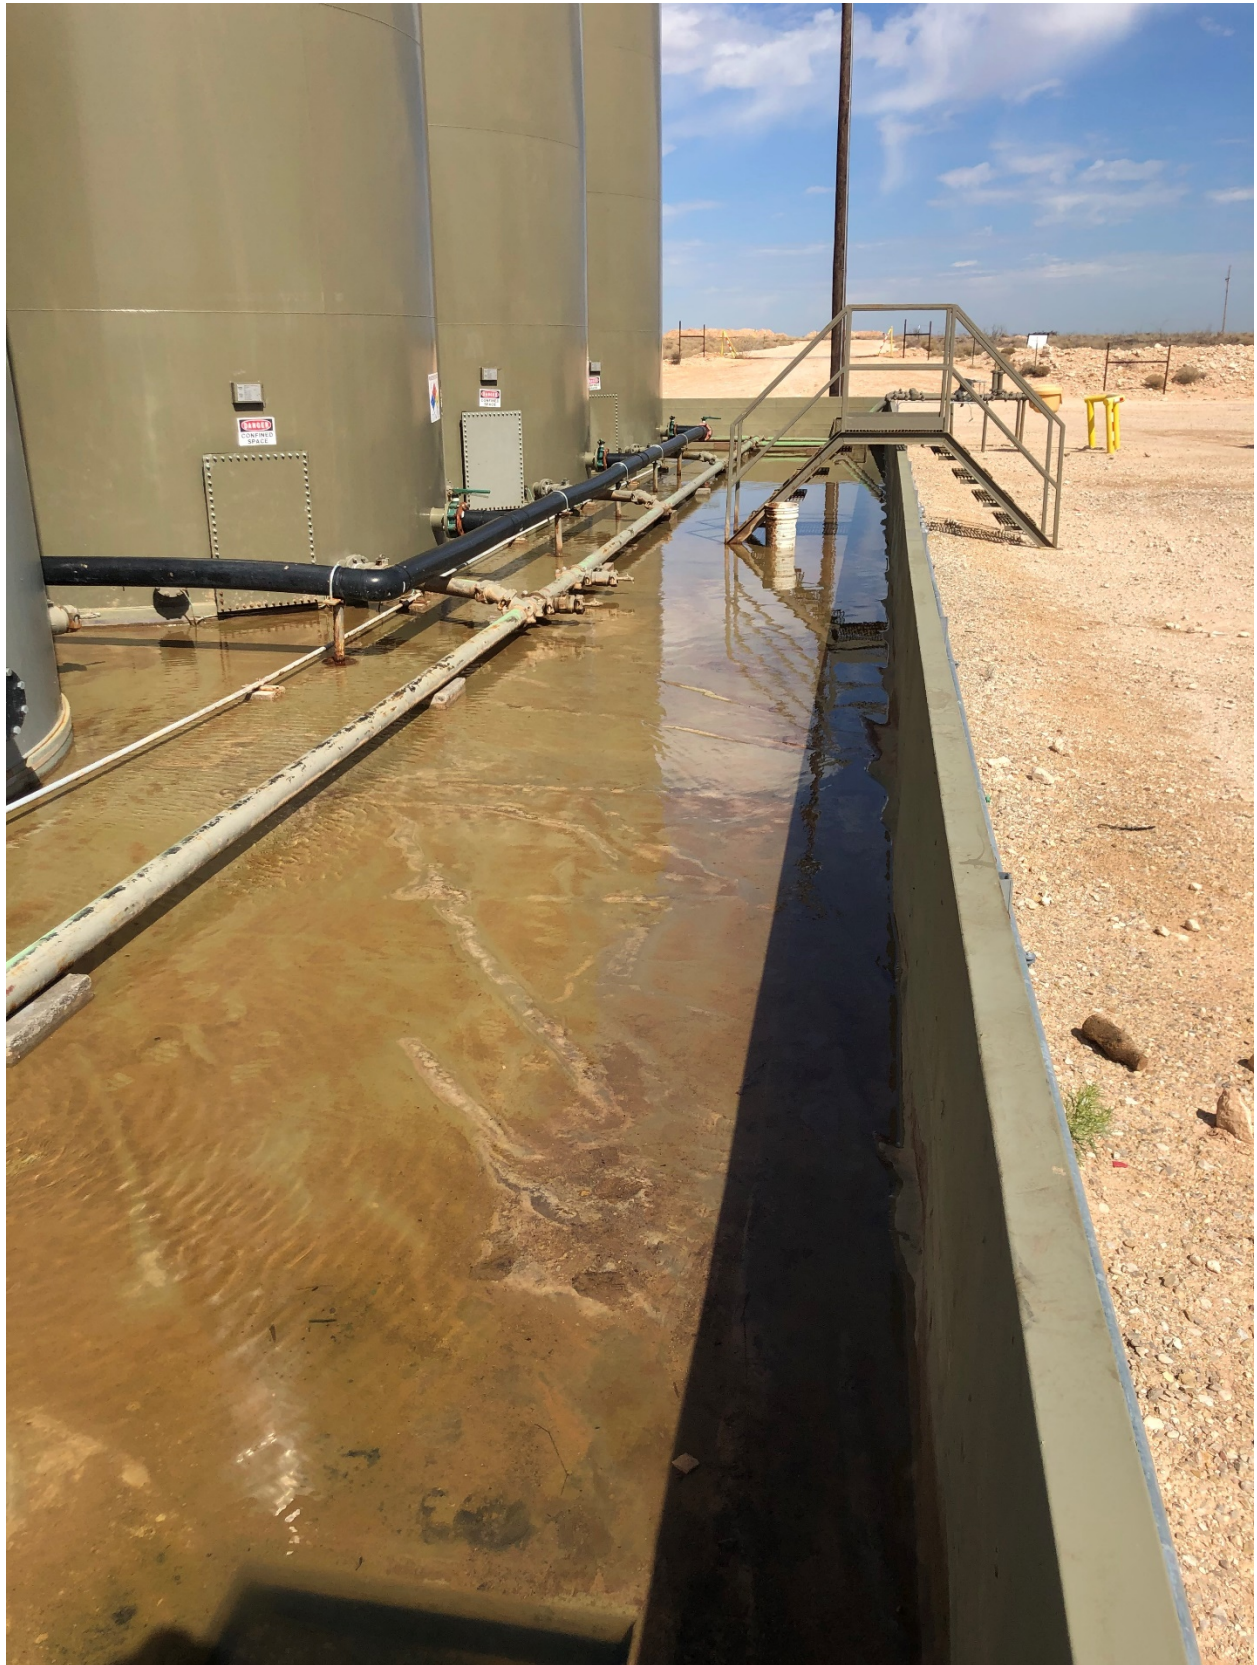
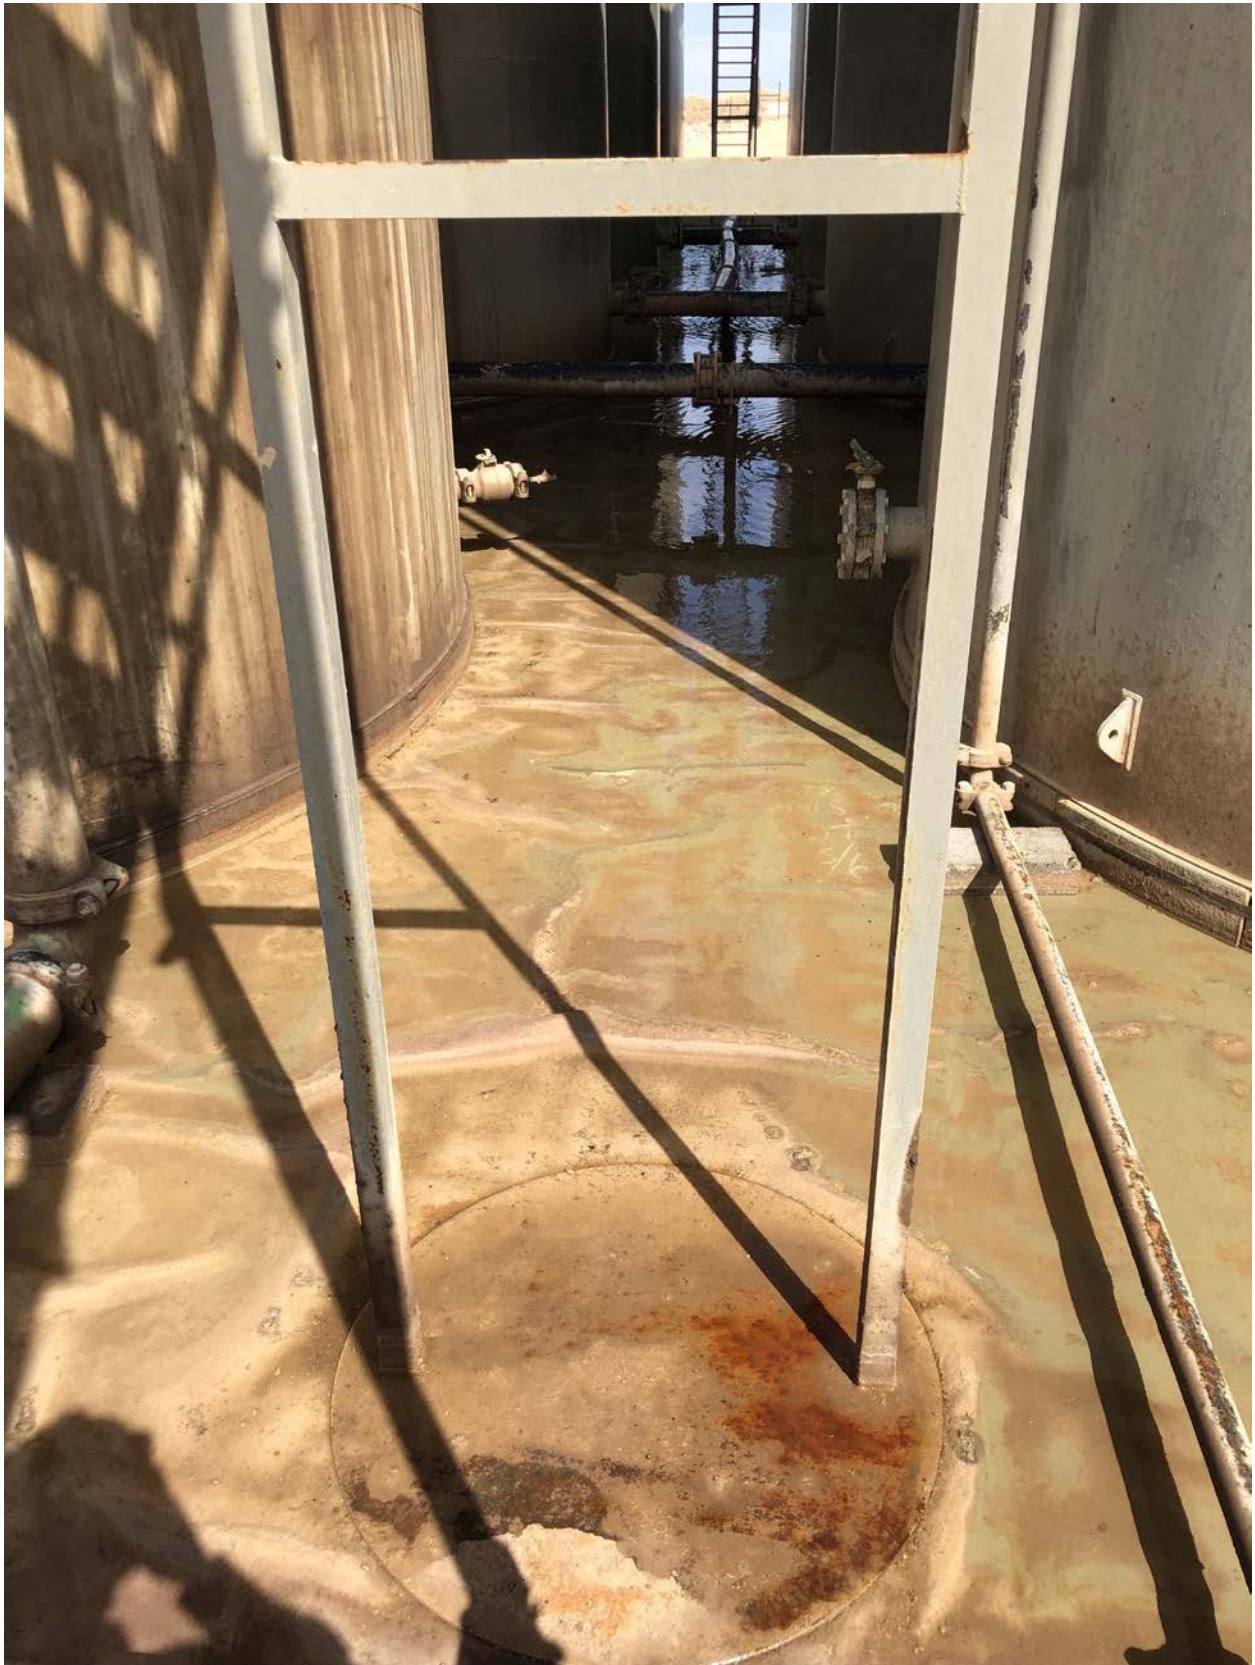
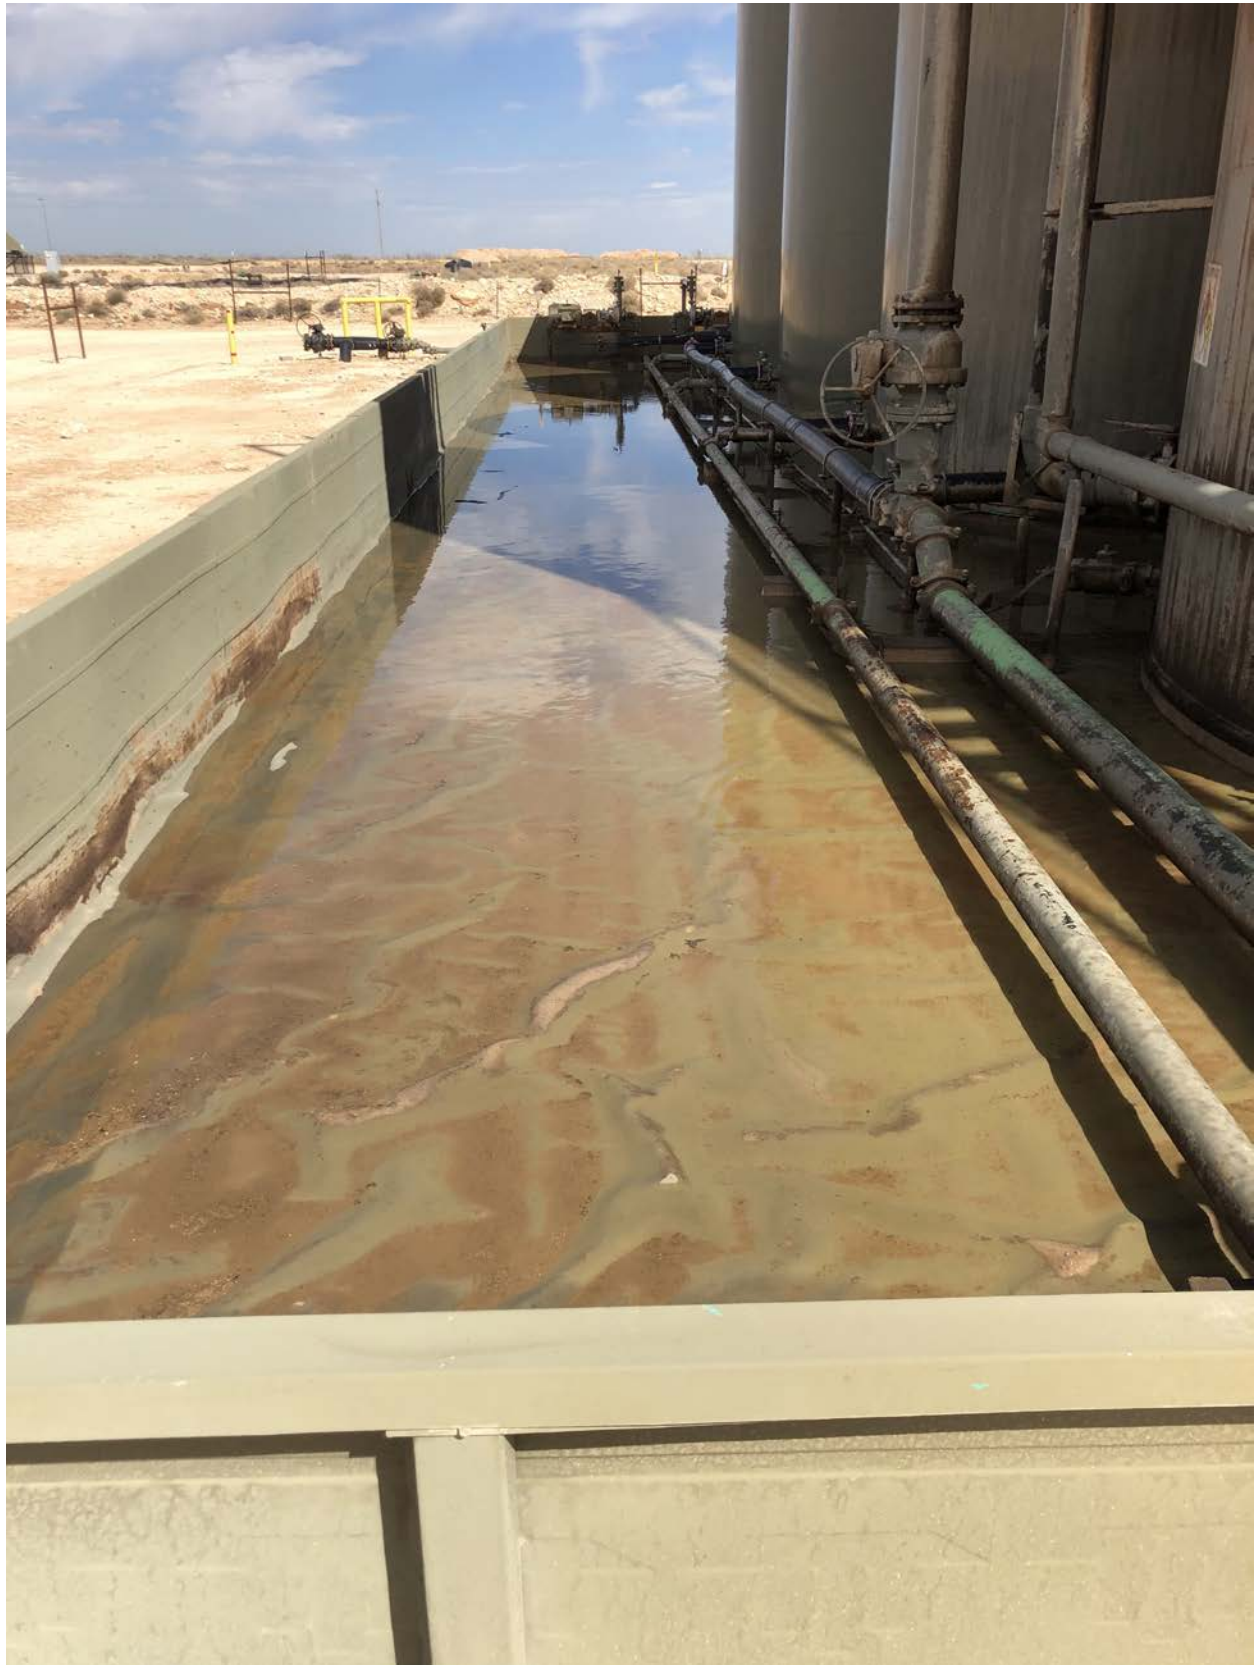
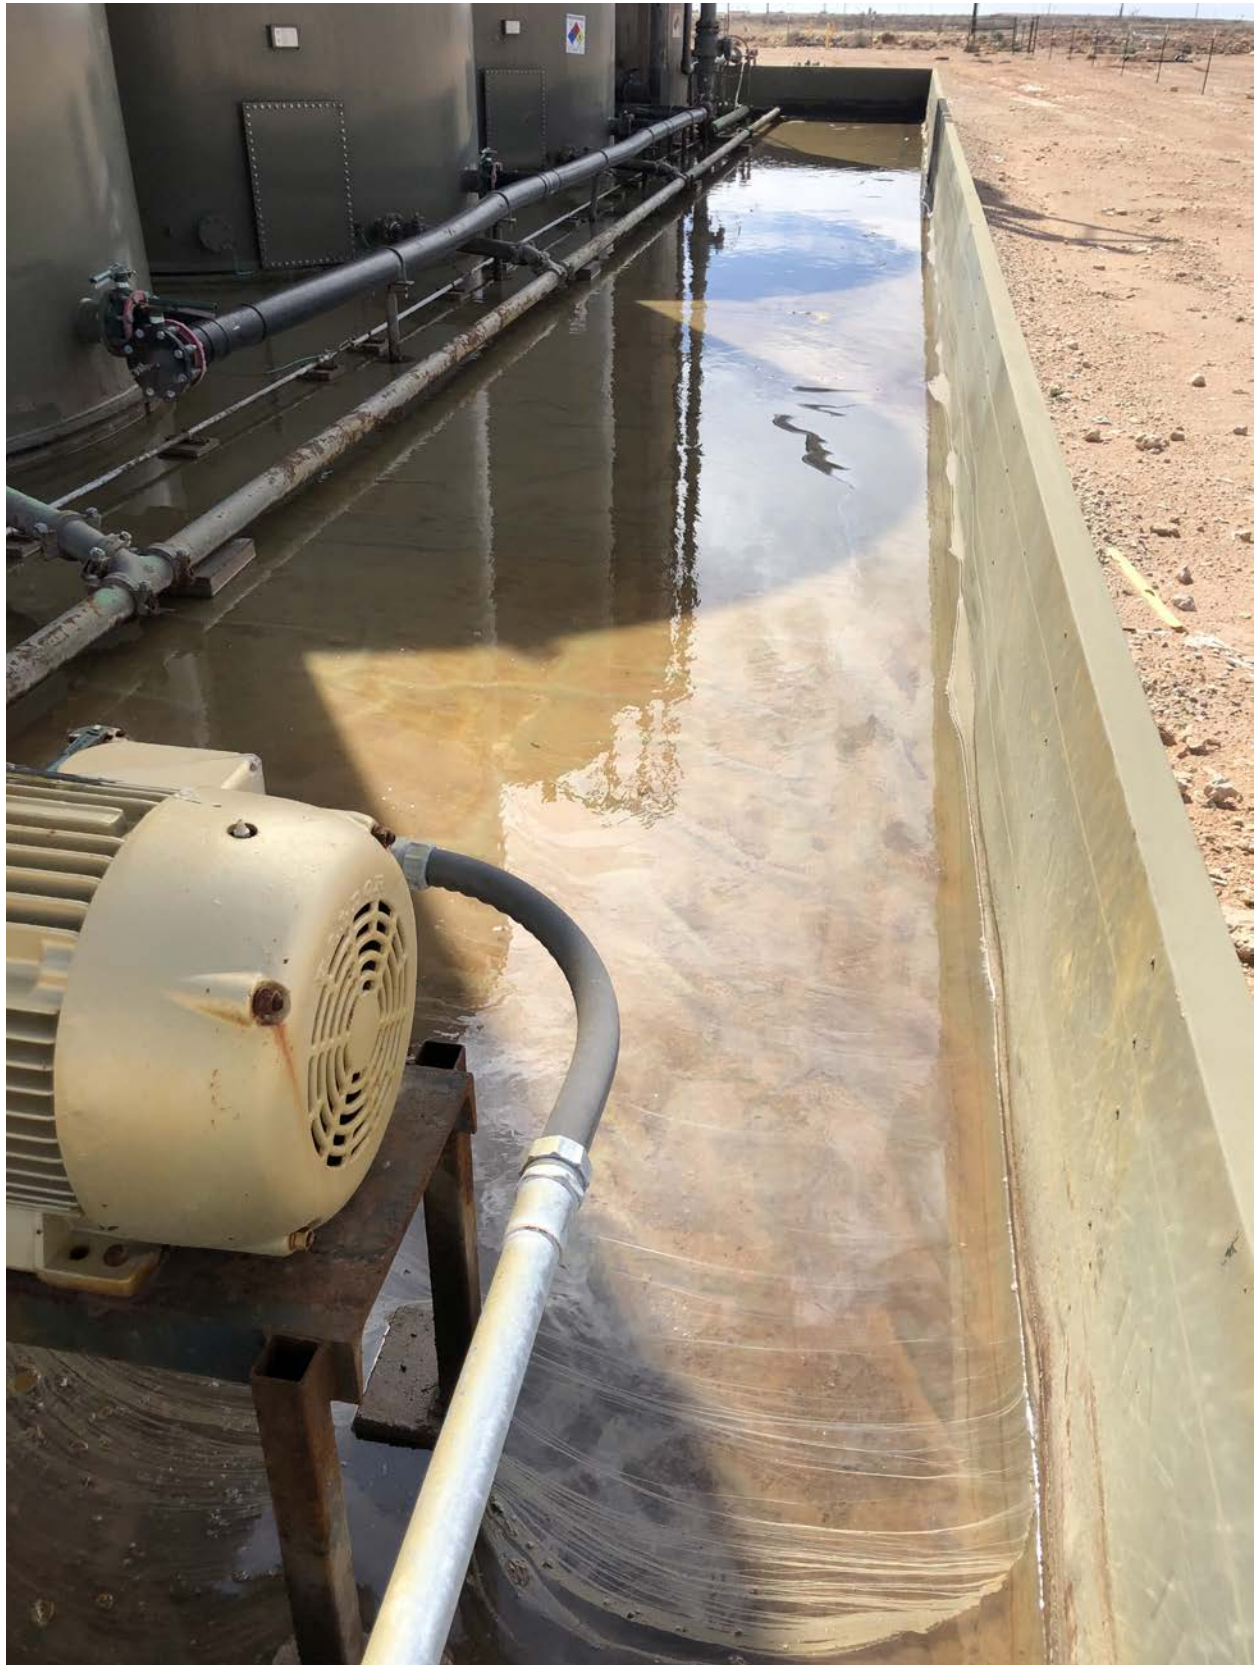
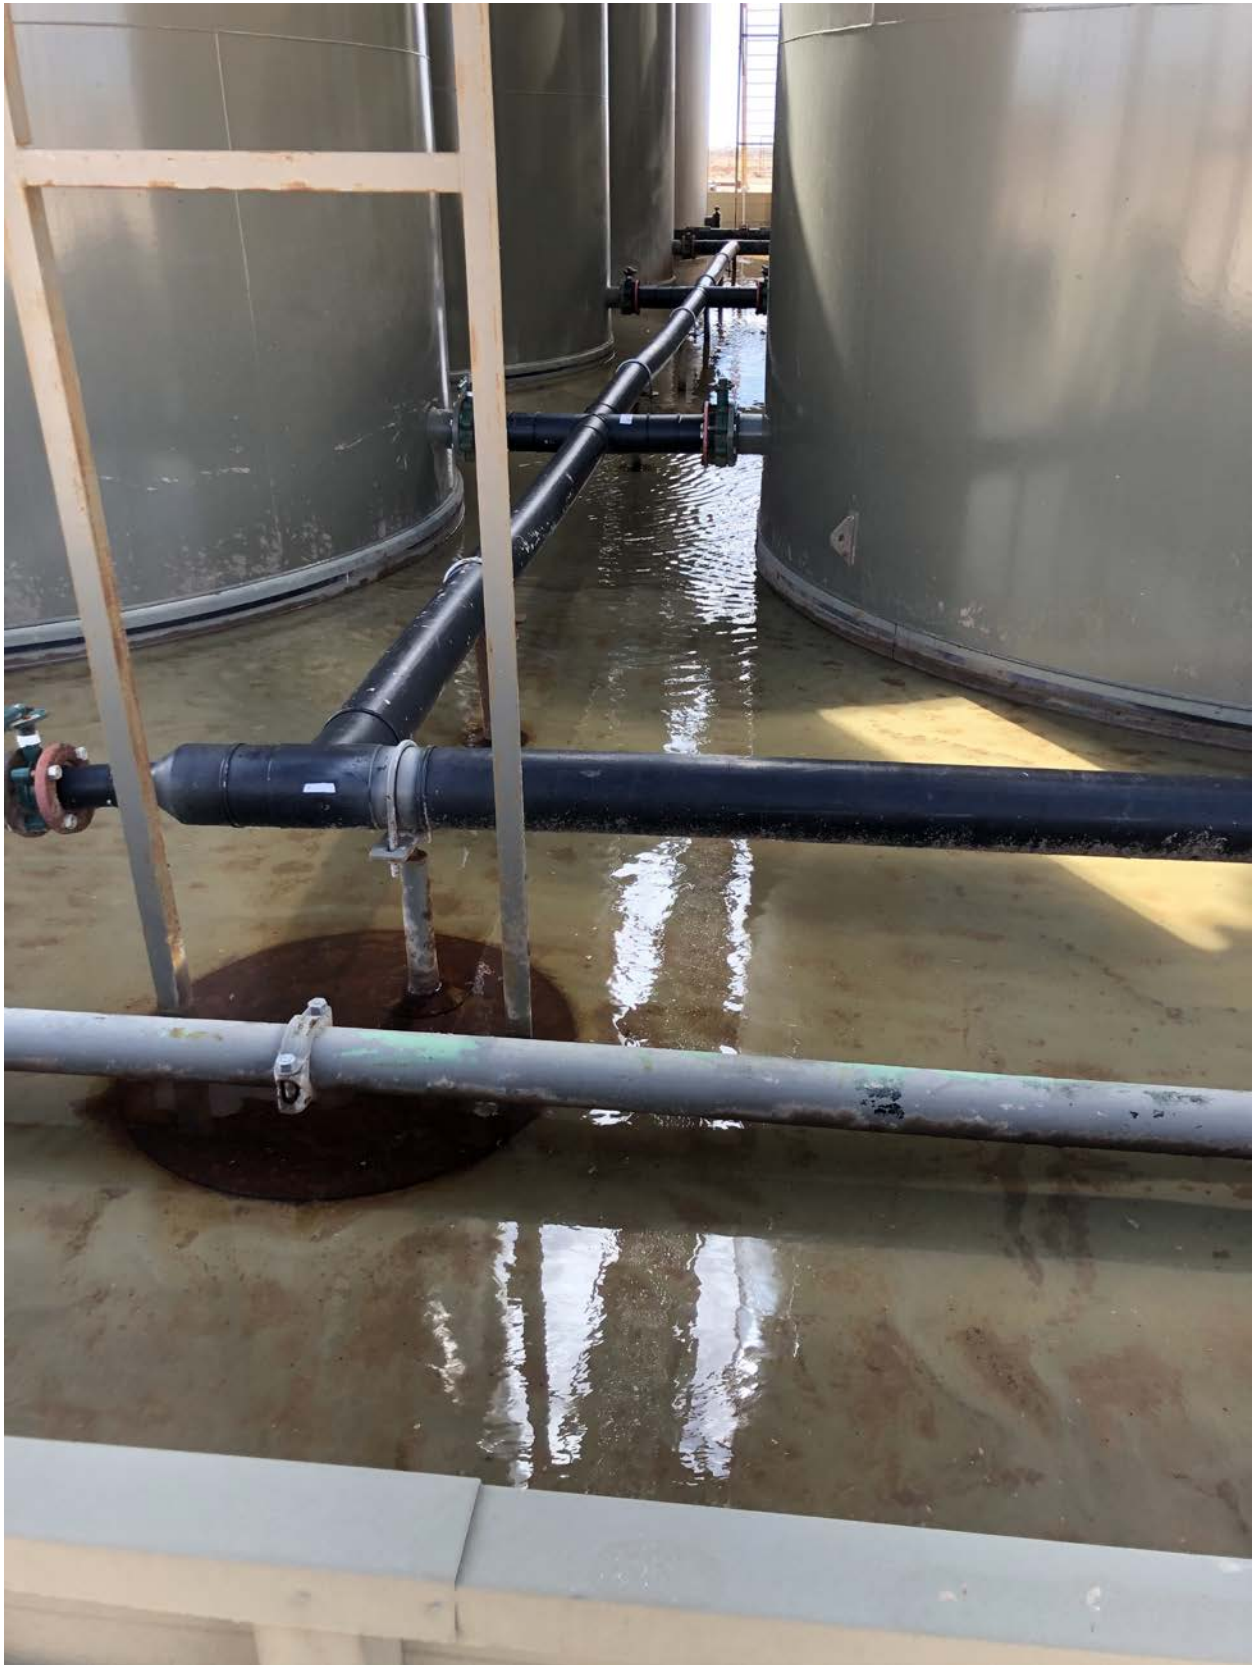
Liner Inspection Photos Taken March 26, 2020

On March 25, 2020, SMA conducted a liner integrity inspection per requirements of 19.15.29.11.A(5)(a) NMAC. Notice was given to New Mexico Oil Conservation Division on March 23, 2020 that the inspection was to occur on the date mentioned above. After a thorough visual inspection of the containment structure, the liner appeared to be intact and had the ability to contain the leak. The containment did have standing water due to a recent rain event, supporting evidence of liner integrity. A Photo Log documenting the inspection is included in Appendix C.

Liner Integrity Was Maintained (per SMA Inspection)

Release Was Contained to Lined Containment Area

Liner Was Able to Contain the Leak

On behalf of Devon Energy Production Company, SMA recommends no further action and requests closure for the release associated with 1RP-4949
