Site Assessment Report and Proposed Remediation Workplan & Deferral Request

Grizzly Energy, LLC

Kersey State Battery

NMOCD Reference No. 2RP-NRM2004550944

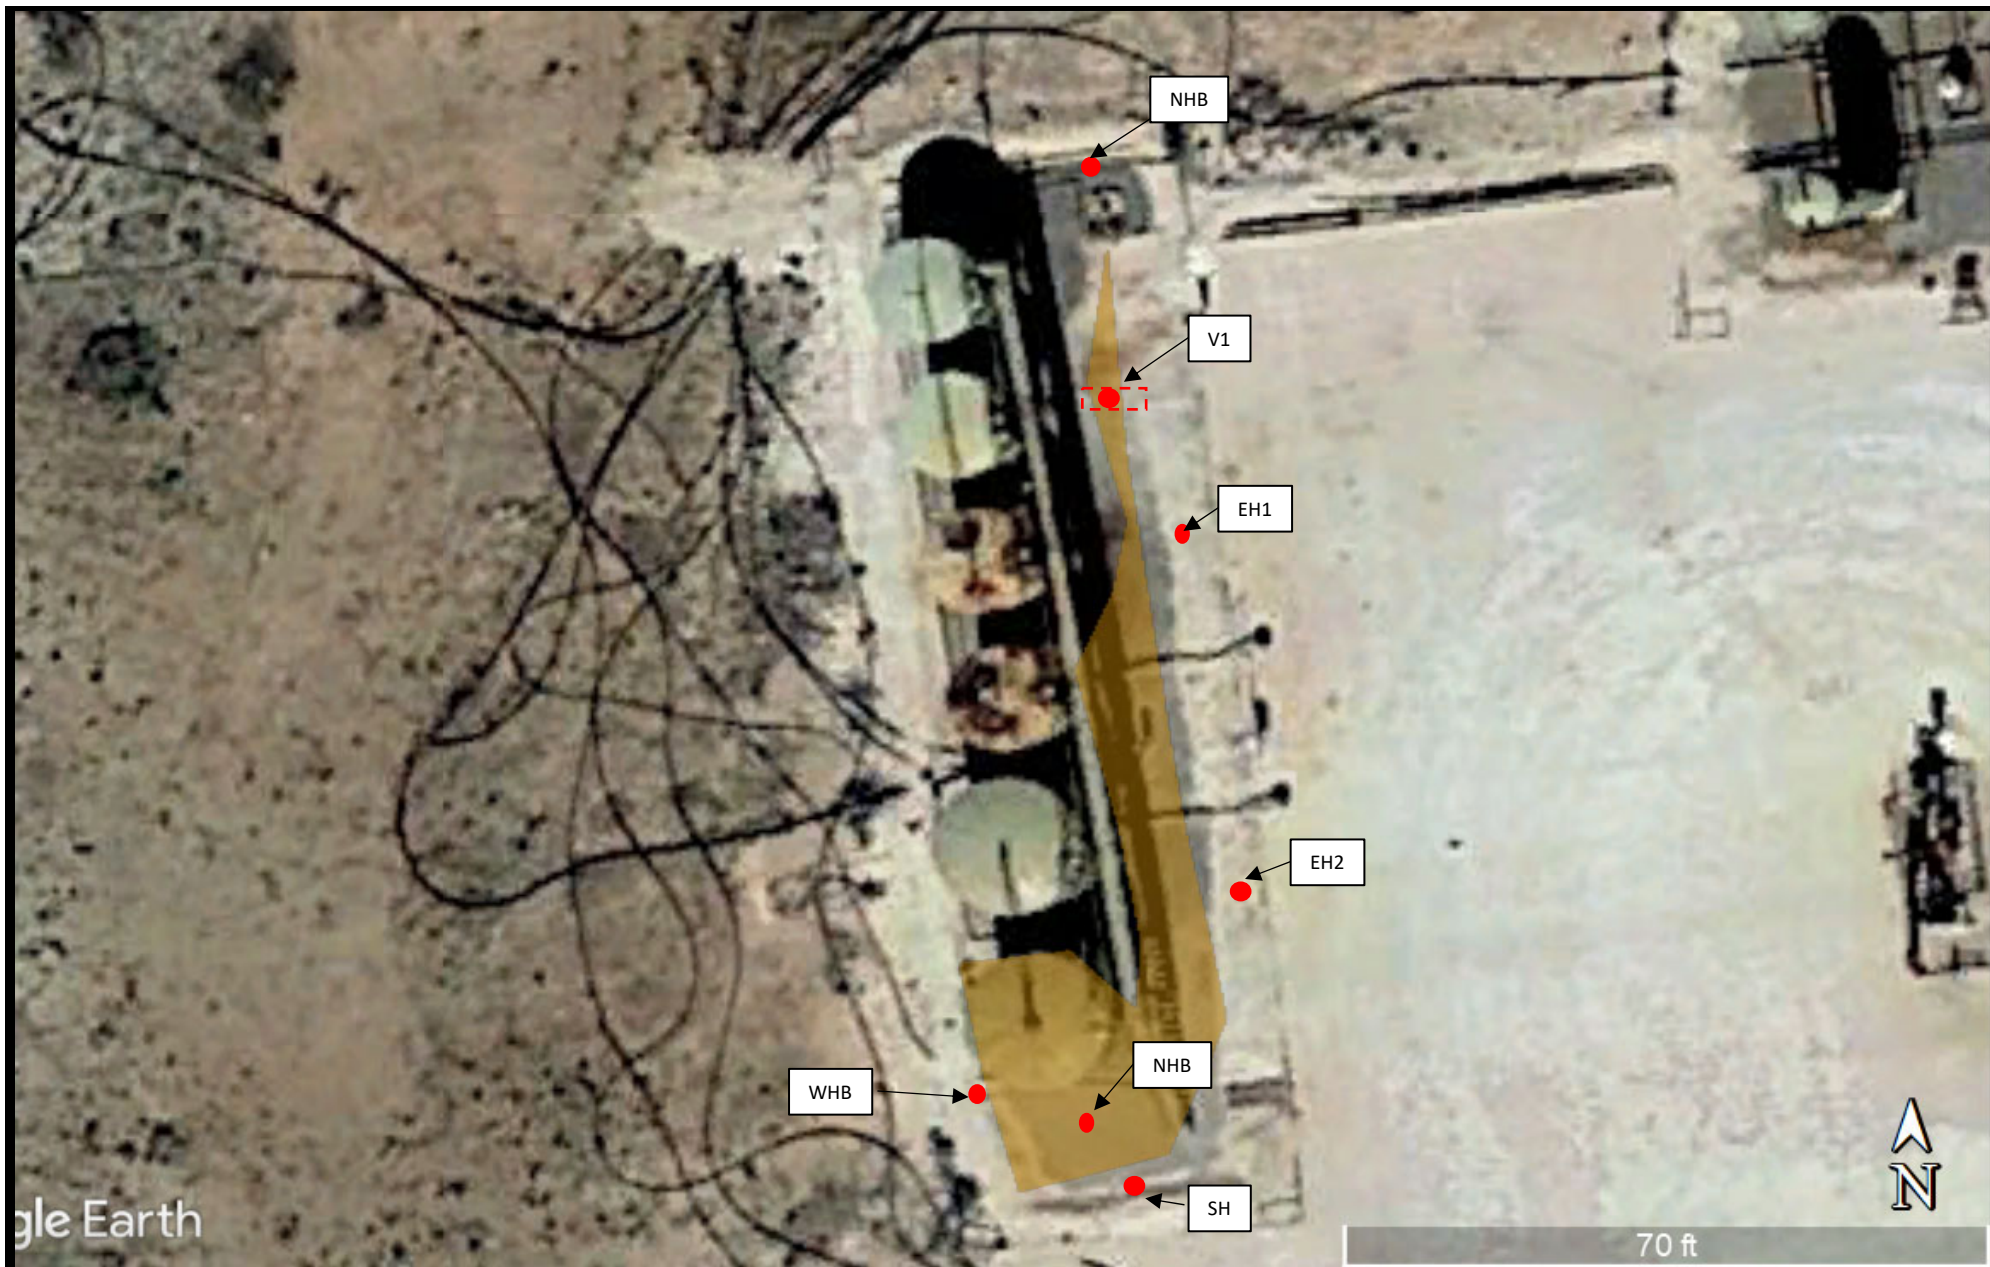
Figure 3

Site and Sample Location Map

●	Sample Point		Excavated Area
	Affected Area		
—	Buried Pipeline		
	Test Trench
