**ORE IDA 14 Federal 2**

## **Delineation Report and Work Plan**

**Unit Letter E, Section 14, T24S, R29E  
Eddy County, New Mexico**

**30-015-28930**

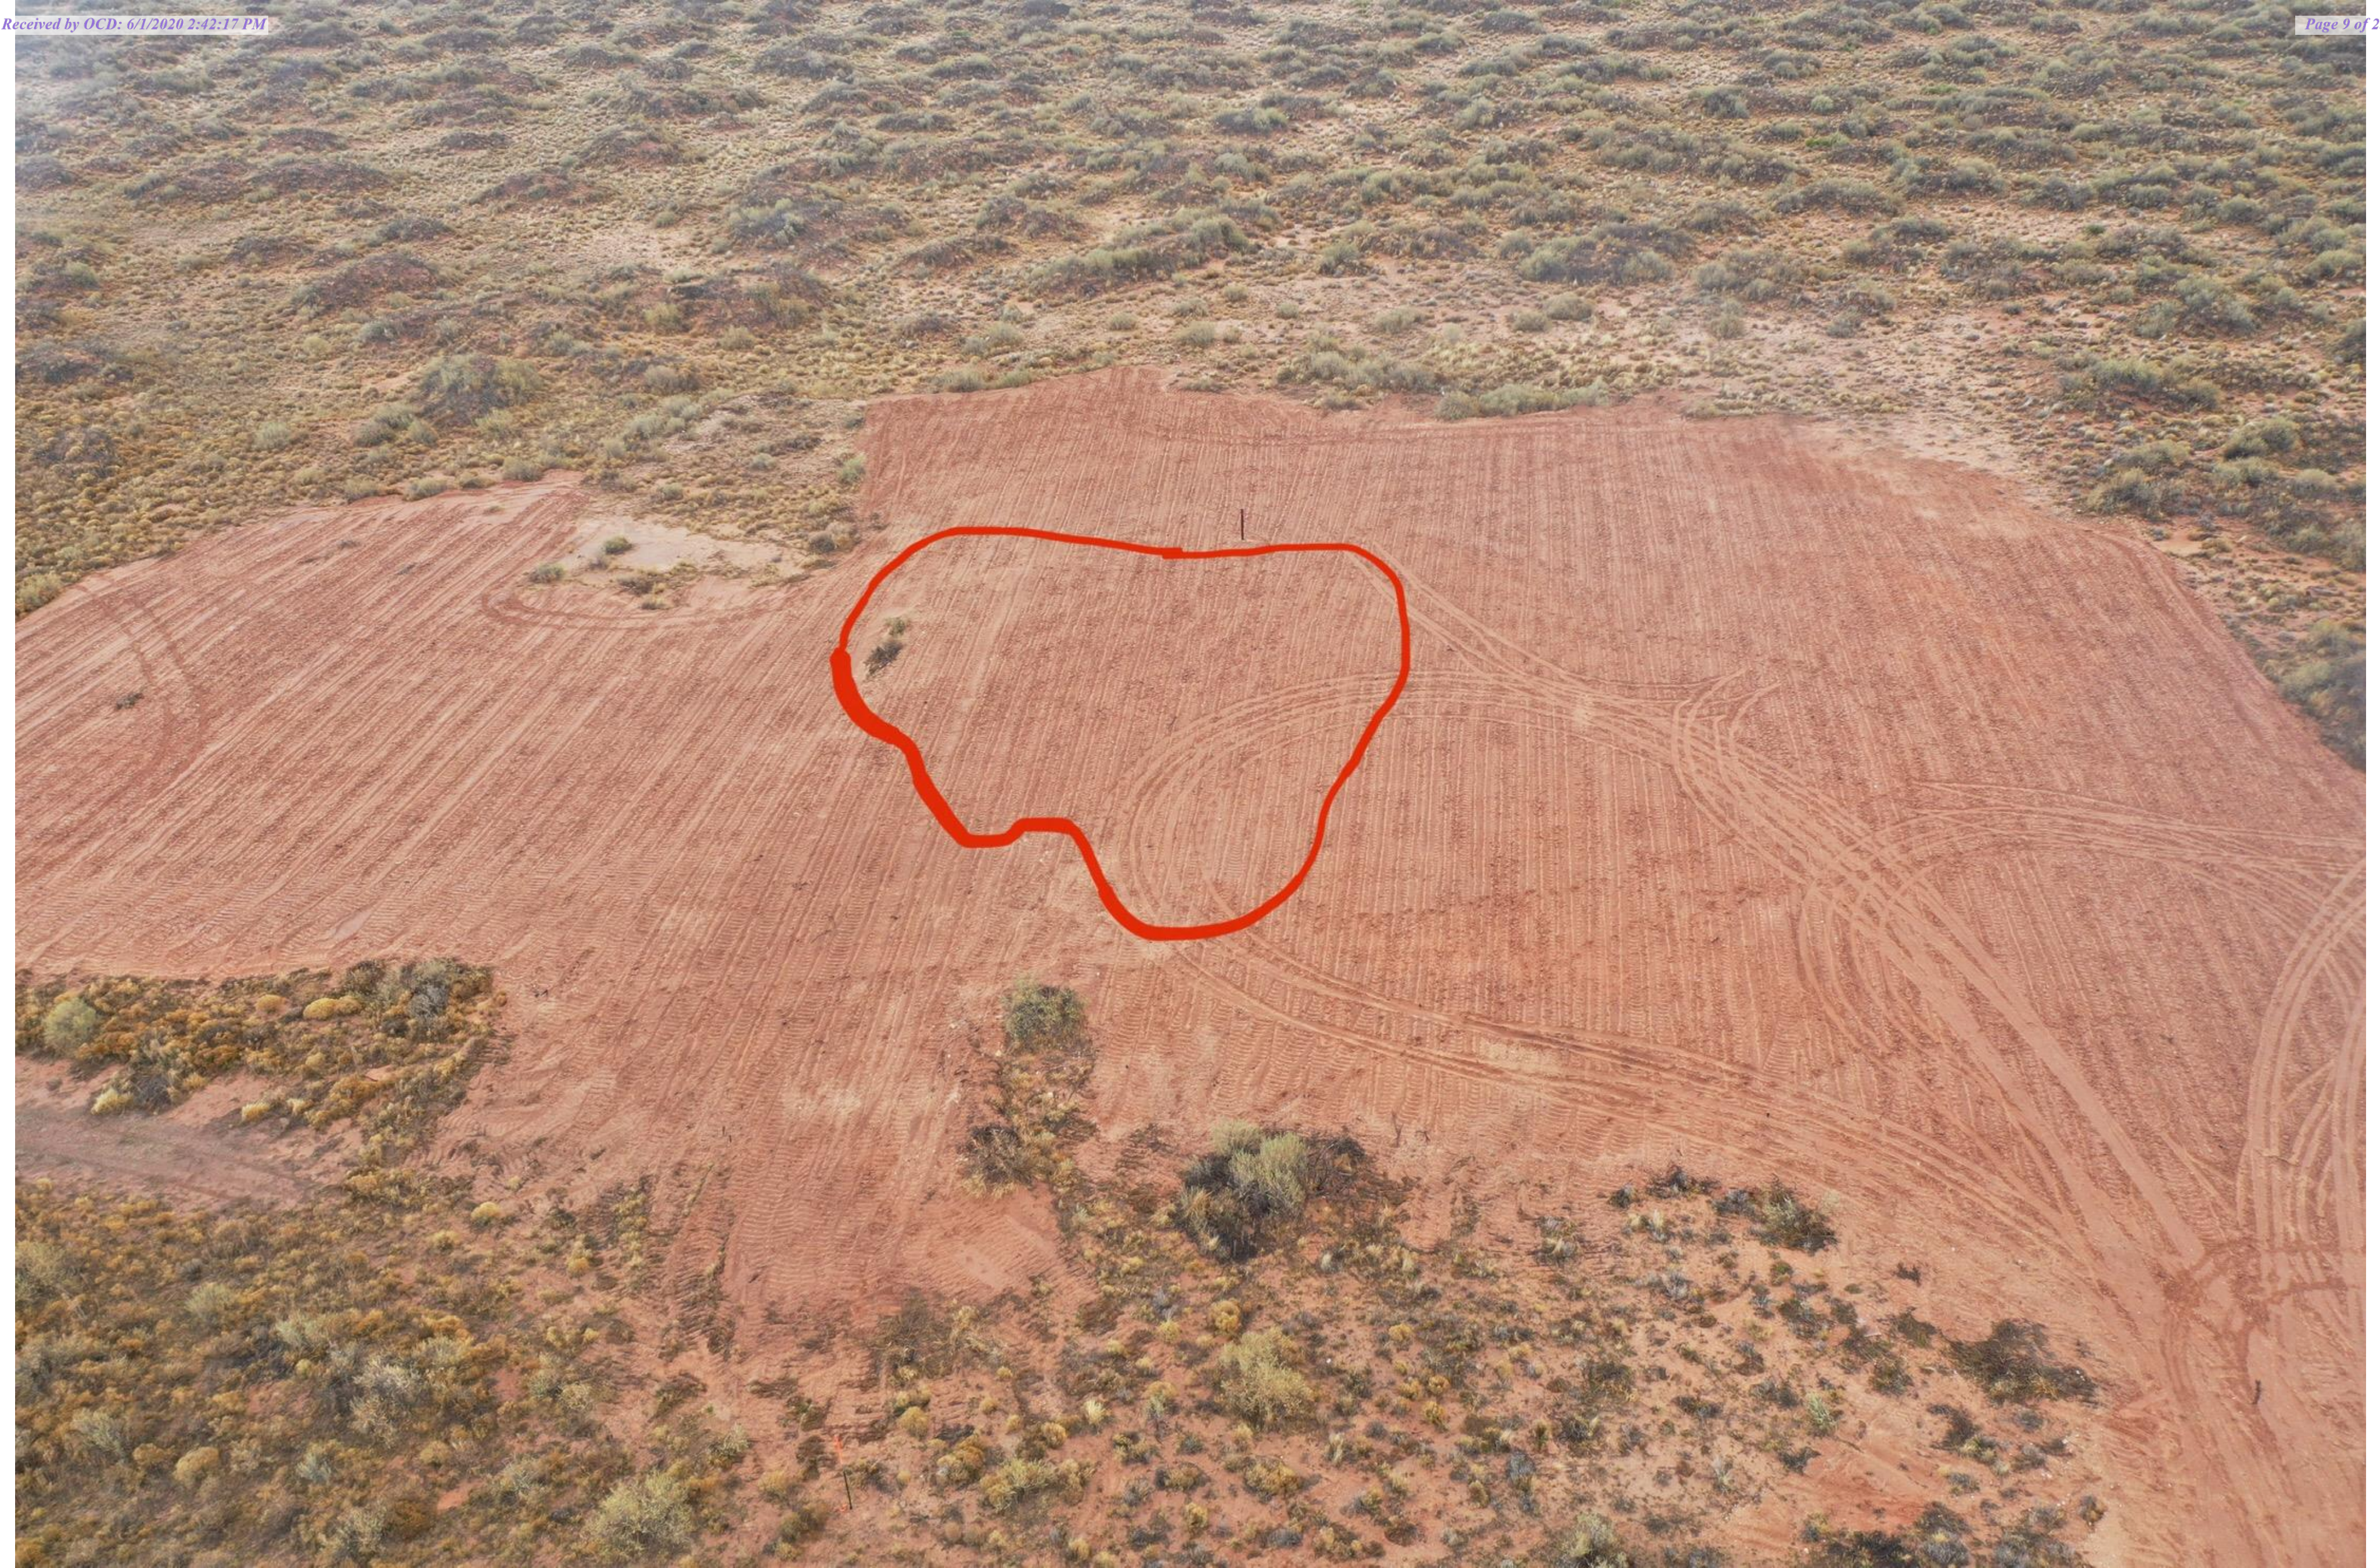
## **Figure 2**

On March 17, 2020, JPC was onsite to photograph, assess and map the spill area. Test holes were advanced at an attempt to determine vertical extent. The first dig hole was advanced on the north end of the leak. Test hole two was advanced to 3' bgs., where dig refusal was encountered. Test hole three was installed at the area where the fluid appeared to have settled causing the greatest impact, and dig refusal was encountered at 3' bgs.

### **Site Plan**

Excavate impacted soil to a depth of 4' bgs. Discrete samples will be taken from the sides and bottom of the excavation area. The representative soil samples will be taken to a commercial laboratory for final analysis and confirmation. The excavated area will be lined with 20 mil. Liner and backfilled according to BLM guidelines.
