Morris 26 E #1

Closure Report

2RP-5152

Subject: Closure Request for Percussion Petroleum – Morris 26 E #1

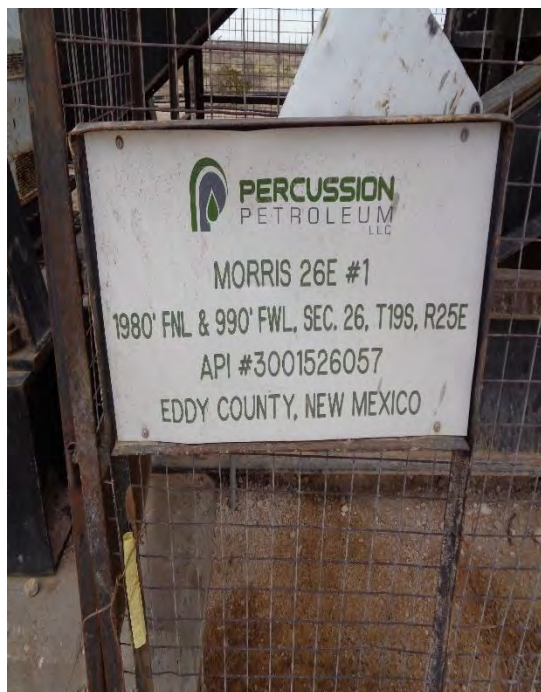
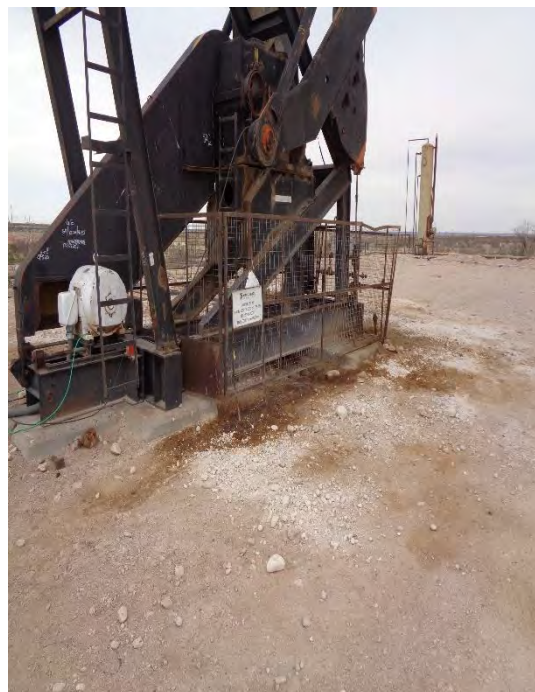
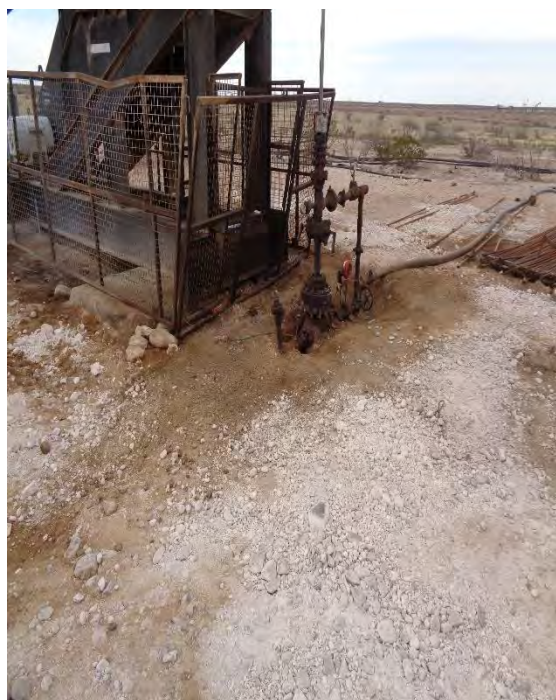
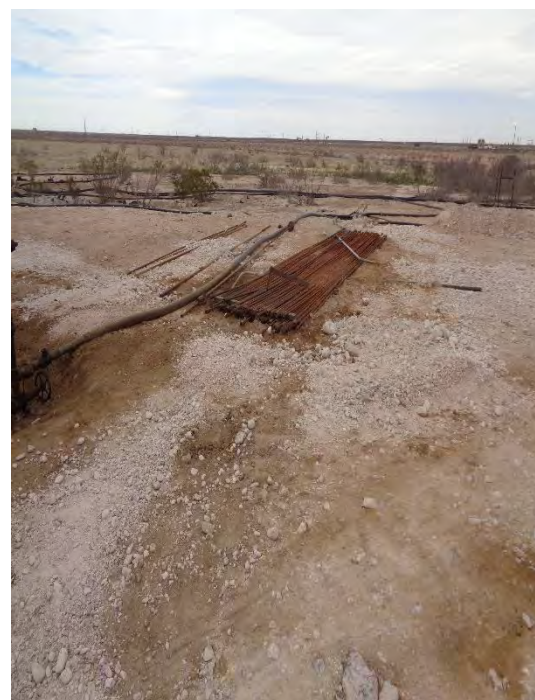
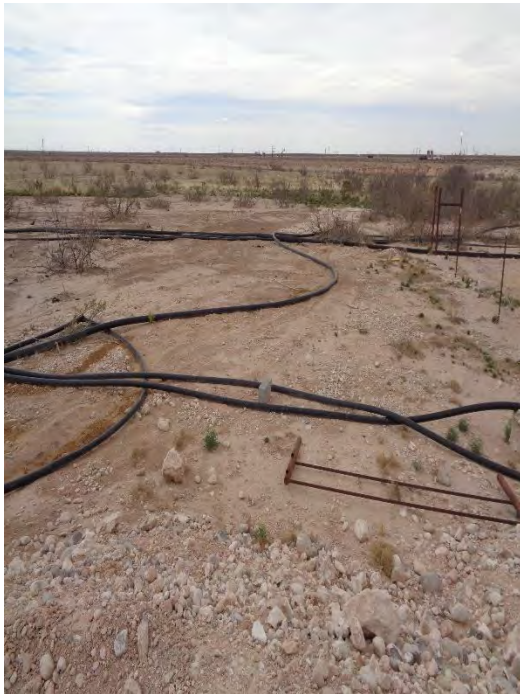
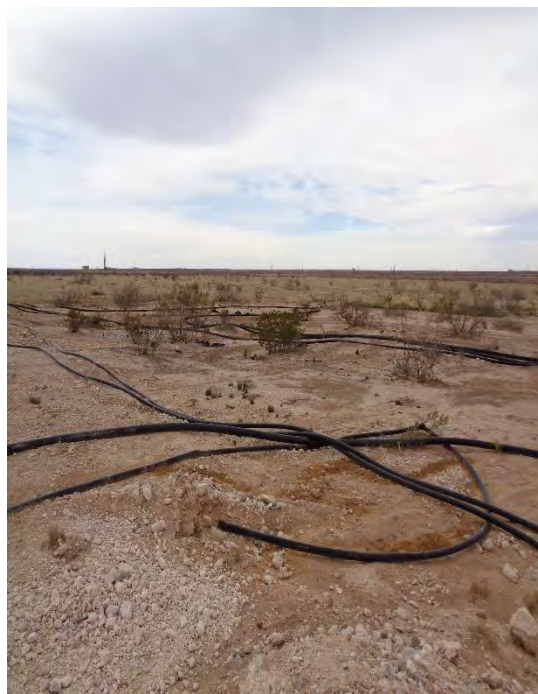
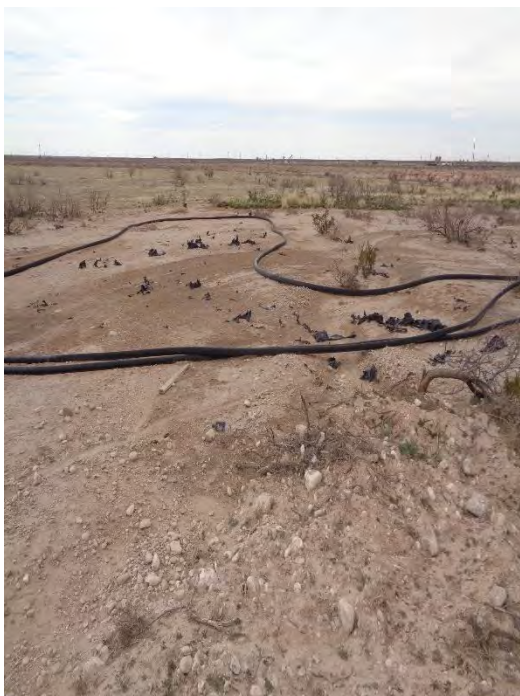
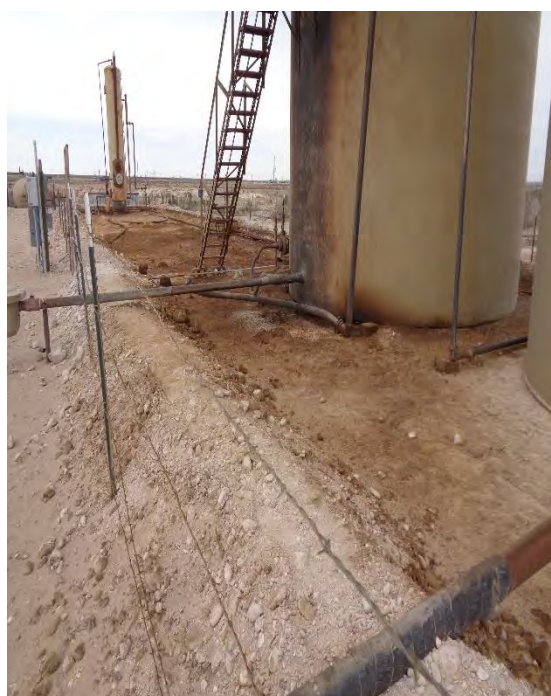
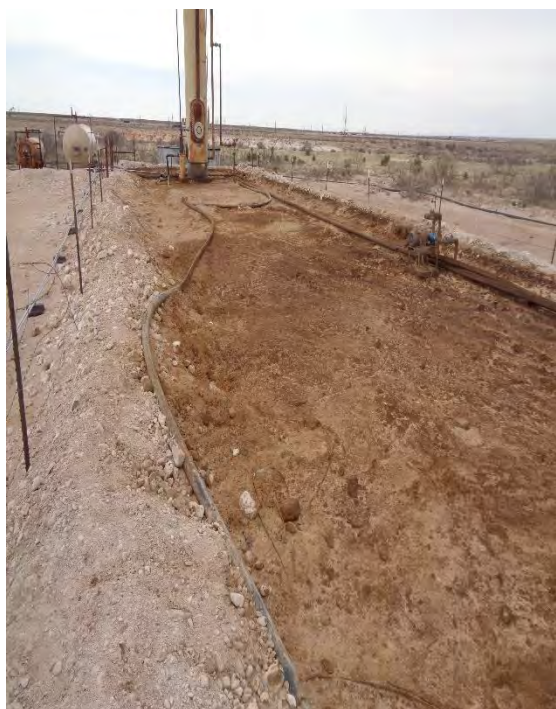
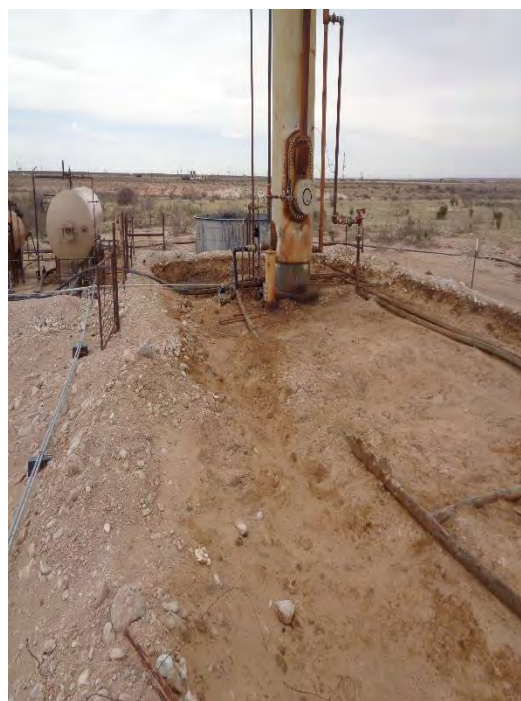
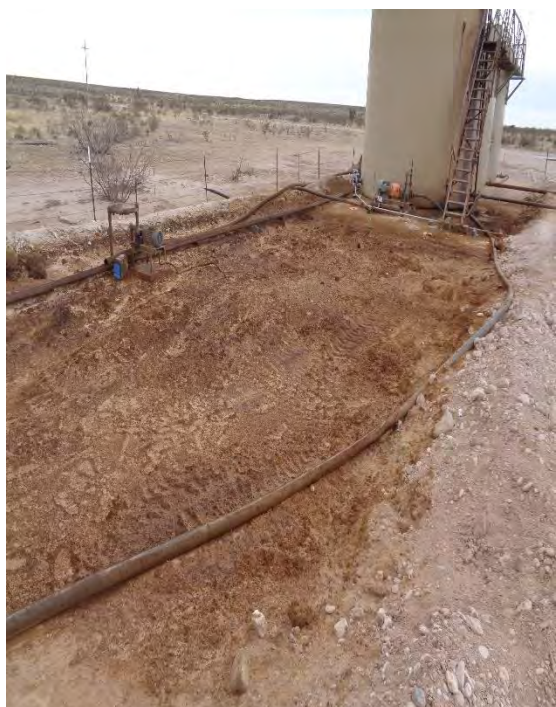
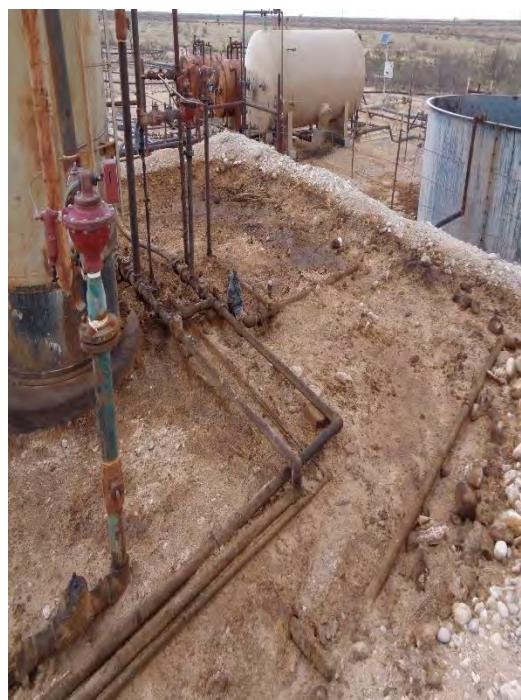
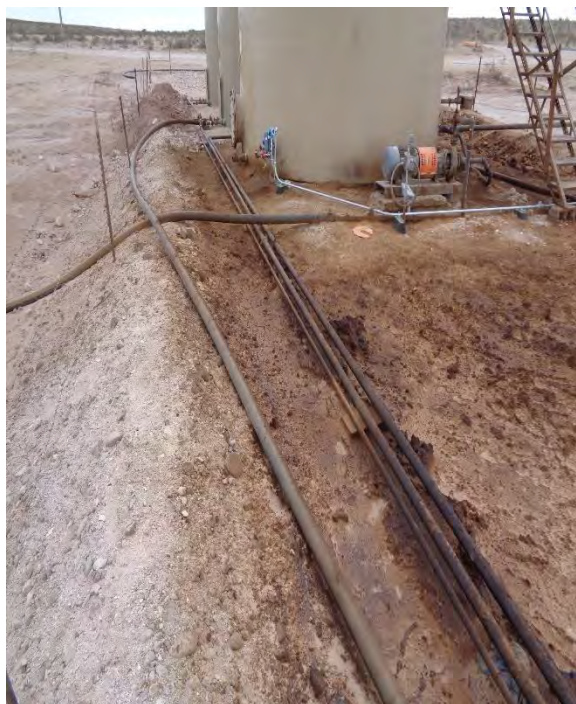
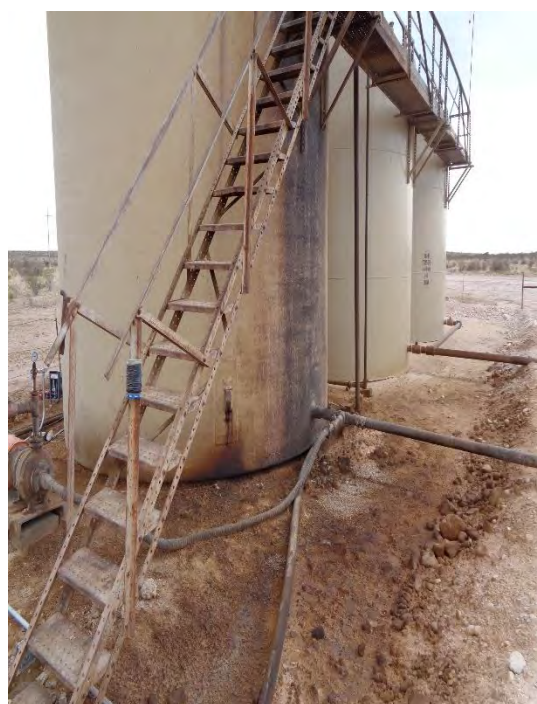
PERCUSSION PETROLEUM- MORRIS 26 E # 1 BATTERY BEFORE PHOTOS

The site is located in Eddy County, New Mexico. The release was located on October 29, 2018. The transfer pump that sends produced water to the SWD had failed. This caused 65bbls of oil and 190bbls of produced water to be released in and around the earthen bermed containment. A vacuum truck was dispatched out to recover approximately 180bbls of produced water and 60bbls of oil. The fluid was released not only inside the earthen bermed containment, location pad but also in the pasture area. The area of impact measured 19,990 sq. ft total. The corresponding C-141 for the release is attached.

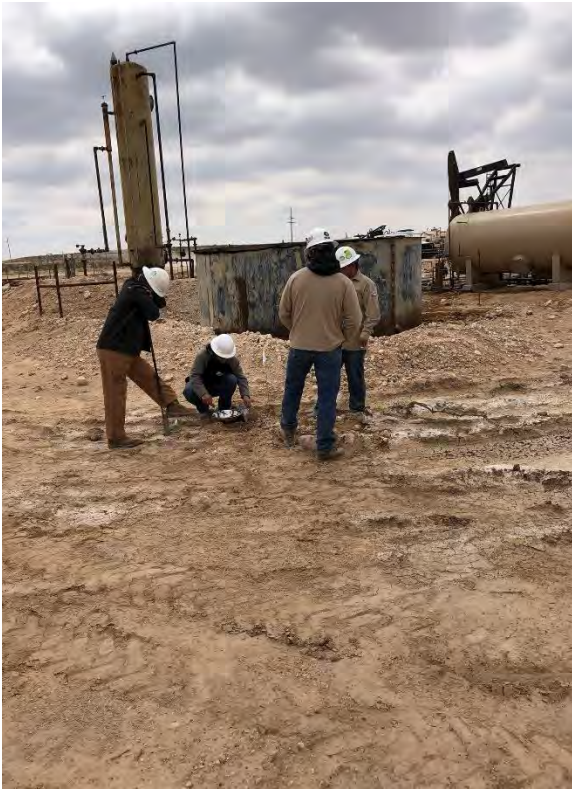
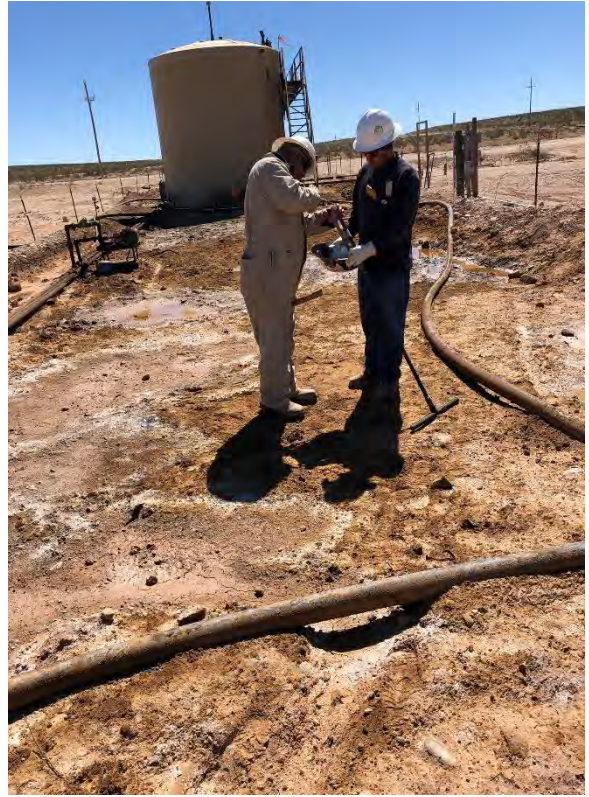
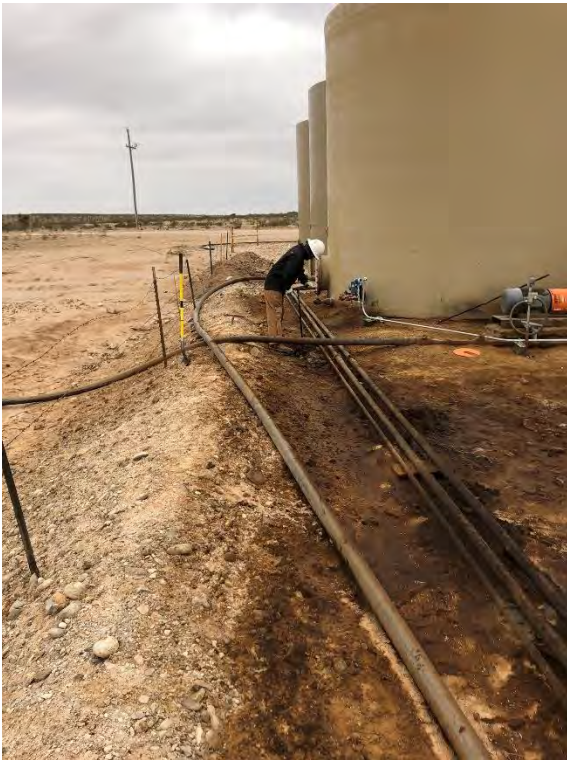
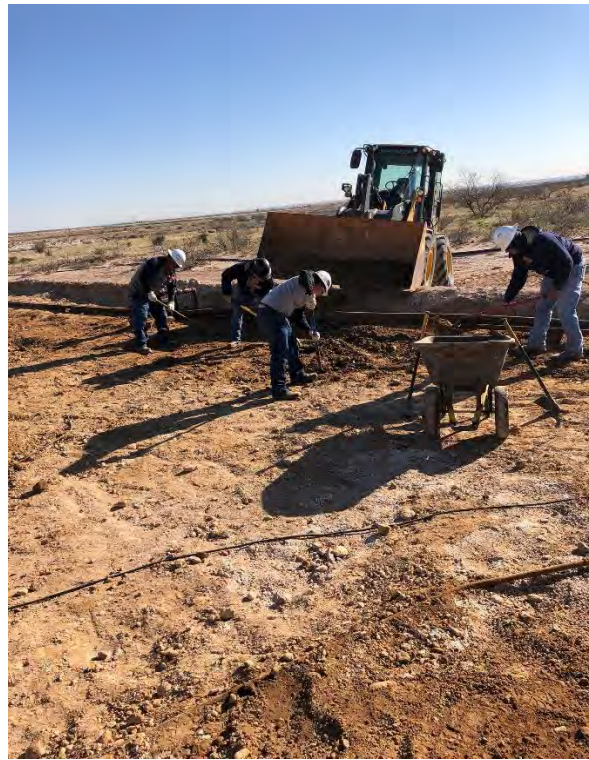
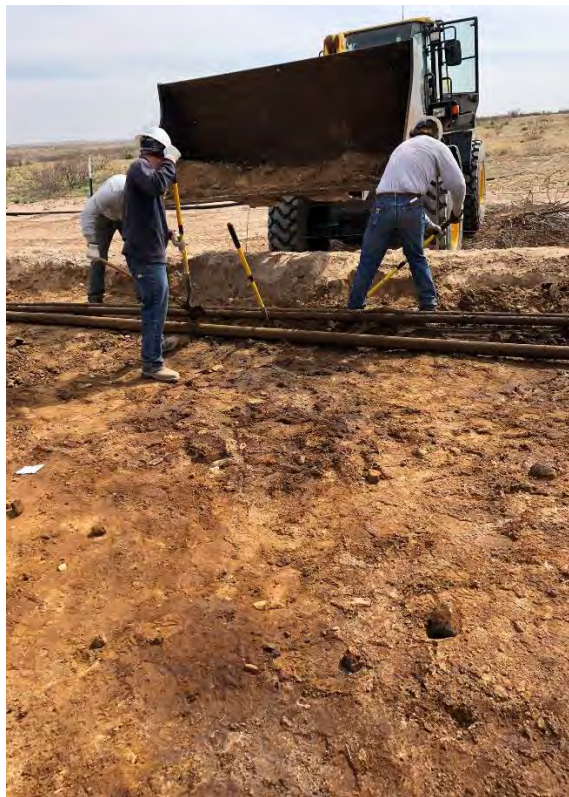
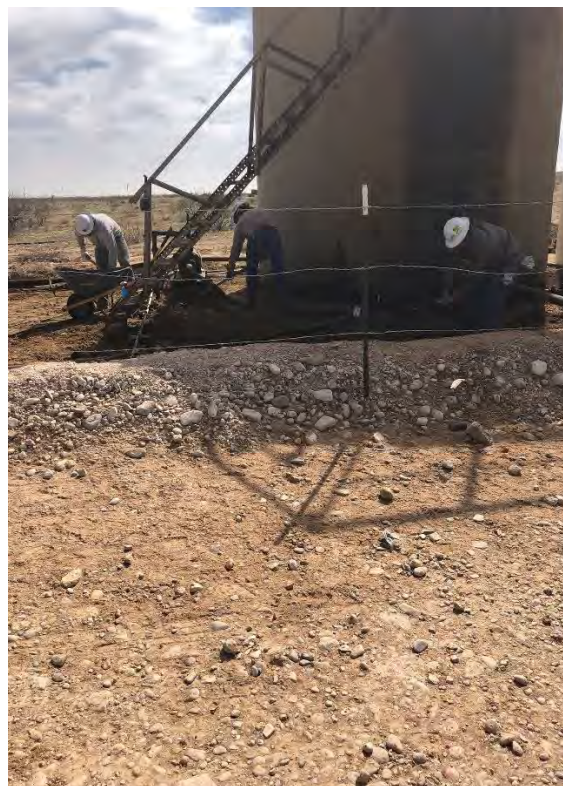
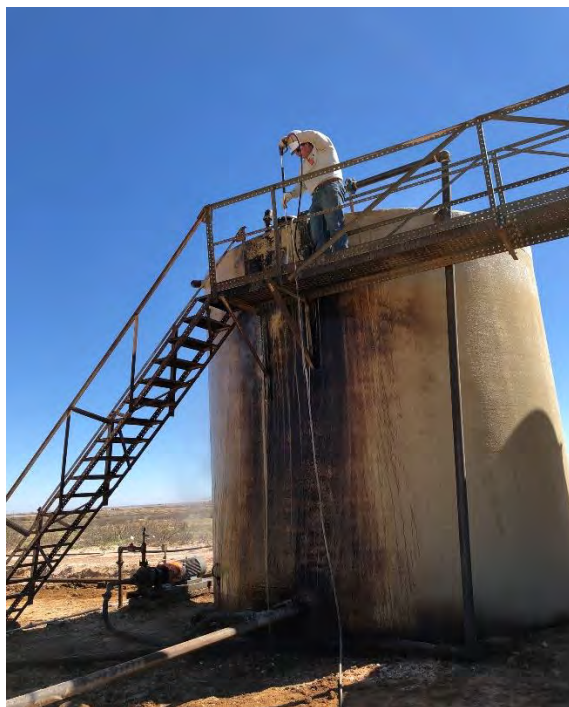
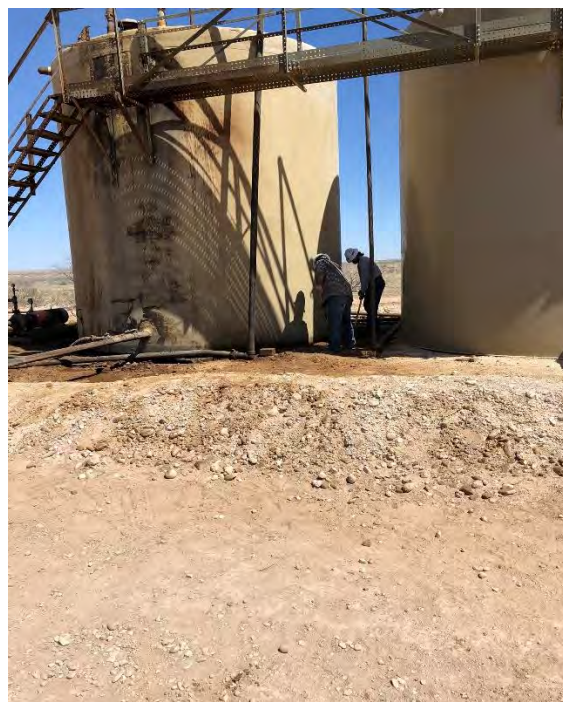
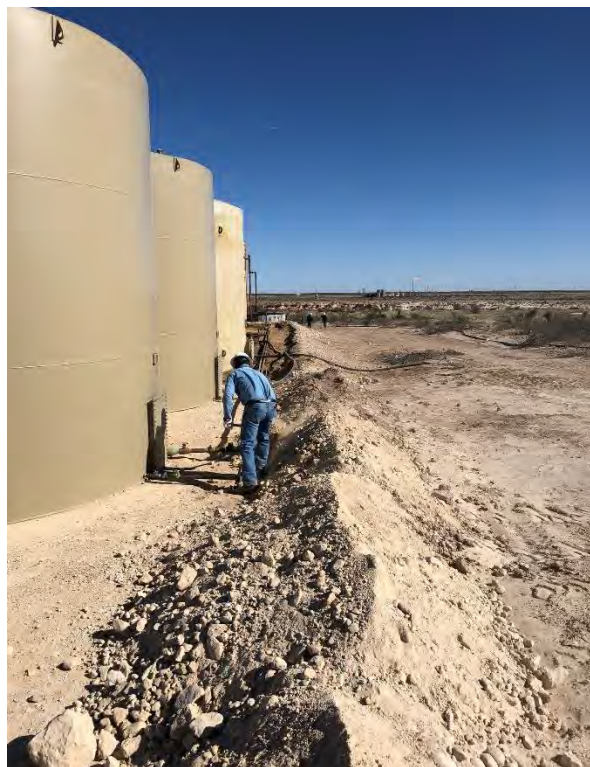
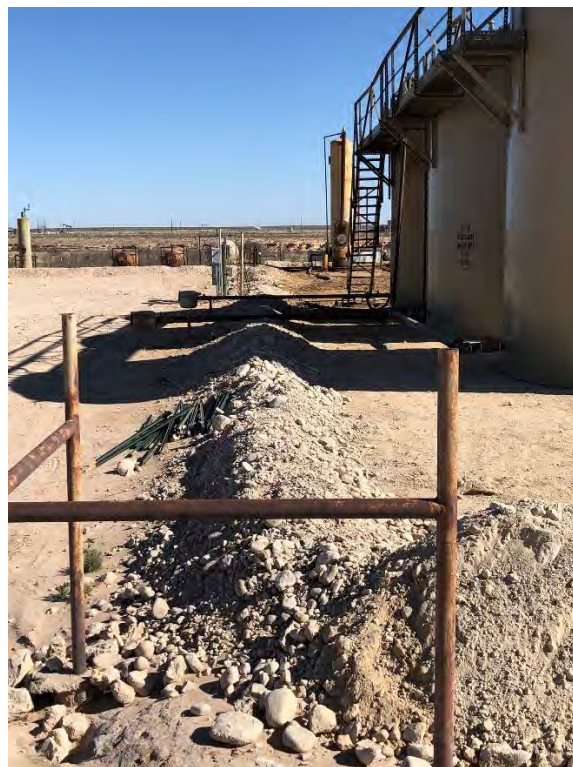
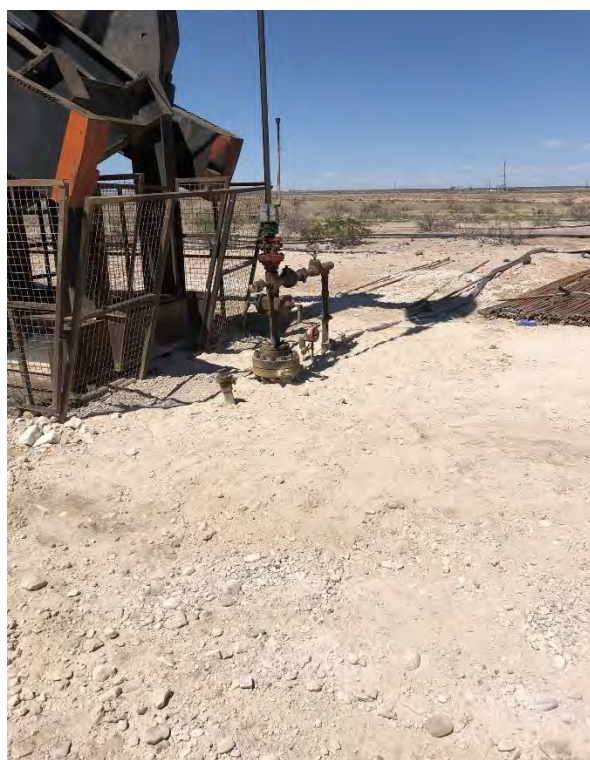
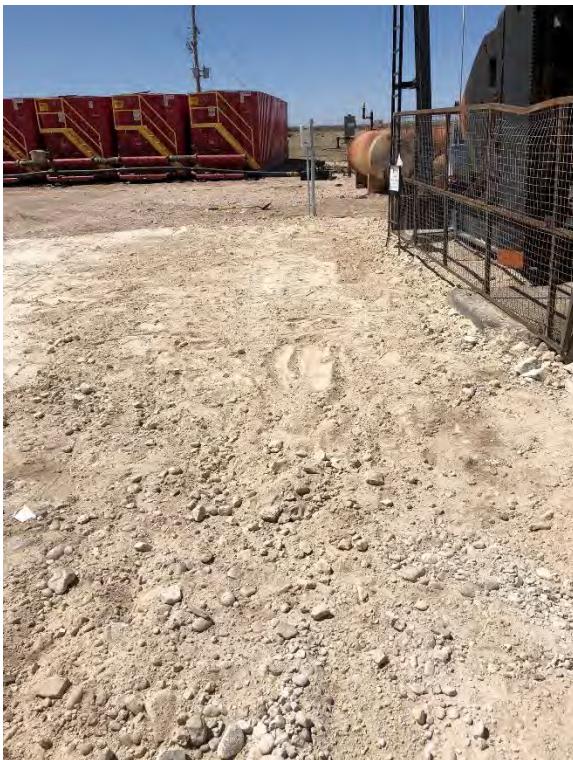
PERCUSSION PETROLEUM- MORRIS 26 E #1 BATTERY DURING PHOTOS

With the vertical samples confirmations from Cardinal Lab's it was determined that 6" to 1' in the area of the containment for sample point 5, 6 and 7, the pasture area was back-dragged due to the sampling data falling under the rule closure criteria, except for SP10 and SP13. These two sample point areas were excavated to 4' bgs, in a 4x4 area, one bottom hole composite was taken and four side walls were jarred and delivered to Cardinal Lab for confirmation.

On April 1, 2019 an email was sent to the NMOCD to request to witness final closure samples. On the pad area all sample points fell well under the concentration levels for the site closure criteria, except for SP17. This area was dug out in a 4x4 section. Sample point 10 and 13 was excavated to 4' bgs, in a 4x4

area, one bottom hole composite was taken and four side walls were jarred and delivered to Cardinal Lab for confirmation. A total of 72 cubic yards were hauled to disposal and 198 yards of clean caliche was brought back in for backfill of the excavation areas mention above as well as rebuilding the berms to meet the SPCC Requirements. The rest of the pad and location was back-dragged to its natural state.
