June 24, 2020

Vertex Project #: 20E-00141-031

**Spill Closure Report:** Apache 25 Federal #006  
Unit P, Section 25, Township 22 South, Range 30 East  
County: Eddy  
API: 30-015-29894  
Tracking Numbers: NAB1919853853

2020 Spill Assessment and Closure  
June 2020

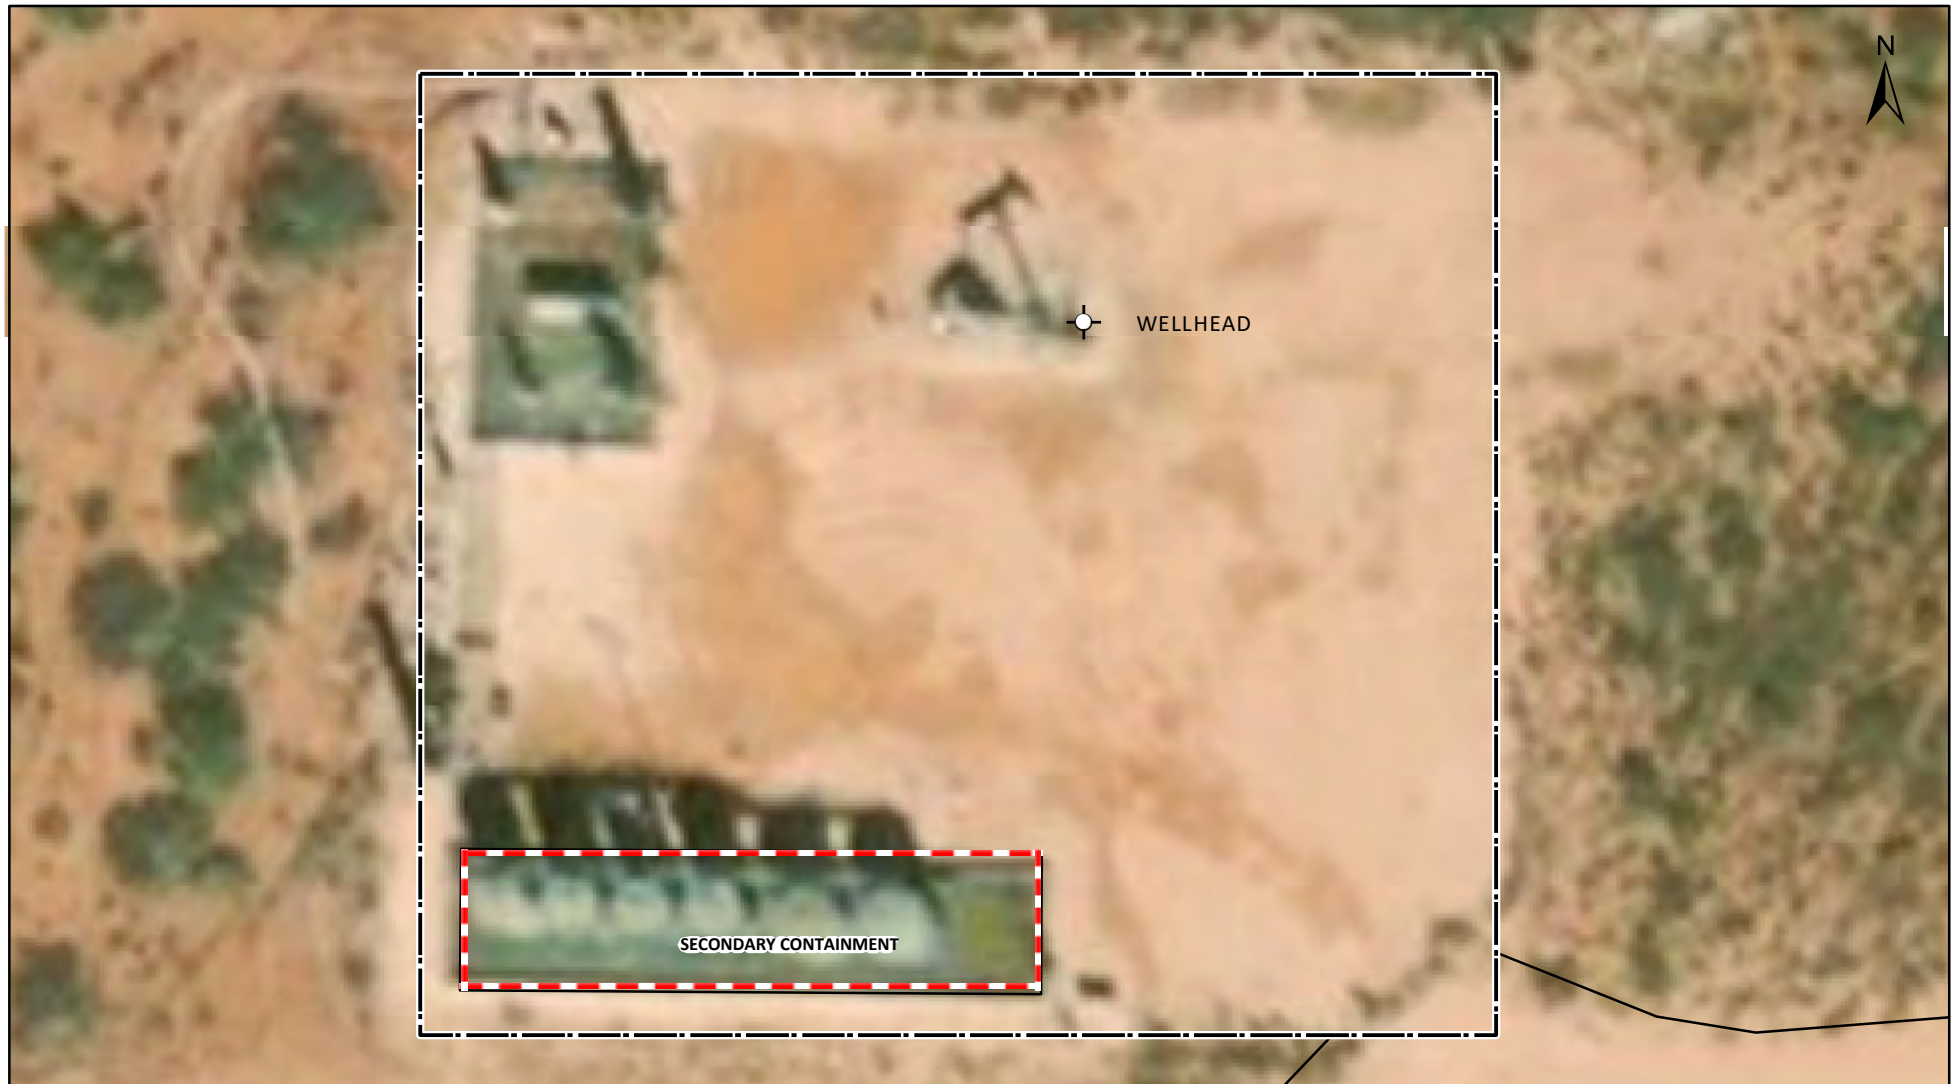
Site Schematic  
Apache 25 Federal #006

SPILL AREA

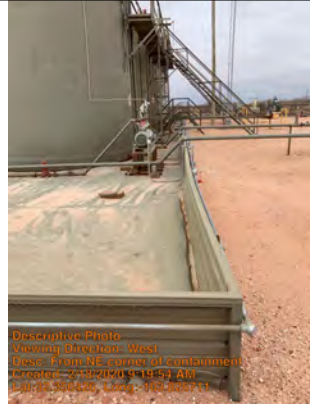
**Viewing Direction: West**

From NE corner of containment

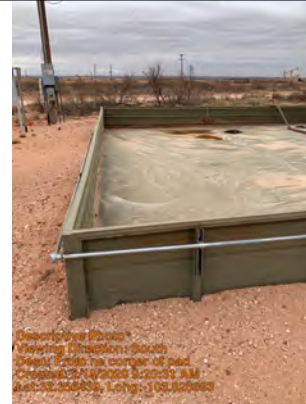
**Viewing Direction: South**

From ne corner of pad

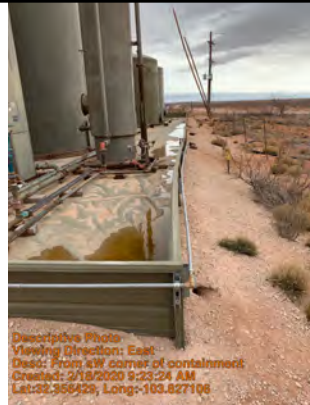
**Viewing Direction: East**

From SW corner of containment

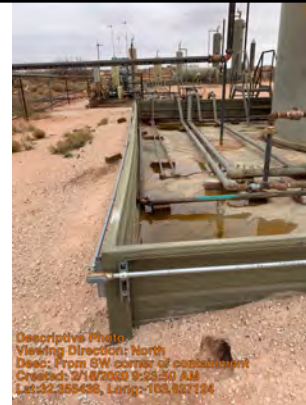
**Viewing Direction: North**

From SW corner of containment

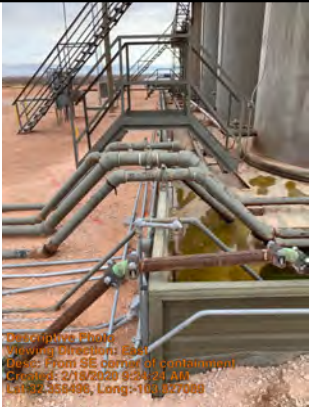
<p><b>Viewing Direction: East</b></p>

<p>Descriptive Photo Viewing Direction: East Date: From SE corner of containment Created: 2/18/2020 9:54:43 AM Lat:32.358498, Long:-100.827088</p> <p>From NW corner of containment</p>	<p><b>Viewing Direction: South</b></p>

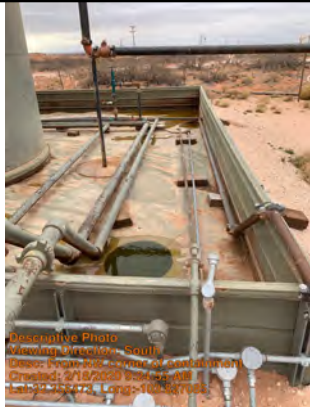
<p>Descriptive Photo Viewing Direction: South Date: From NW corner of containment Created: 2/18/2020 9:54:43 AM Lat:32.358473, Long:-100.827088</p> <p>From NW corner of containment</p>
<p><b>Viewing Direction: West</b></p>

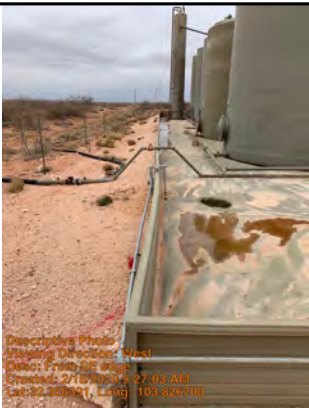
<p>Descriptive Photo Viewing Direction: West Date: From SE edge Created: 2/18/2020 9:54:43 AM Lat:32.358501, Long:-100.827090</p> <p>From SE edge</p>	<p><b>Viewing Direction: North</b></p>

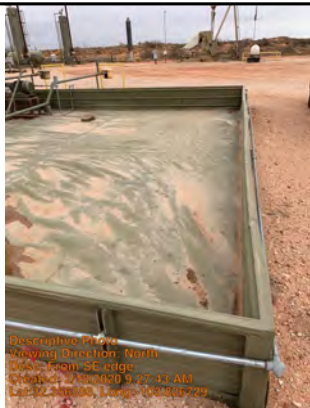
<p>Descriptive Photo Viewing Direction: North Date: From SE edge Created: 2/18/2020 9:54:43 AM Lat:32.358500, Long:-100.827089</p> <p>From SE edge</p>

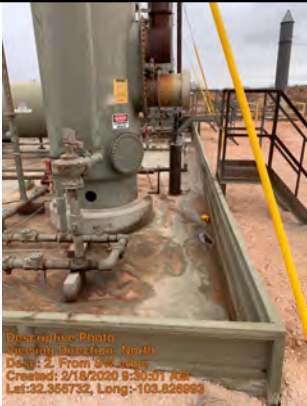
<p><b>Viewing Direction: North</b></p>

<p> <small>           Descriptive Photo            Viewing Direction: North            Desc: 2. From SE Edge            Created: 2/18/2020 9:30:01 AM            Lat:32.356732, Long:-103.826983         </small> </p>	<p><b>Viewing Direction: West</b></p>

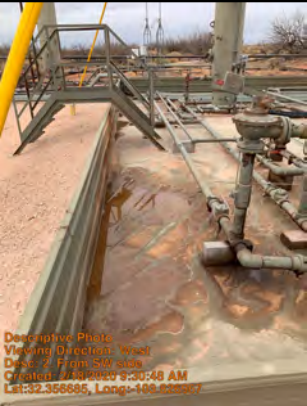
<p> <small>           Descriptive Photo            Viewing Direction: West            Desc: 2. From SE side            Created: 2/18/2020 9:30:48 AM            Lat:32.356885, Long:-103.82697         </small> </p>

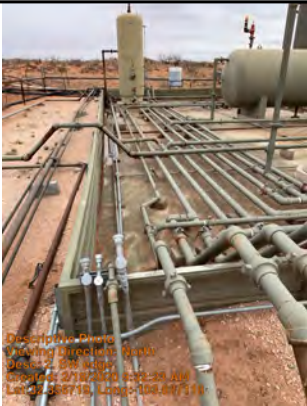
<p> <small>           Descriptive Photo            Viewing Direction: North            Desc: 2. SW edge            Created: 2/18/2020 9:30:19 AM            Lat:32.356732, Long:-103.826983         </small> </p>	<p><b>Viewing Direction: East</b></p>

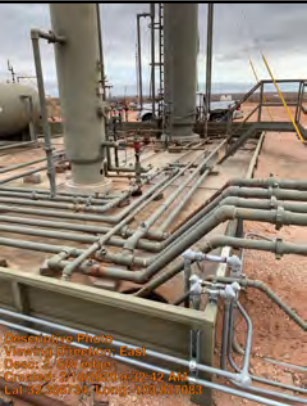
<p> <small>           Descriptive Photo            Viewing Direction: East            Desc: 2. SW Edge            Created: 2/18/2020 9:30:47 AM            Lat:32.356732, Long:-103.826983         </small> </p>

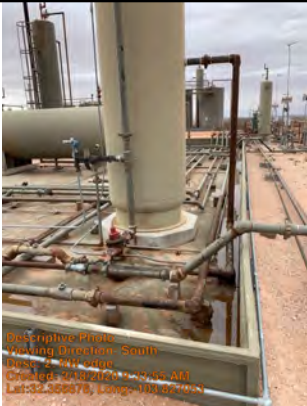
<p><b>Viewing Direction: South</b></p>

<p>Descriptive Photo Viewing Direction: South Deck: 2, NW edge Created: 2/18/2020 9:34:16 AM Lat:32.355878, Long:-103.827072</p> <p>2. NW edge</p>	<p><b>Viewing Direction: East</b></p>

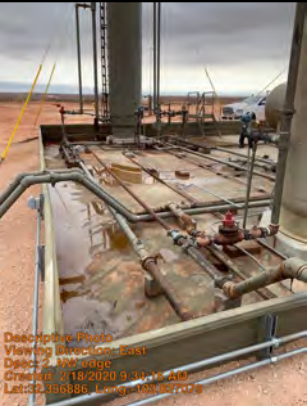
<p>Descriptive Photo Viewing Direction: East Deck: 2, NW edge Created: 2/18/2020 9:34:16 AM Lat:32.355886, Long:-103.827072</p> <p>2. NW edge</p>
<p><b>Viewing Direction: South</b></p>

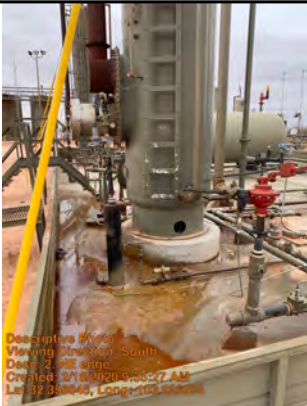
<p>Descriptive Photo Viewing Direction: South Deck: 2, NE edge Created: 2/18/2020 9:35:27 AM Lat:32.355846, Long:-103.826884</p> <p>2. NE edge</p>	<p><b>Viewing Direction: West</b></p>

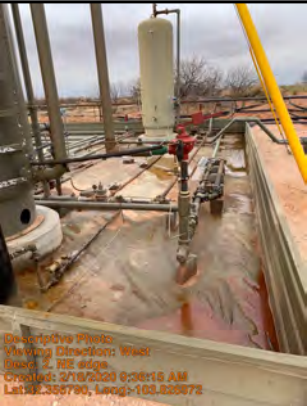
<p>Descriptive Photo Viewing Direction: West Deck: 2, NE edge Created: 2/18/2020 9:35:18 AM Lat:32.355790, Long:-103.826872</p> <p>2. NE edge</p>
