June 18, 2020

Vertex Project #: 20E-00141-005

Spill Closure Report: SDE 31 Federal CTB
Unit C, Section 31, Township 23 South, Range 32 East
County: Lea
API: N/A
Tracking Number: NRM2014559127

2020 Spill Assessment and Closure

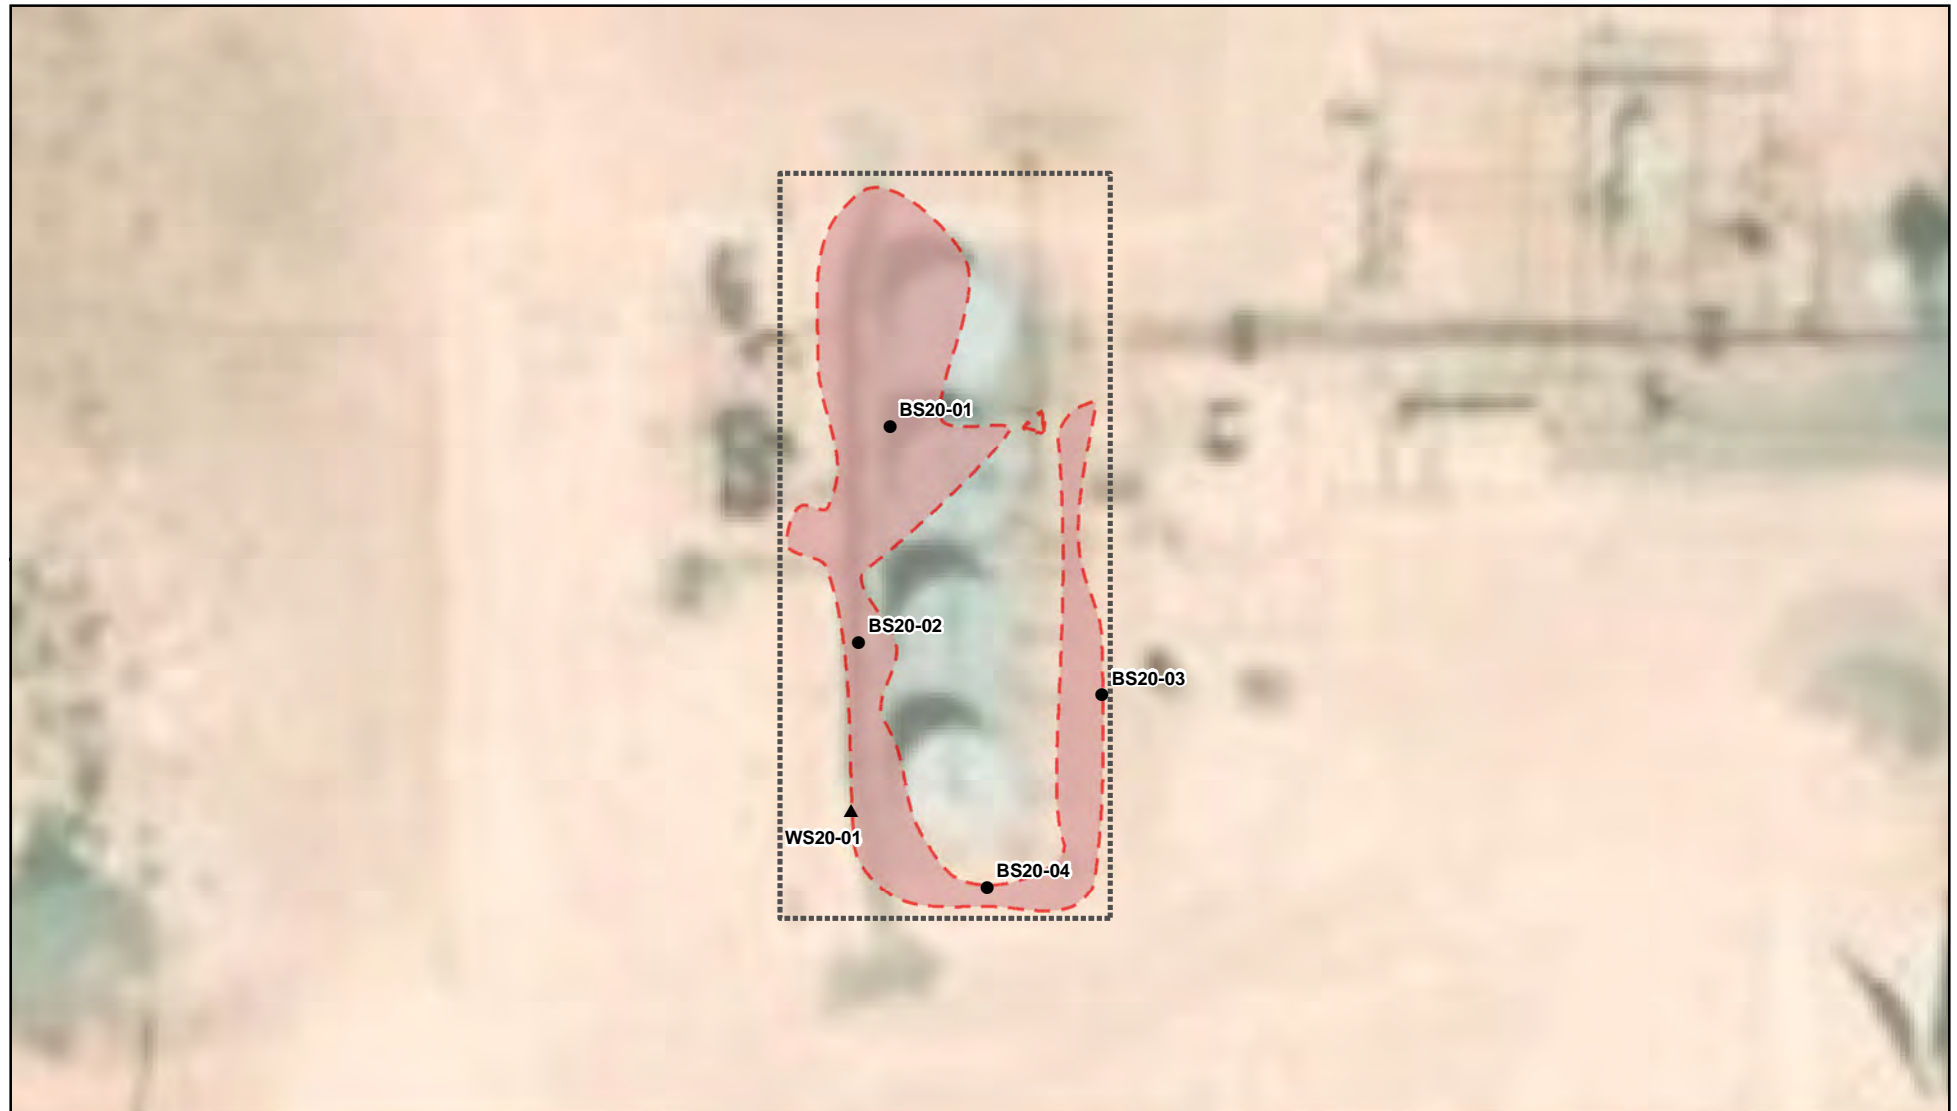
- Base Sample
- ▲ Wall Sample
- Berm
- Spill (approximately 1,462 sq. ft.)

Of the four confirmatory samples, one sample (BS20-03) failed to meet NM OCD closure criteria. Additional excavation was completed in the area of that sample location on April 13, 2020, and the confirmatory sample was re-collected. A wall sample was collected at the same time to bring the total number of confirmatory samples to five. The final laboratory results for this site are shown in Table 3.

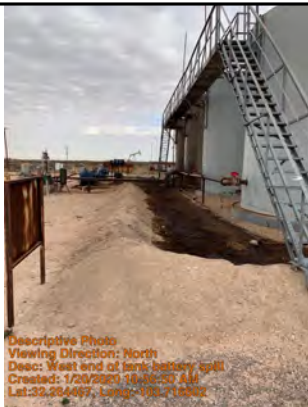
West end of tank battery spill

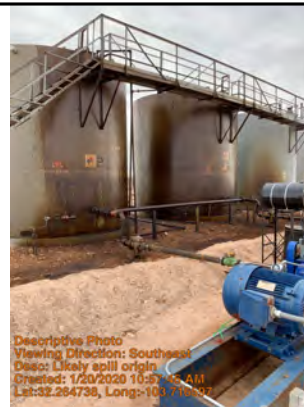
Likely spill origin

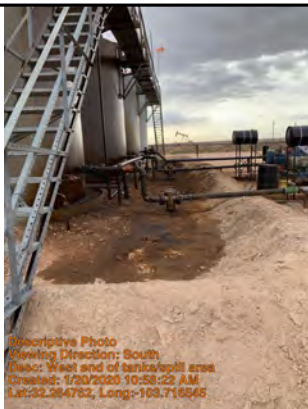
West end of tanks/spill area

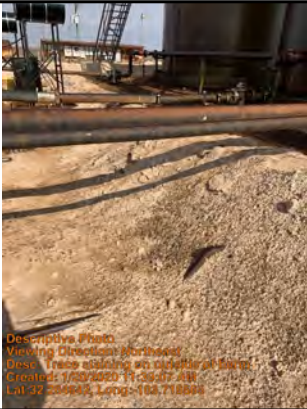
<p>Descriptive Photo Viewing Direction: Northeast Desc: Trace staining on outside of berm Created: 7/8/2020 11:26:07 AM Lat: 32.259445, Long: -103.718884</p>

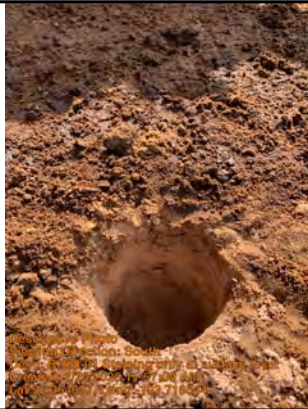
<p>Descriptive Photo Viewing Direction: South Desc: BH20-01 Staining only at surface level Created: 7/8/2020 11:27:08 AM Lat: 32.259445, Long: -103.718884</p>
Trace staining on outside of berm	BH20-01 Staining only at surface level

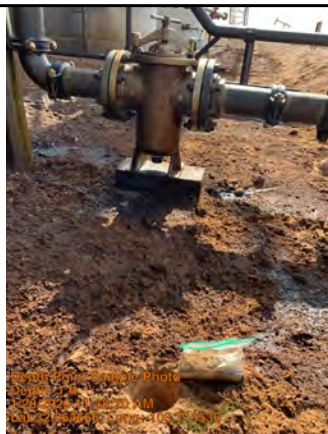
Sample Point ID: BH20-01

Depth: 1 ft.

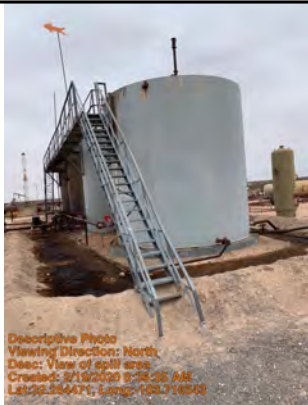
View of spill area

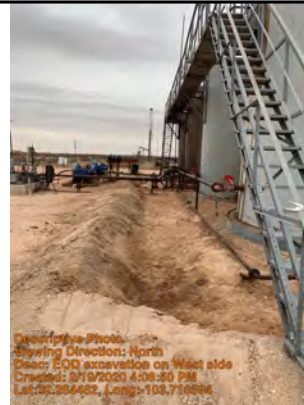
EOD excavation on West side

Hand excavation of the contaminated soil was conducted between February 19 and 20, 2020, with a Vertex representative on-site to conduct field screening to guide the excavation and determine final horizontal and vertical extents of the excavation area as presented on Figure 2 (Attachment 2). As remediation activities were completed, Vertex collected a total of four five-point composite confirmatory samples from the base of the excavation, at a depth of approximately 2 feet bgs. Each composite sample was representative of no more than 200 square feet per the alternate sampling method outlined in Subparagraph (c) of Paragraph (1) of Subsection D 19.15.29.12 NMAC, which does not require prior NM OCD approval. The composite samples were placed into laboratory-provided containers, preserved on ice, and submitted to a National Environmental Laboratory Accreditation Program-approved laboratory for chemical analysis.

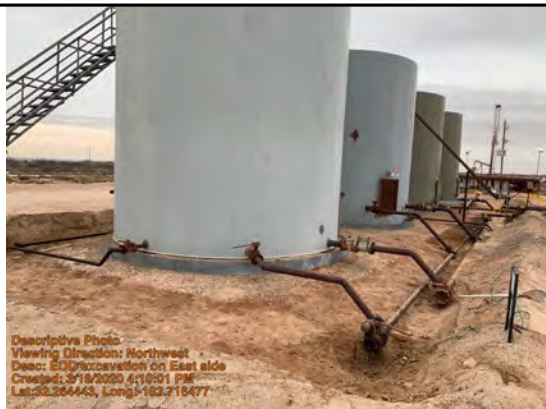
EOD excavation on East side

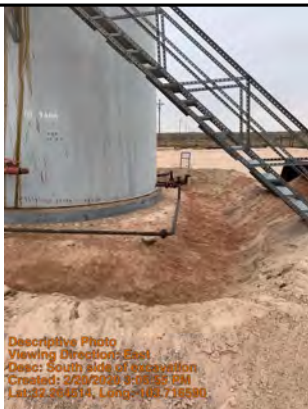
South side of excavation

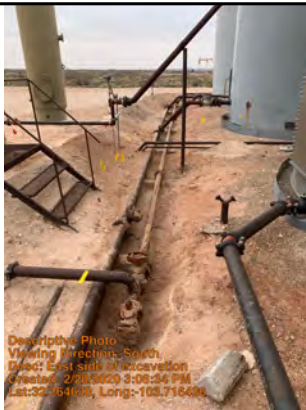
Descriptive Photo
Viewing Direction: South
Date: East side of excavation
Created: 2/20/2020 3:08:34 PM
Lat:32.764028, Long:-103.716488

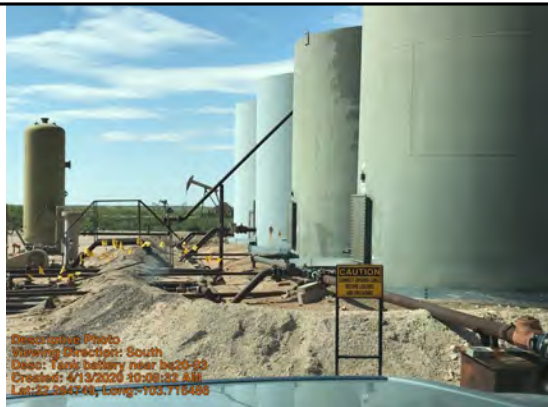
Tank battery near bs20-03

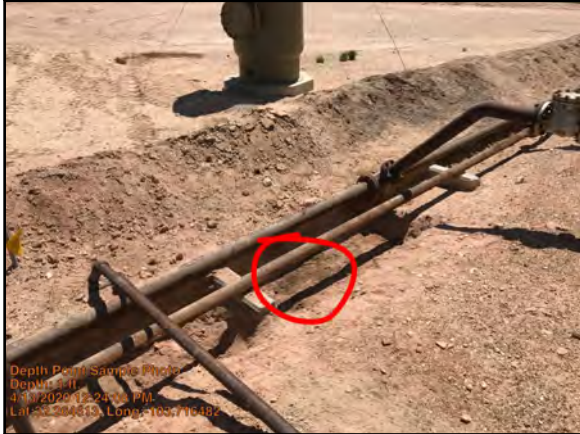
Sample Point ID: ES-Base20-03

Depth: 1 ft.
