## Release Notification and Corrective Action

**REMEDATION REPORT**  
**Produced Water Flow line Leak**

C.S. Caylor Lease  
1RP-2553

Lea County, New Mexico

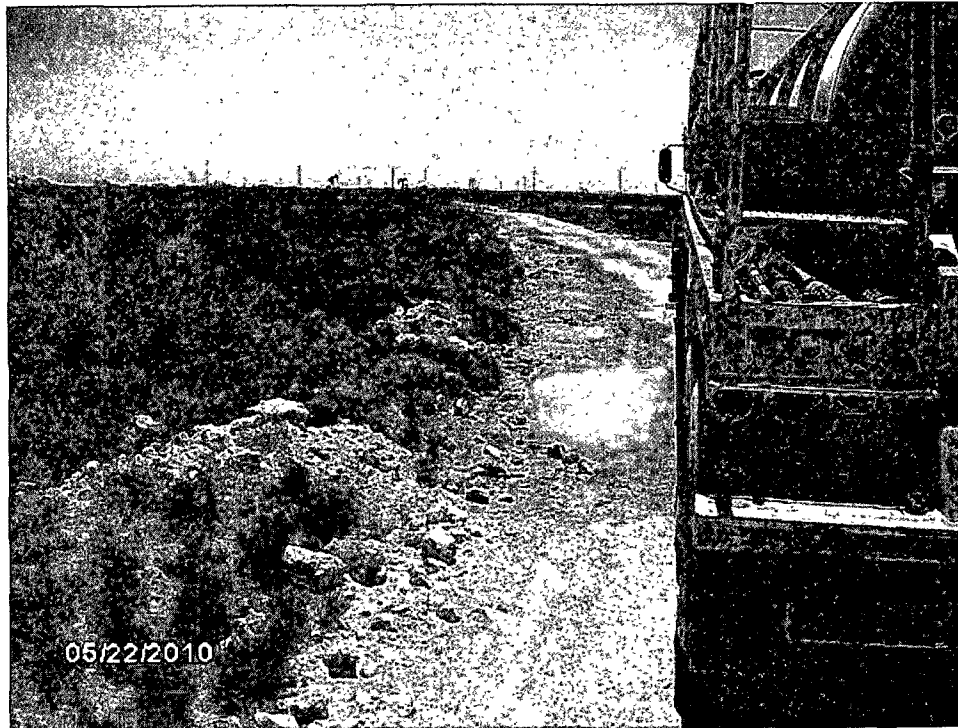
May 22, 2010 - Leak area viewing south.

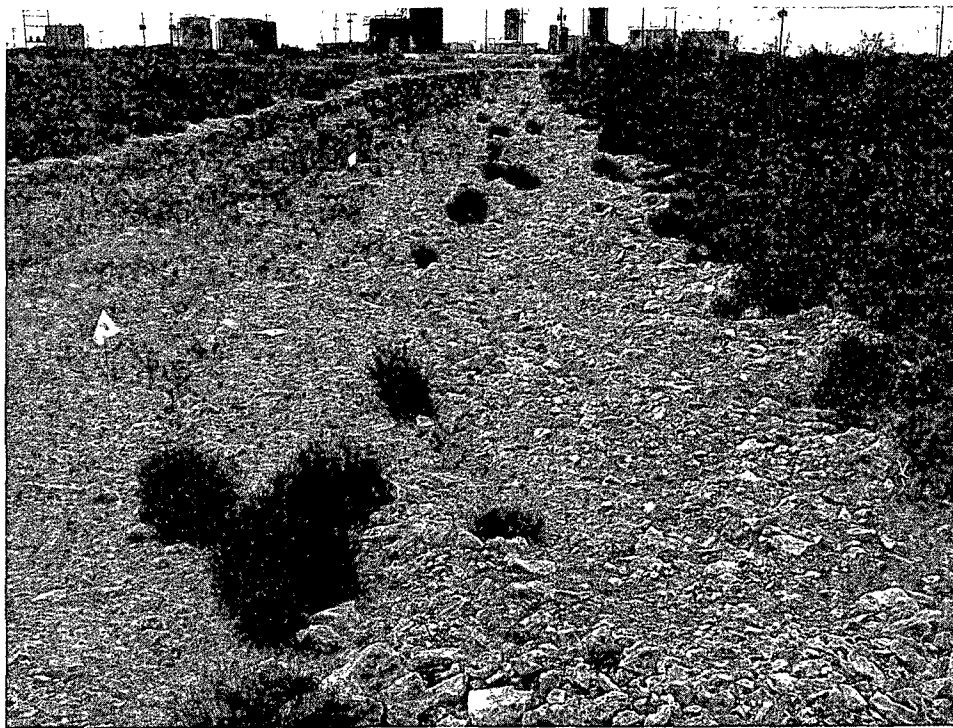
June 3, 2010 - Leak area viewing north.

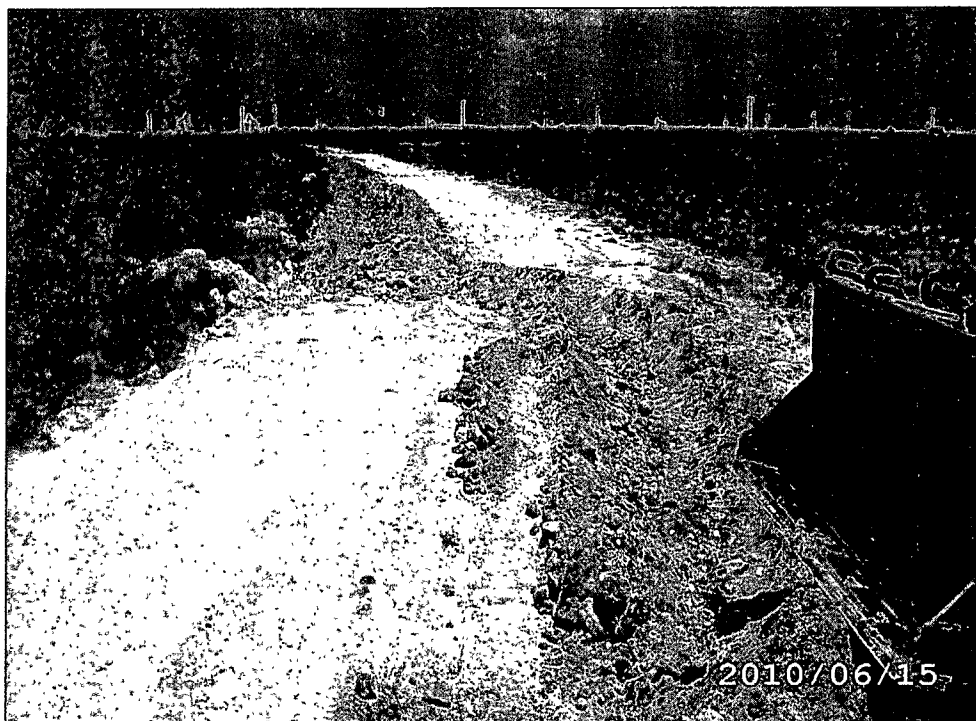
June 15, 2010 - Excavated leak location viewing south.

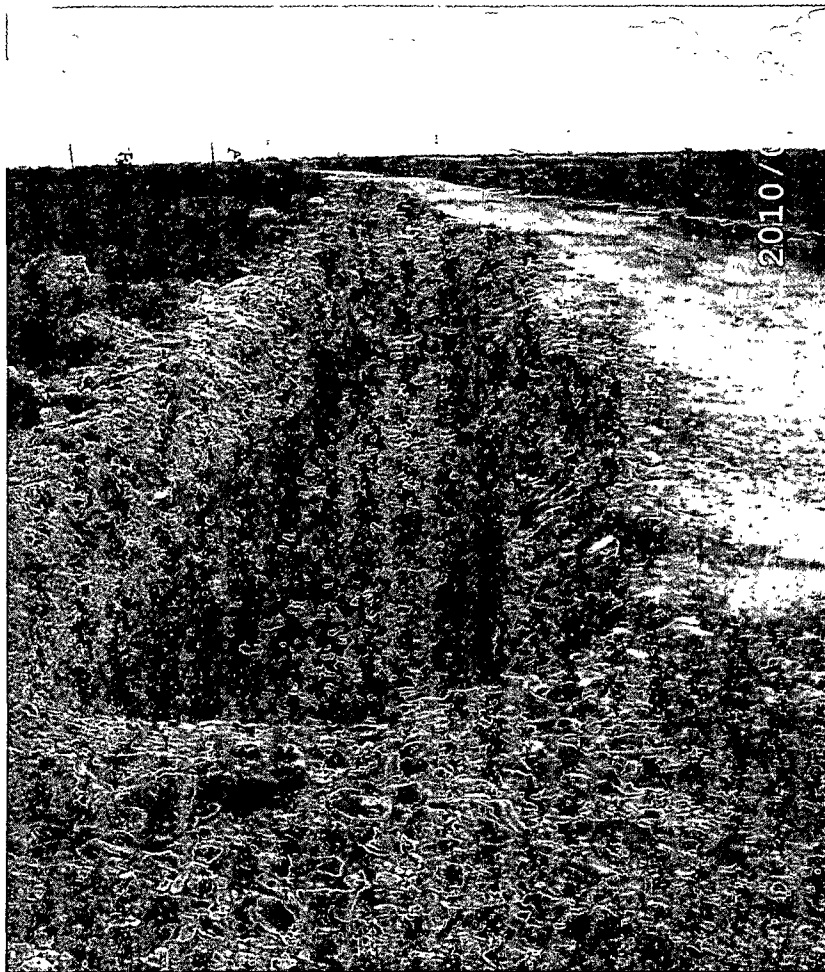
June 18, 2010 - Excavated leak area (approximately 5 to 8 feet) viewing south.

On June 18 and 23, 2010, LAI personnel collected samples between 5 and 8 feet bgs which reported chloride concentrations between 32 mg/Kg for sample SS-1 to 448 mg/Kg in sample SS-5. Sidewall samples were collected near locations SS-1, SS-6 and SS-9, which reported chloride concentrations between 32 and 80 mg/Kg. Analytical laboratory reports are presented in Appendix A.
