Closure Report

*Re: EBDU Injection Lateral
Case # NRM2015533063*

On May 13, 2020 a release occurred due to a 2 inch steel transition failed on the injection line. The release (GPS: 32.49956, -103.12059) is located north of Eunice, NM in unit letter C section 12 township 21S range 37E. A groundwater survey was conducted utilizing data from NMOSE and USGS. The three nearest wells of record indicate that groundwater is 60 feet below ground surface.

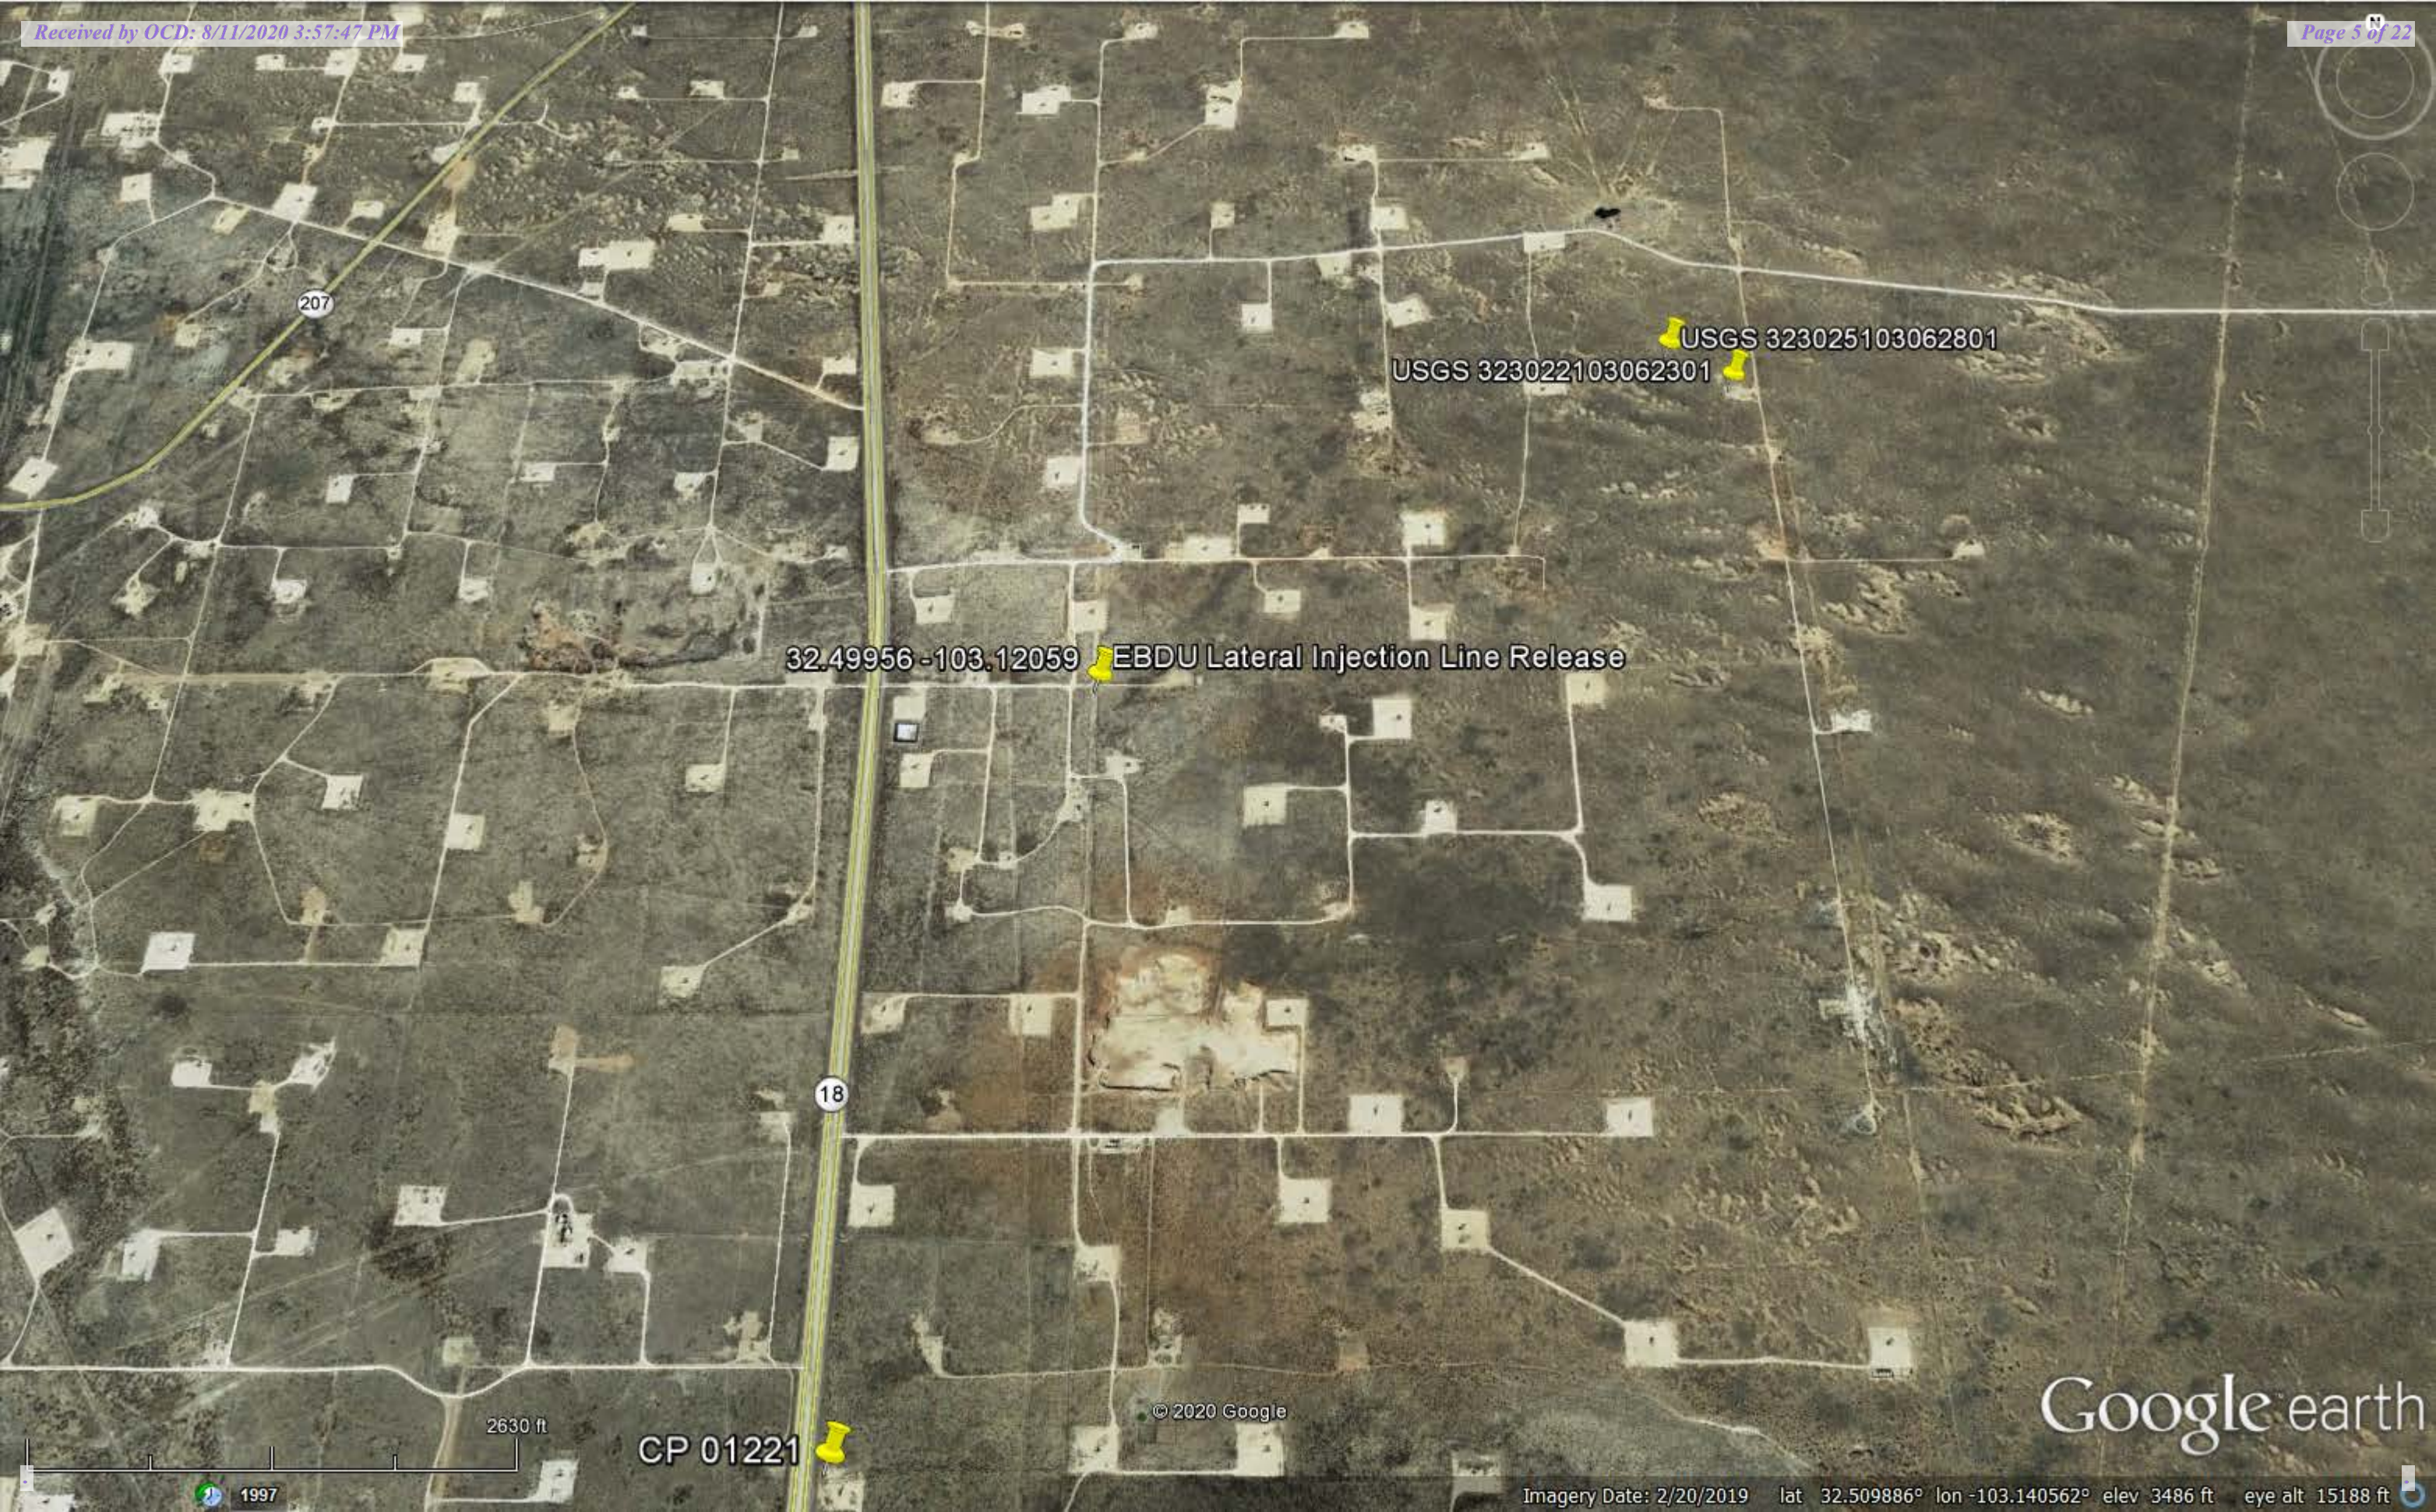
USGS 323025103062801
USGS 323022103062301

32.49956 -103.12059 EBDU Lateral Injection Line Release

CP 01221

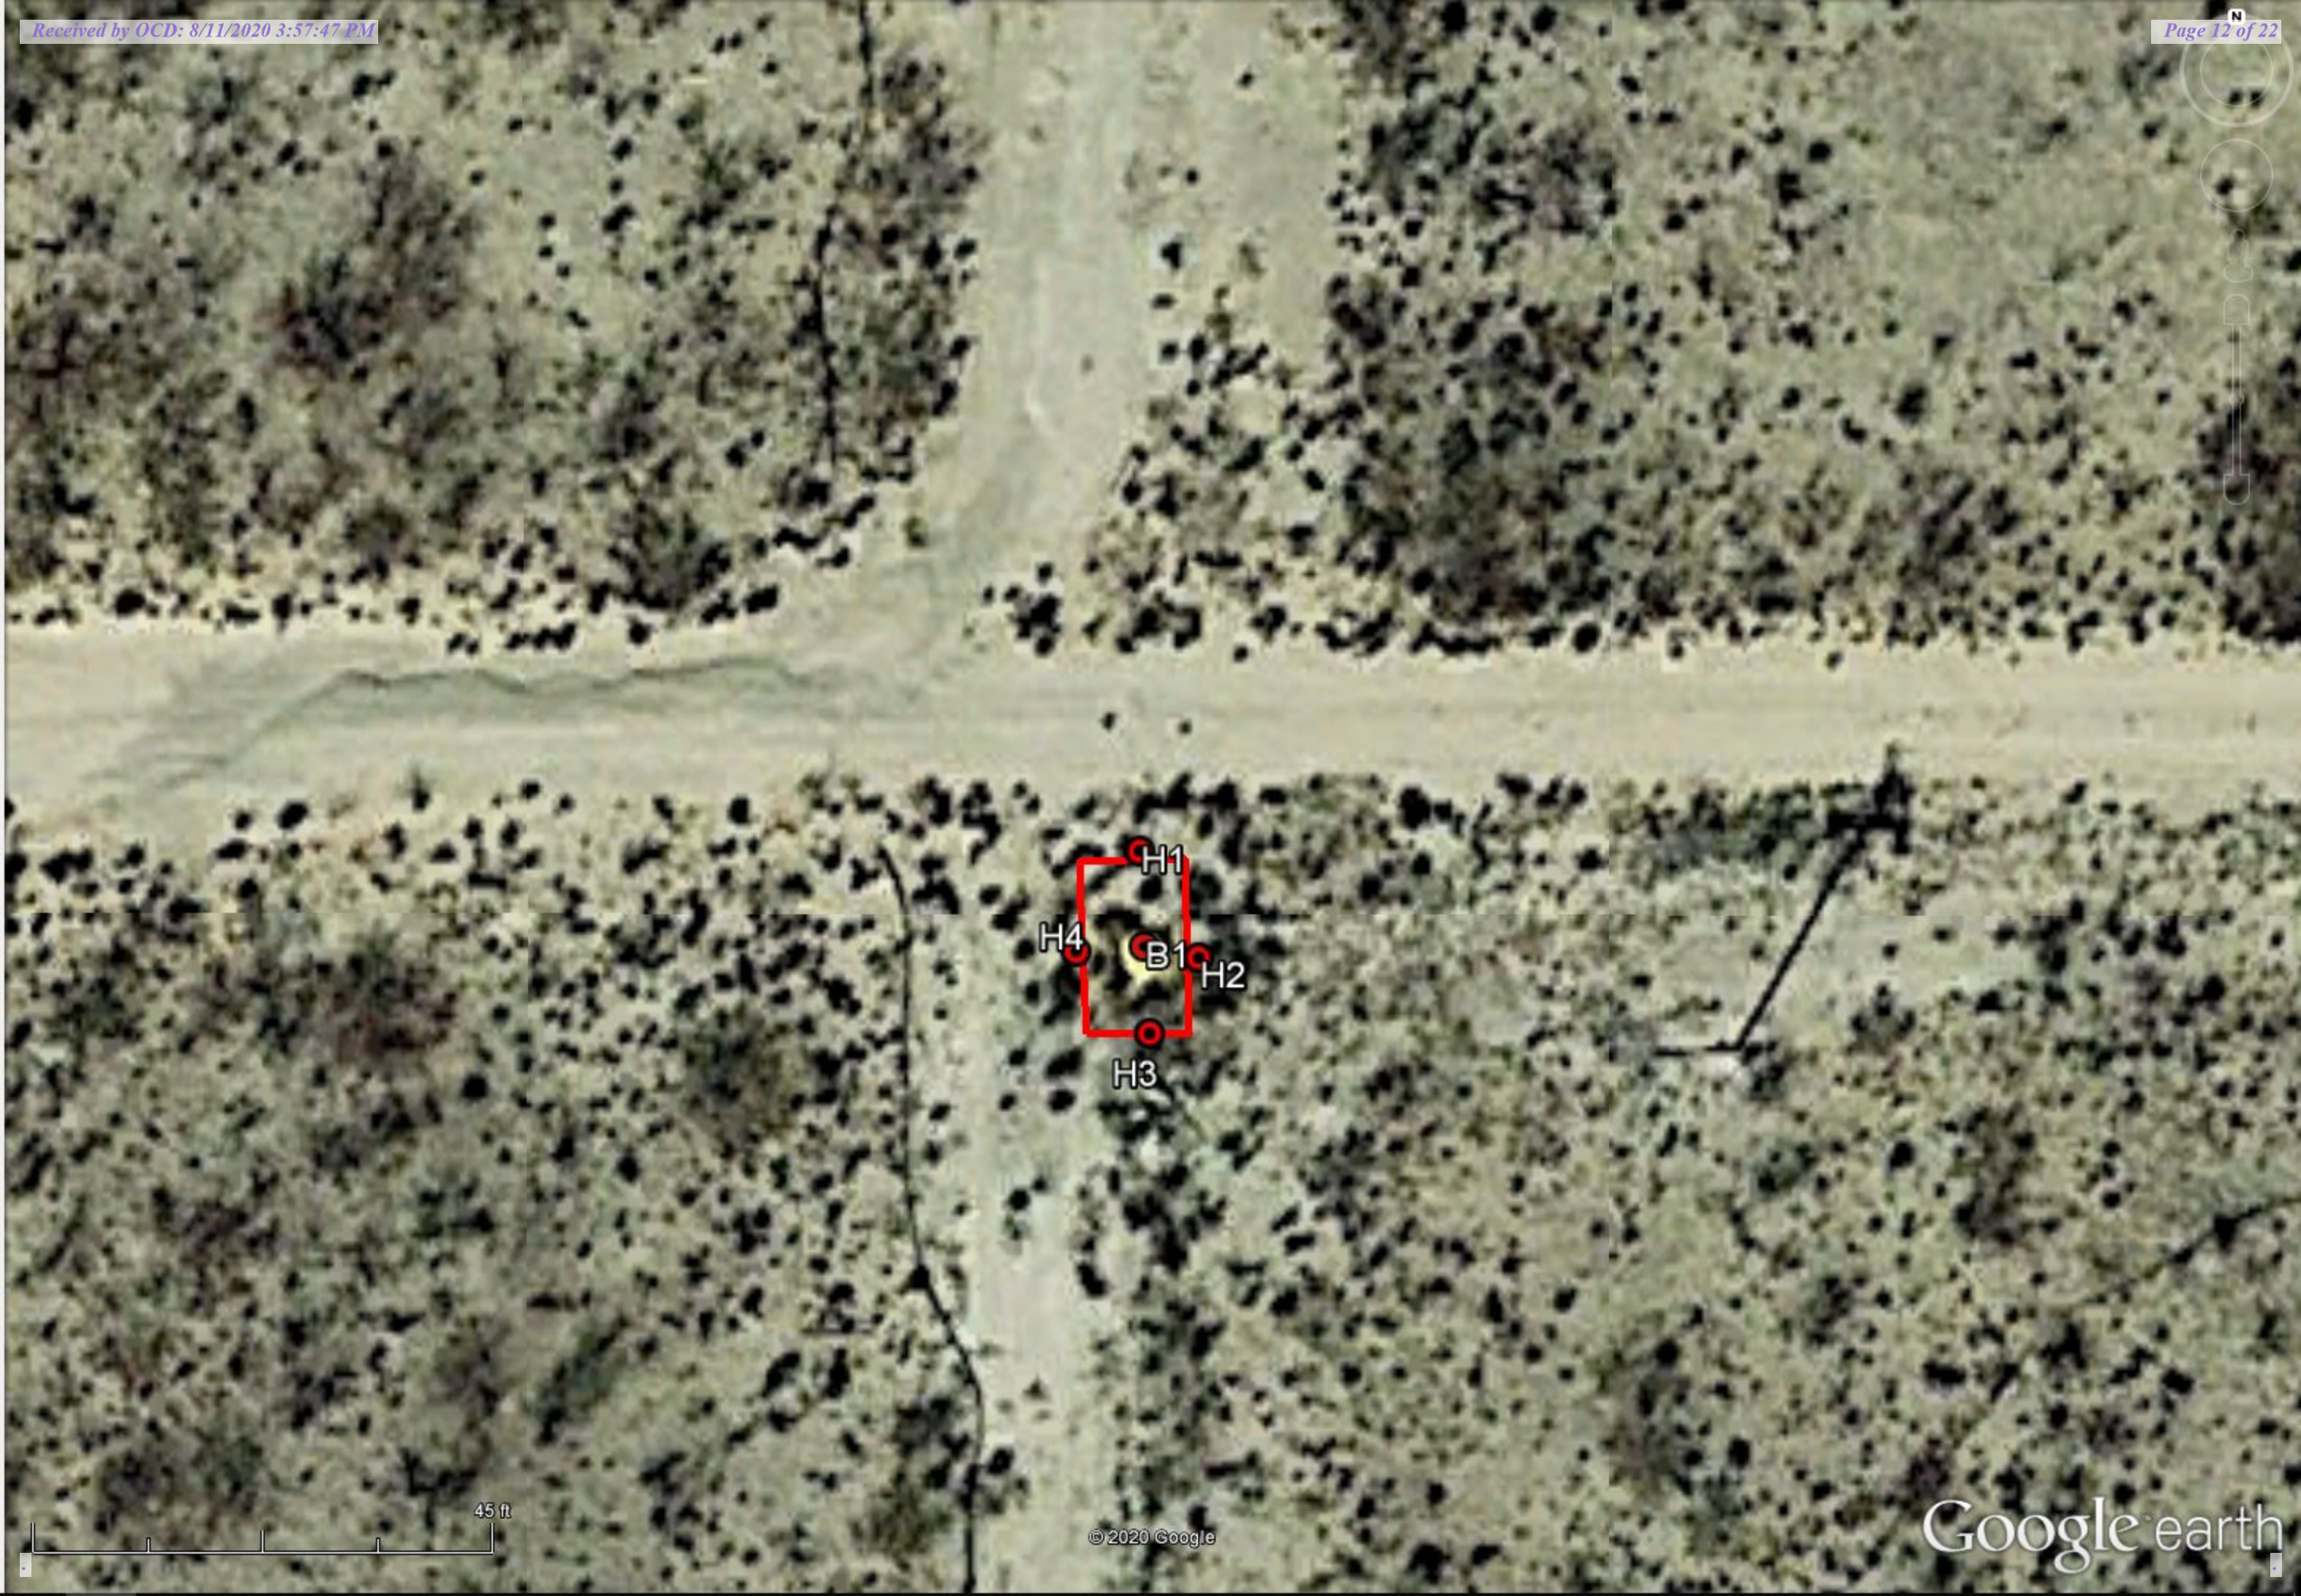
NEDU Injection Line

Map ID	Sample Date	Sample ID	Depth	Chloride	Benzene	Toulene	Ethybenzene	Total Xylenes	Total BTEX	GRO	DRO	EXT DRO	GPS Coordinates
Horizontal Samples													
H1	8/10/2020	HC1	S	336	<0.050	<0.050	<0.050	<0.150	<0.300	<10.0	<10.0	<10.0	32.499636 -103.120570
H2	8/10/2020	HC2	S	<16.0	<0.050	<0.050	<0.050	<0.150	<0.300	<10.0	<10.0	<10.0	32.499608 -103.120551
H3	8/10/2020	HC3	S	64	<0.050	<0.050	<0.050	<0.150	<0.300	<10.0	<10.0	<10.0	32.499587 -103.120566
H4	8/10/2020	HC4	S	16	<0.050	<0.050	<0.050	<0.150	<0.300	<10.0	<10.0	<10.0	32.499609 -103.120590
Bottom Samples													
B1	8/10/2020	B1	3'	160	<0.050	<0.050	<0.050	<0.150	<0.300	<10.0	<10.0	<10.0	32.499611 -103.120568

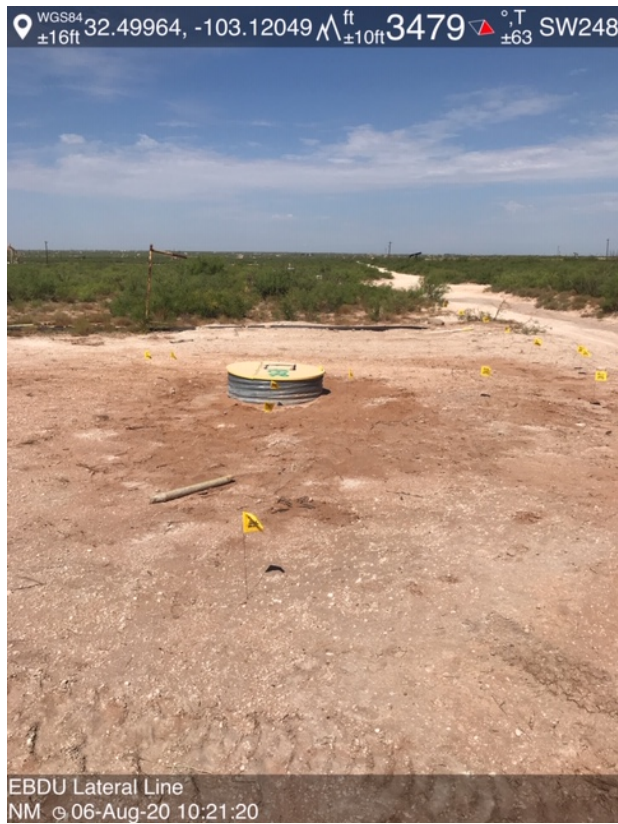
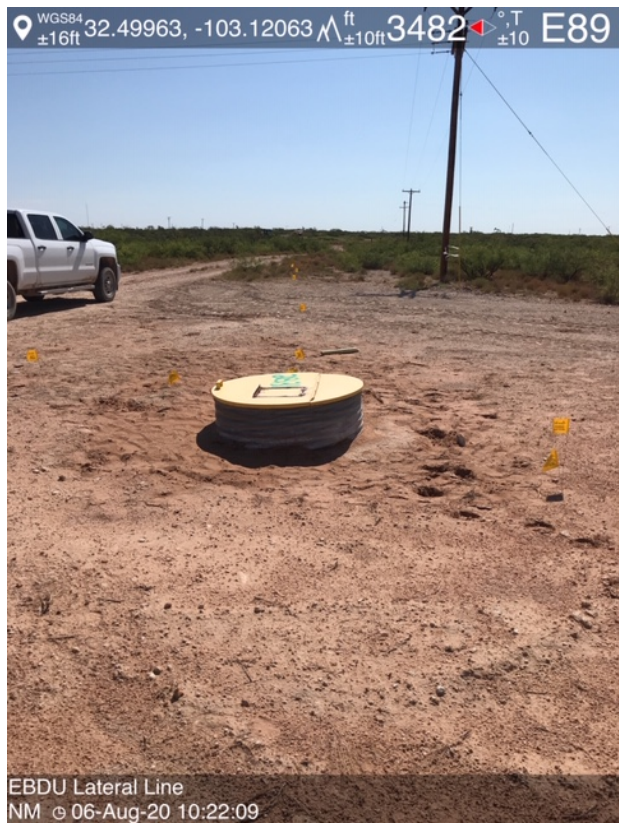
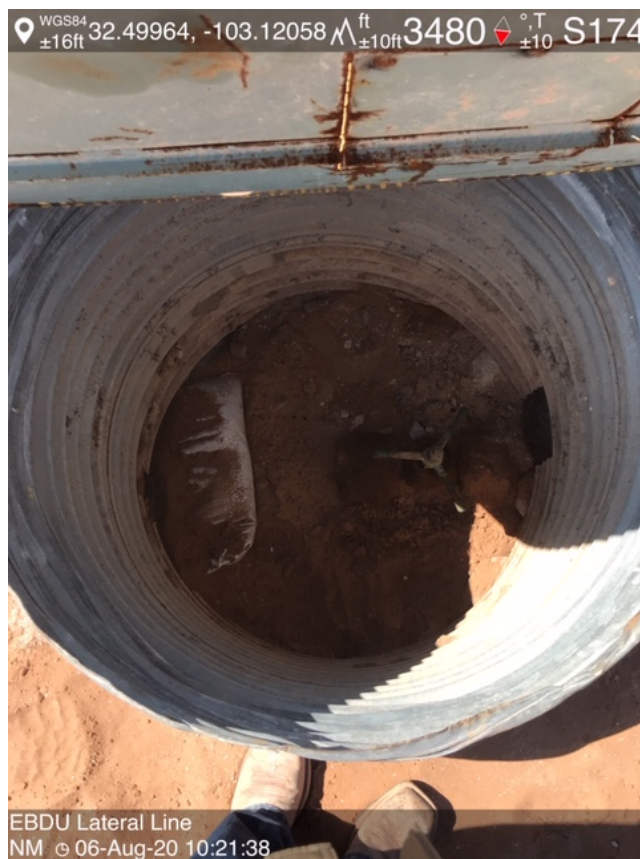
The saturated soil was excavated during the line repair. All excavated material (24 cubic yards) was hauled to an OCD approved facility. After the line was repaired a tin horn was installed at the repair and clean imported topsoil was backfilled to surface around the tin horn. On August 10, 2020 final five point bottom and horizontal composite samples were collected not exceeding 200 square feet and submitted to a commercial laboratory for analysis of chloride, TPH, and BTEX. The laboratory results were below table one standards.
