Release Notification

| Site Name: Fiddle Fee 23X 1H | Site Type: Oil & Gas |

RE: FIDDLE FEE 23X 1H LETTER REPORT, EDDY COUNTY, NEW MEXICO

Fiddle Fee 23X 1H Liner Integrity Inspection Photo Log
NRM2014856222

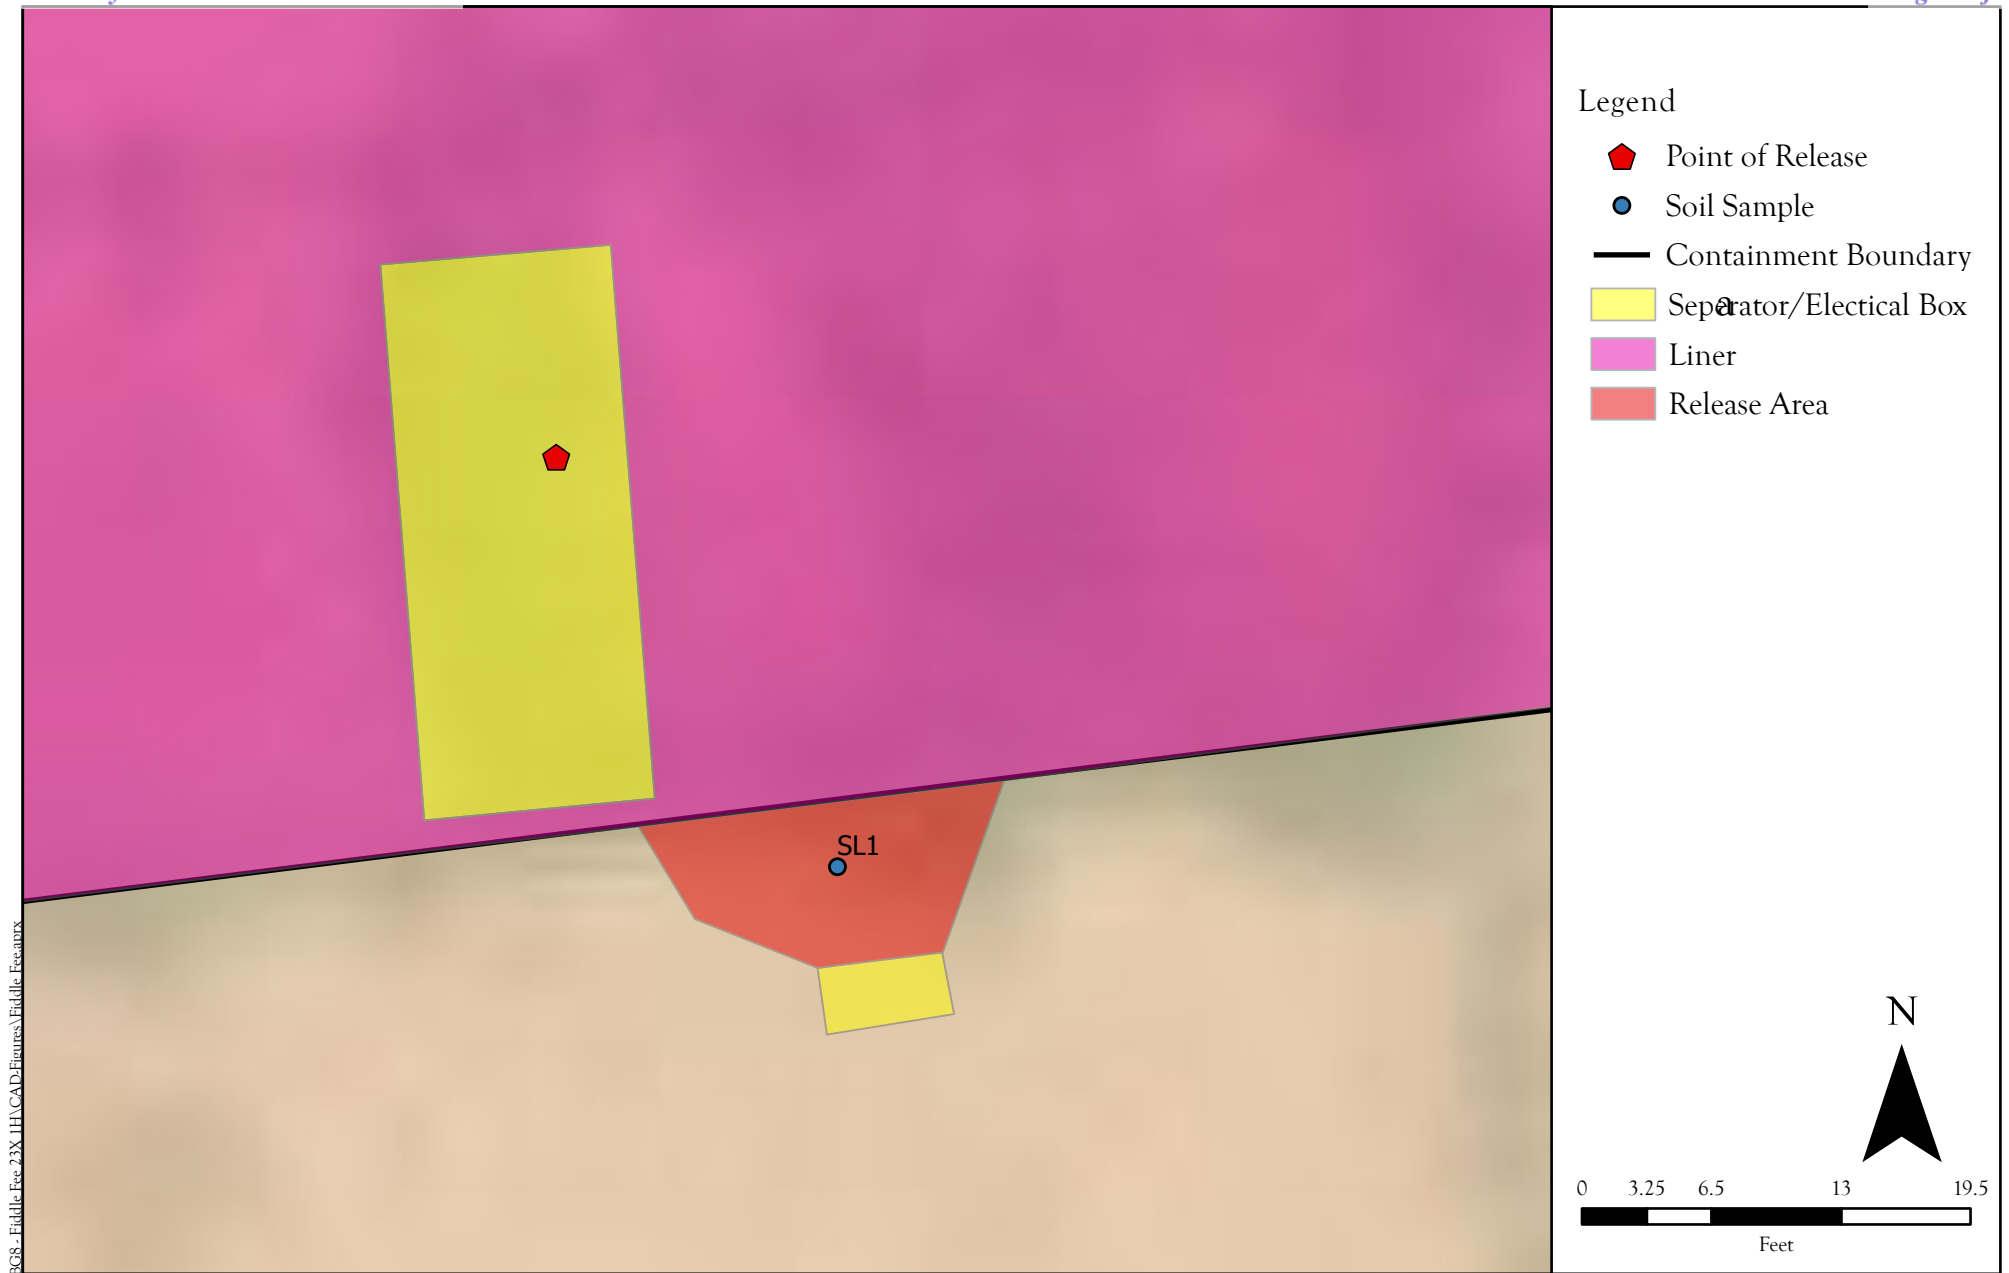
Figure 3

Site and Sample Location Map
 Fiddle Fee 23X 1H - Marathon Oil, Permian LLC
 UL: H S: 23 T: 24S R: 28E Eddy County, New Mexico

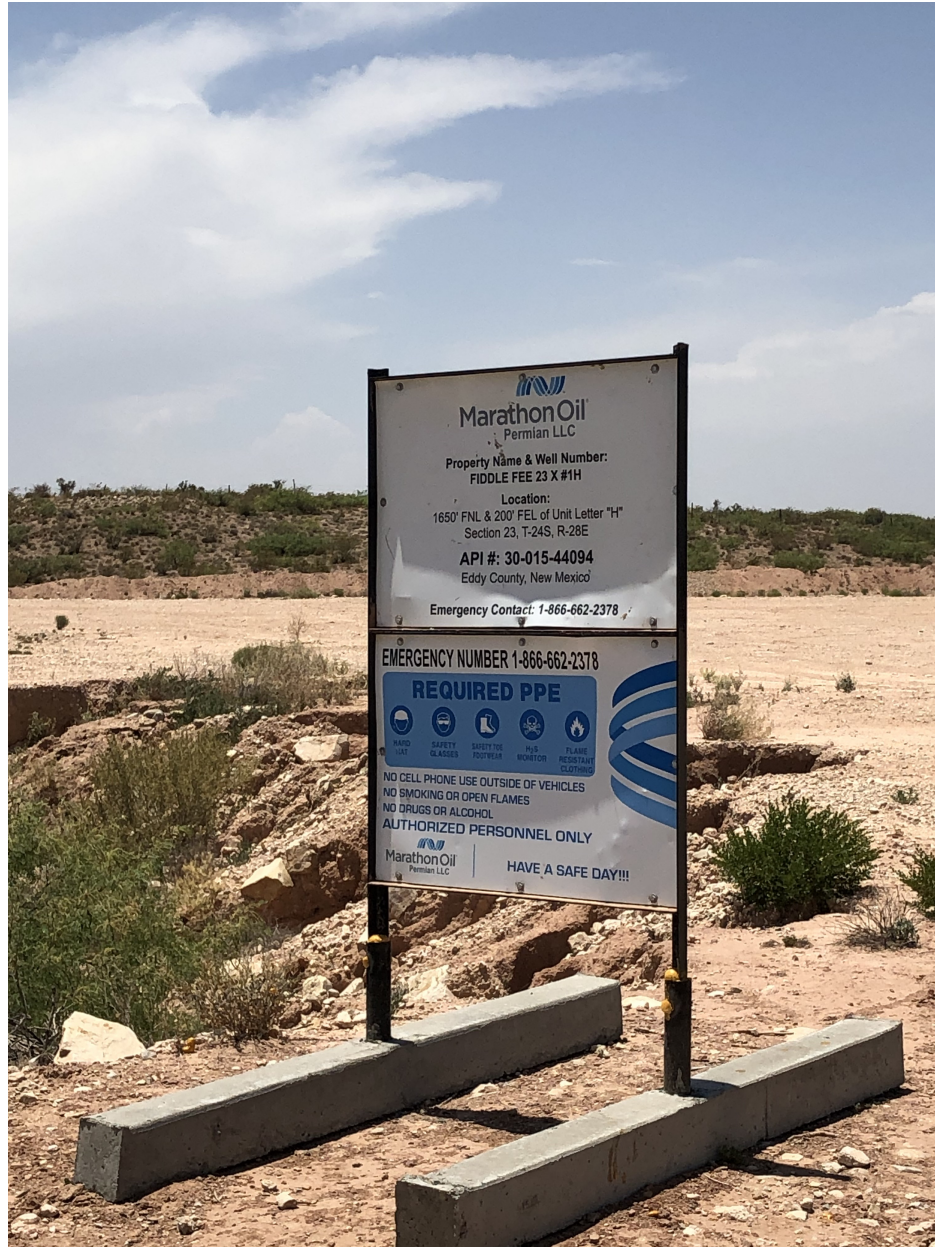
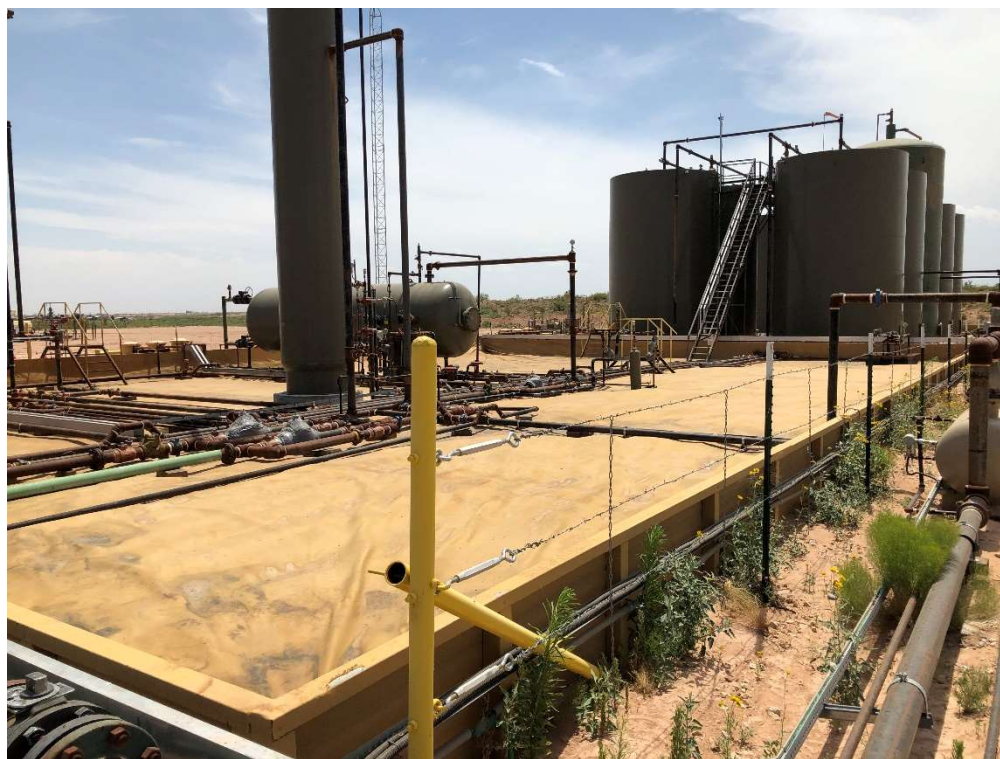
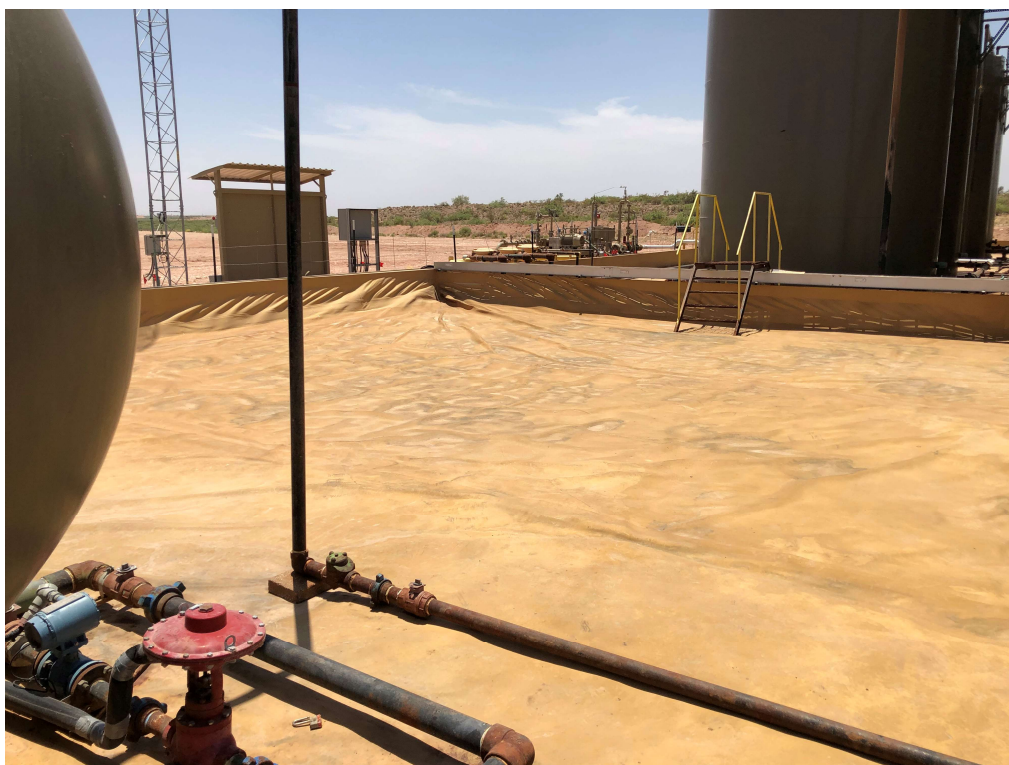
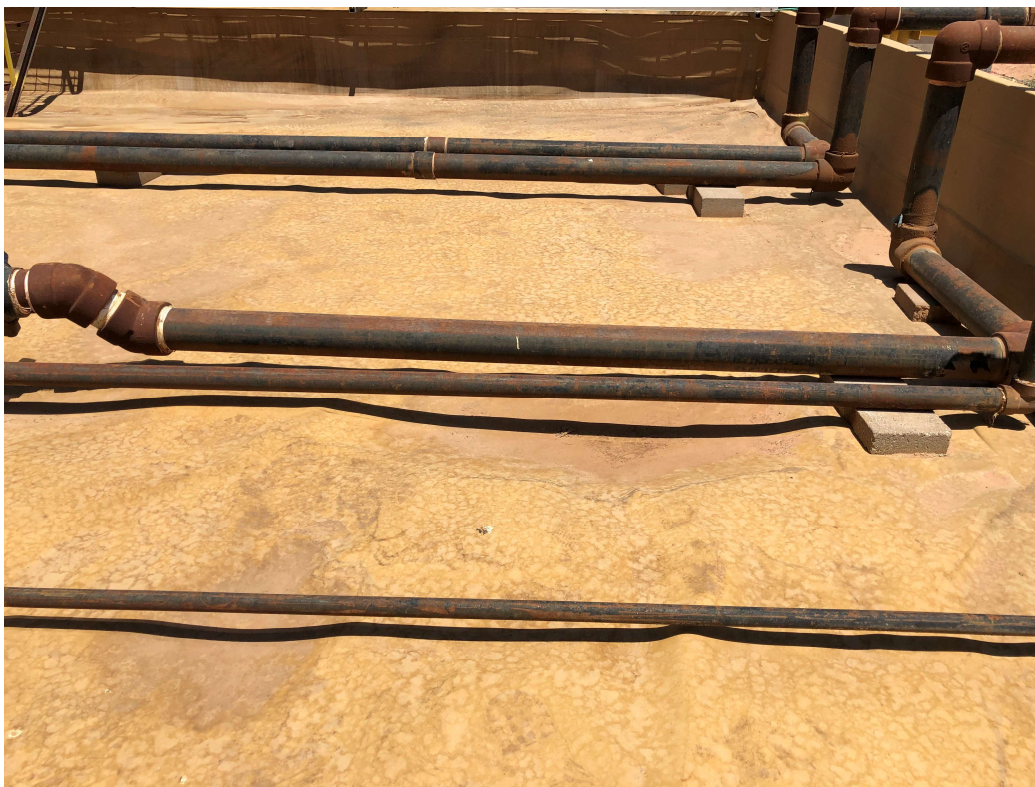
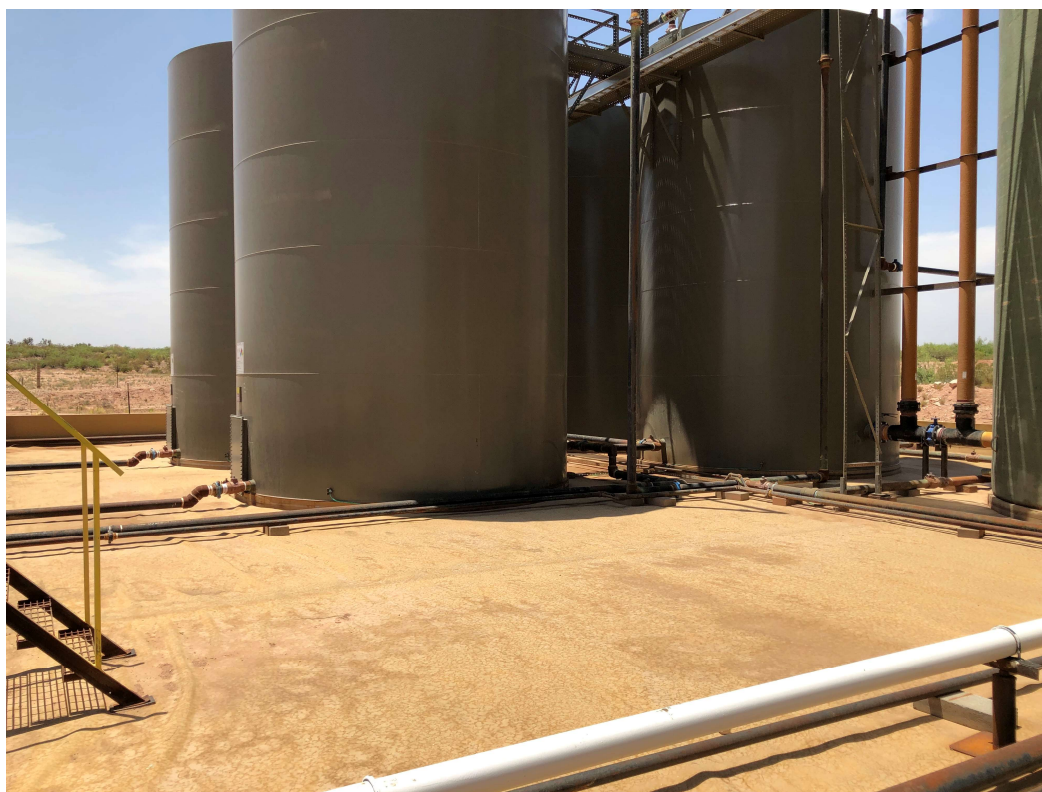
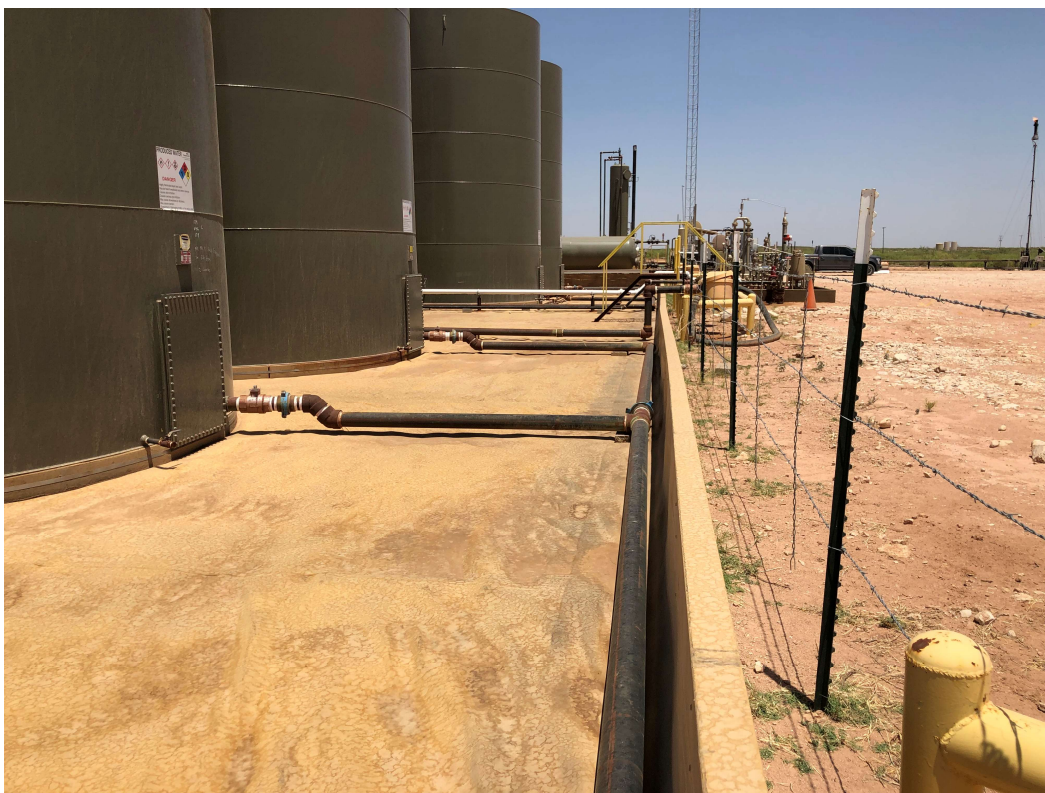
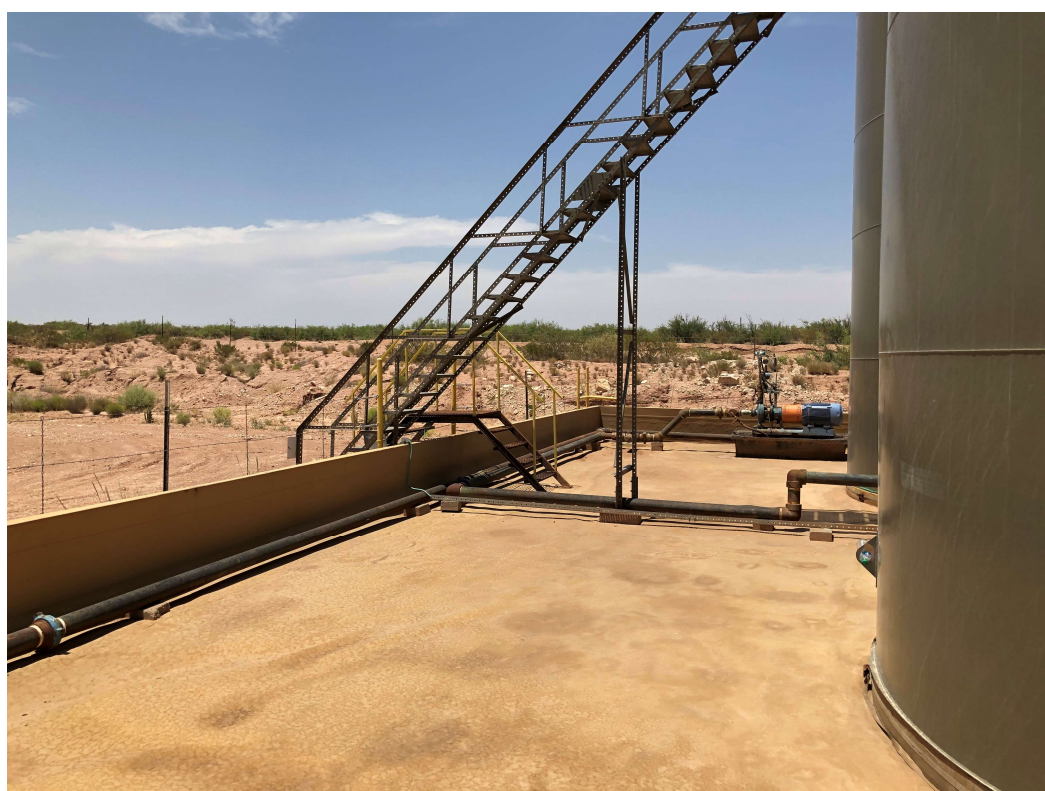
Liner had the ability to contain the leak in question:

powerwashed 6/10
no failures in containment or liner
overspray area sampled.

The liner inspection conducted by Marathon is included at the end of this report. SMA recommends no further action for this release.
