August 31, 2020

Vertex Project #: 20E-00141-024

**Spill Closure Report:** Todd 14 Battery  
Unit K, Section 14, Township 23 South, Range 31 East  
County: Eddy  
Incident Tracking Number: NRM2000935403

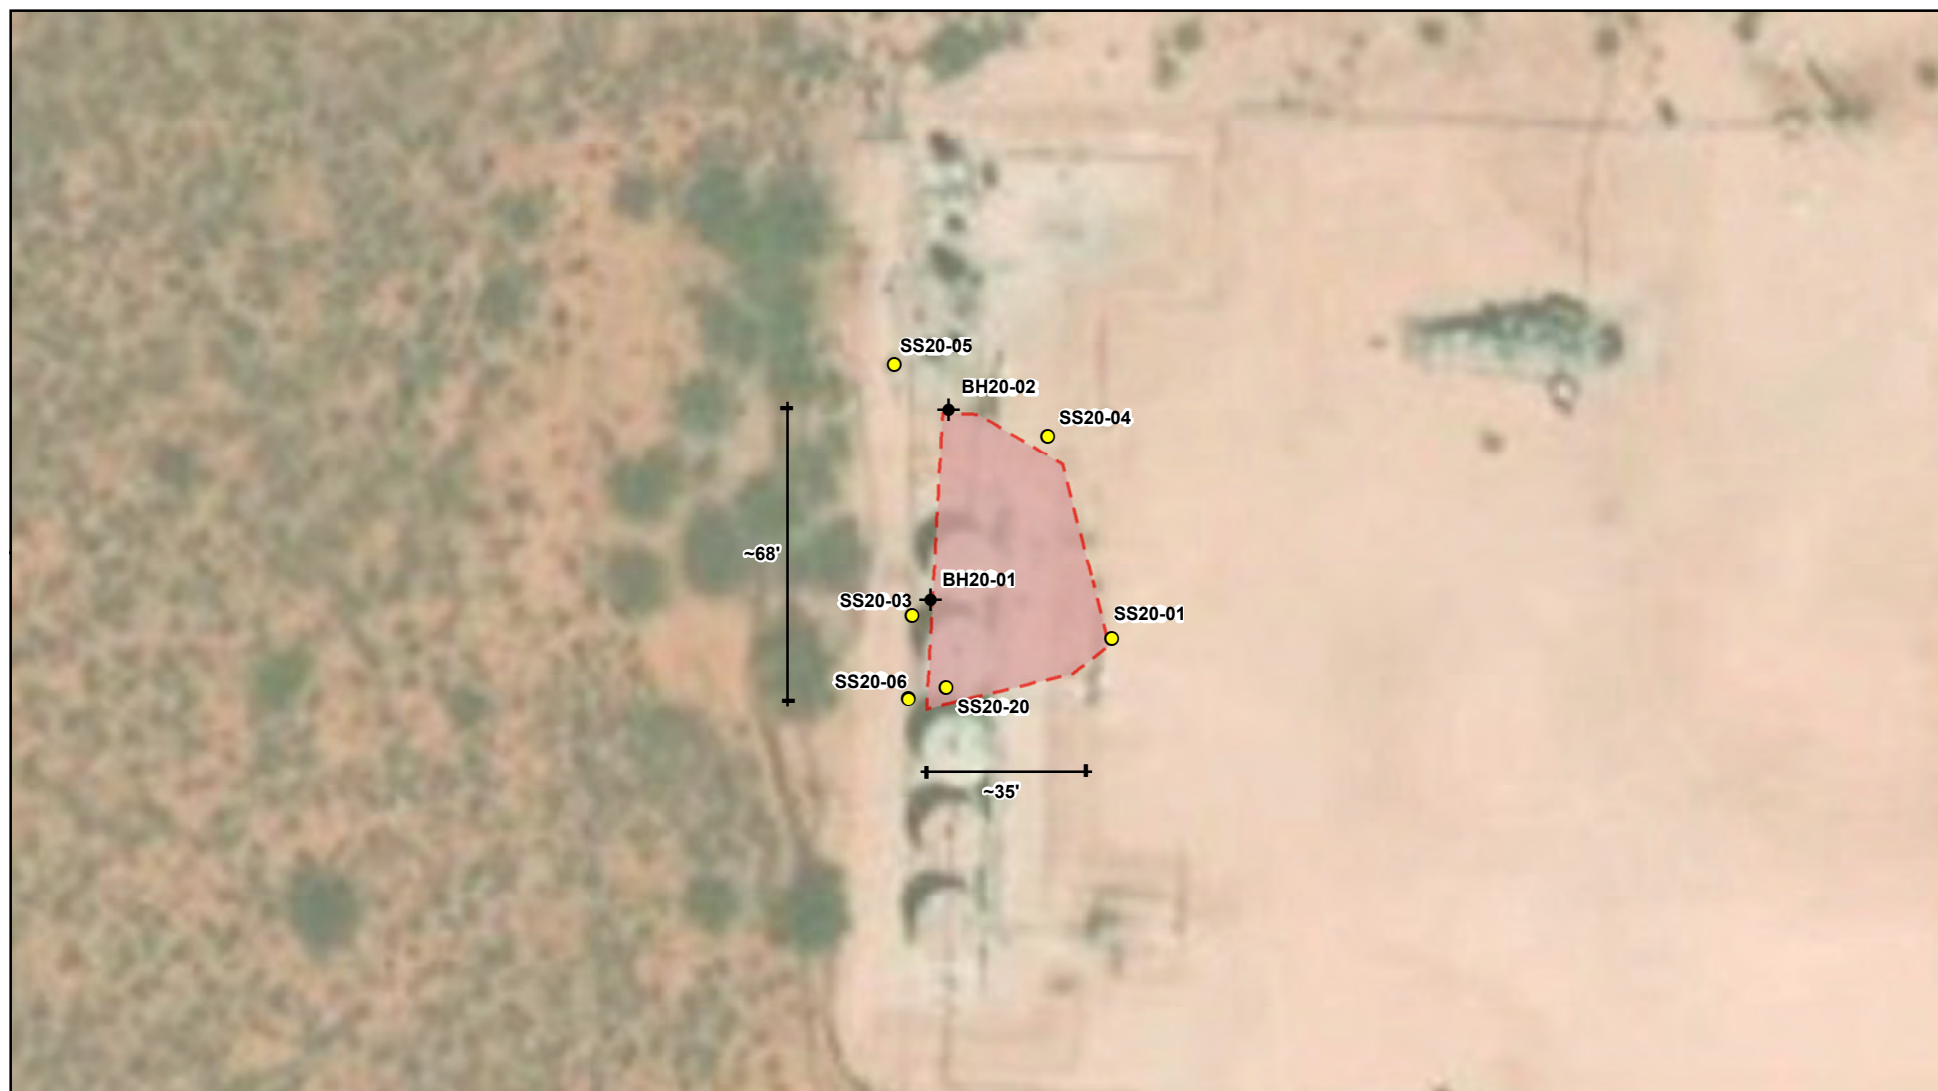
- ✦ Borehole
- Surface Sample
- Spill Area (~1,808 sq. ft.)
